Rail Accident Report

Train dispatch accident at Elstree & Borehamwood station 7 September 2018

Report 03/2019
May 2019

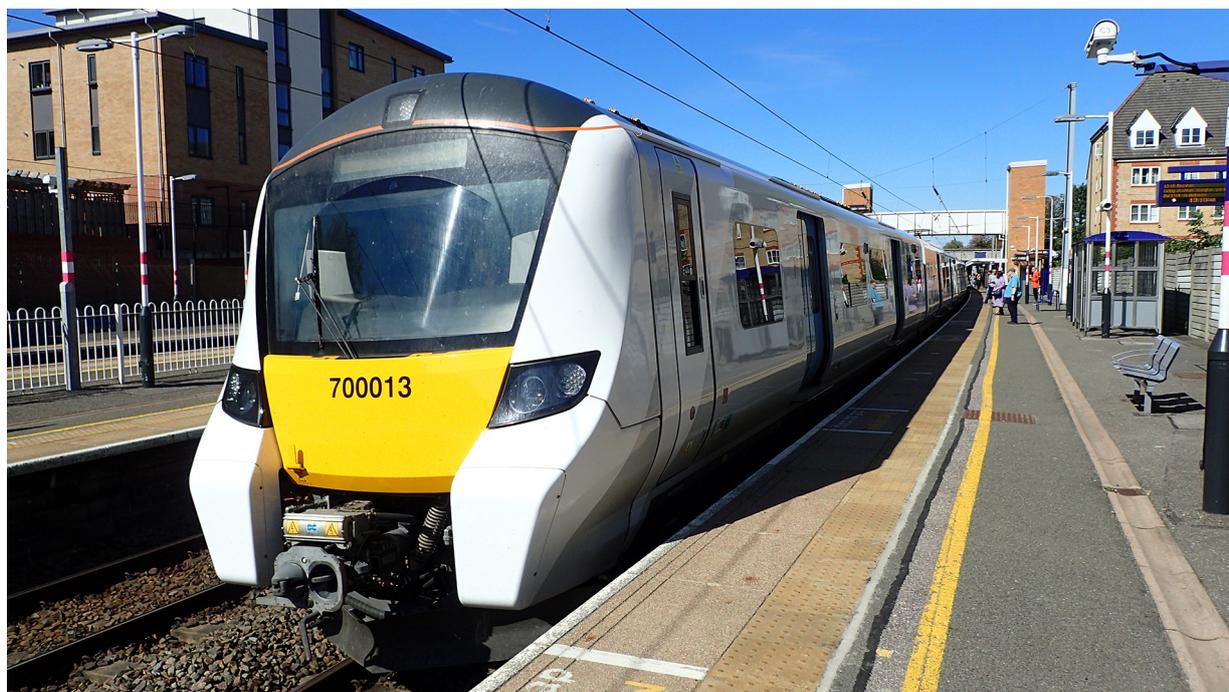
Figure 4: A class 700 EMU of the type involved in the accident

- 13 The train service involved was 9O47³, the 13:52 hrs service from St Albans City to Sutton, running via the Thameslink route through central London (figure 2).
- 14 Train 9O47 was formed of an eight coach class 700 Electric Multiple Unit (EMU)⁴ (figure 4), unit number 700060. This unit was first accepted into traffic by GTR on 2 July 2018⁵. By the date of the accident, it had covered approximately 19,000 miles and therefore had not yet reached the 20,000 mile interval for its first planned maintenance intervention since delivery.

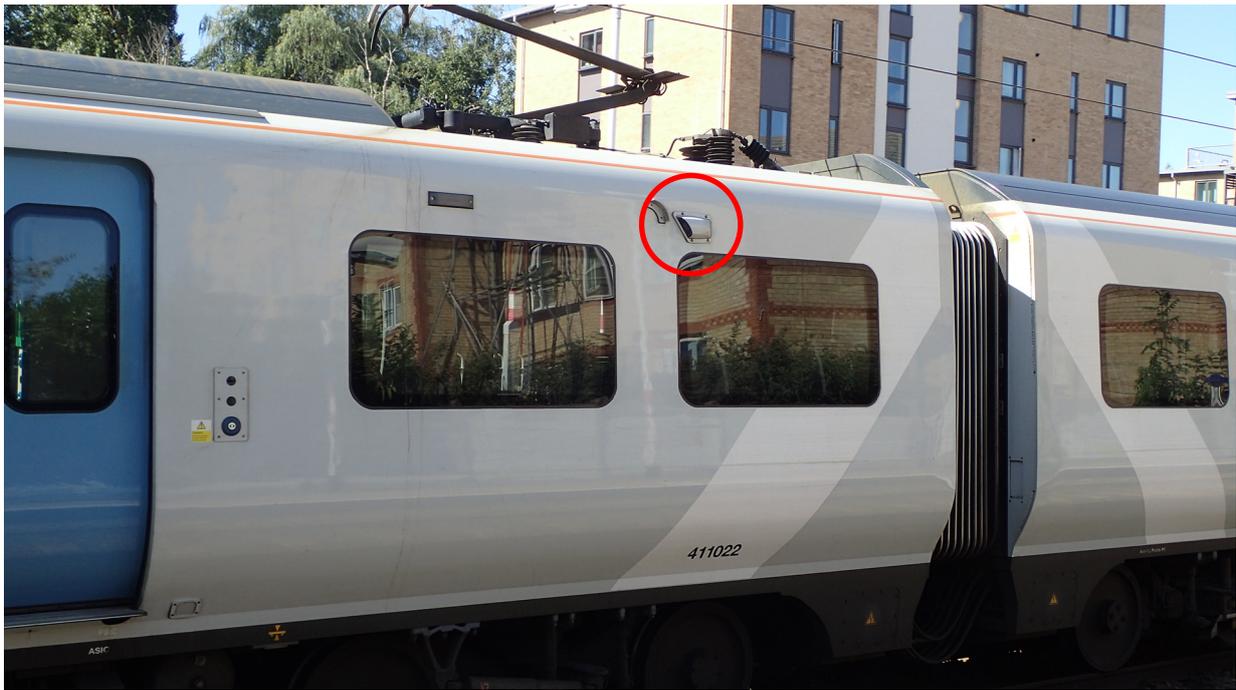
39 Each coach on a class 700 train is fitted with exterior mounted CCTV cameras, one on each side (figure 5). These provide an external image of the doors, the side of the vehicles and the adjacent platform edge.

Figure 5: Exterior mounted CCTV camera (circled) on a class 700 coach

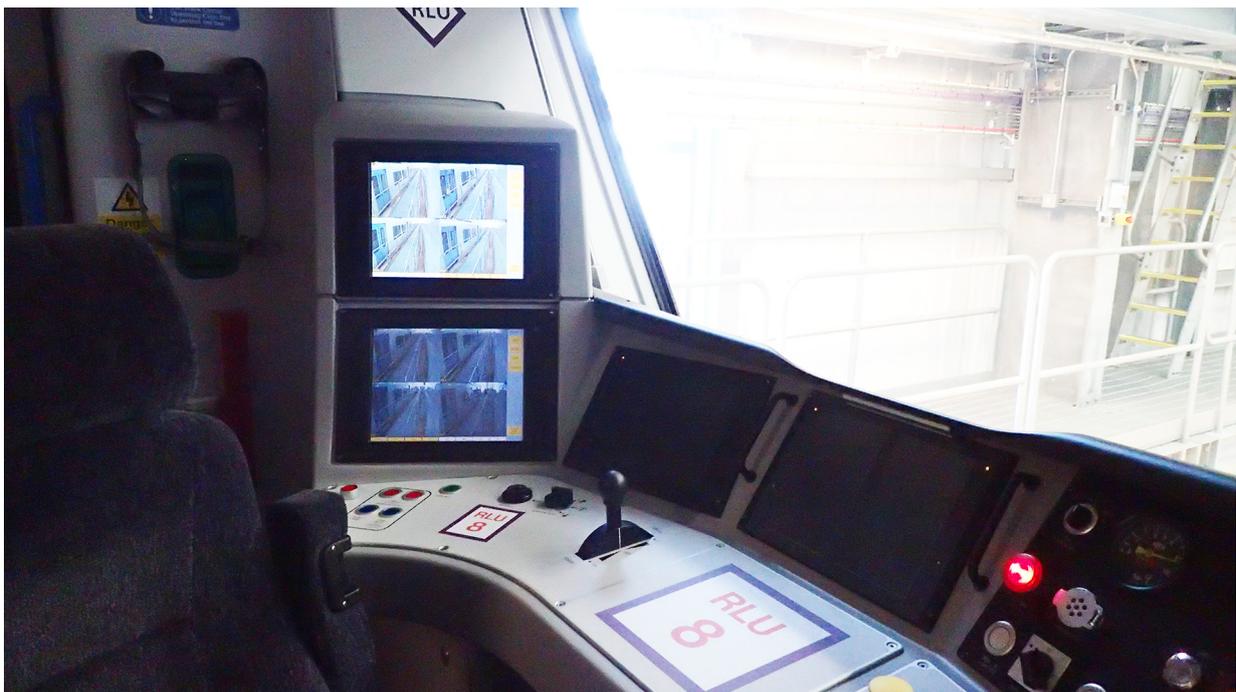
40 The CCTV images are displayed to the driver on two monitor screens in the cab, located to the left side of the driving position (figure 6). On an eight-coach class 700 train, four images, one for each coach, are displayed on each of the screens (figure 7). Each image measures 104 mm horizontally by 87 mm vertically. A 'heartbeat' indicator displayed on the screen confirms to the driver that the images are 'live' and that the screens have not 'frozen'.

Figure 6: The cab desk of a class 700 train

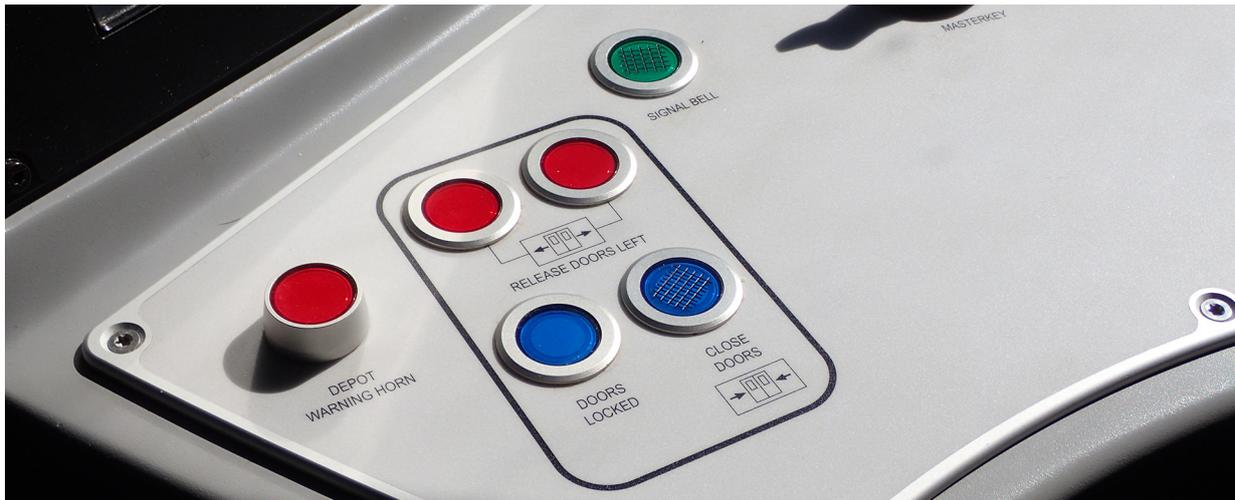
- 41 Door controls are provided in the driver's cab (figure 8). They are duplicated on each side of the cab, and control the doors on the respective side of the train. Two buttons¹², marked 'release doors', must be pressed simultaneously to allow the doors to be opened¹³. Doors are closed using a single push button. A 'doors locked' indication is provided to advise the driver when the doors are locked and the 'traction interlock' has been achieved. The traction interlock system detects when the doors are closed and locked and prevents the driver applying power to move the train unless both conditions have been met.

Figure 8: The door controls provided on the cab desk of the class 700 train
