Rail Accident Investigation Branch

Rail Accident Report

**Near miss between a passenger train and lorry
at Mucking AHB level crossing, Essex
13 March 2019**

Report 16/2019
December 2019

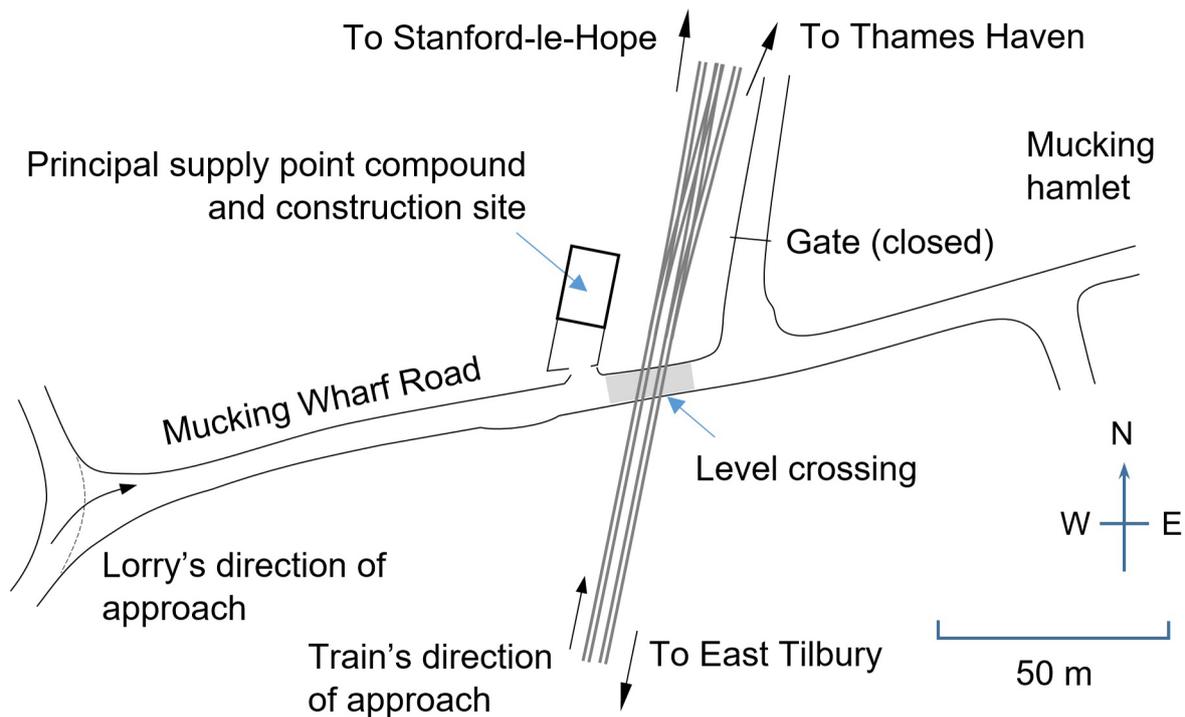
Figure 2: The site and surrounding features

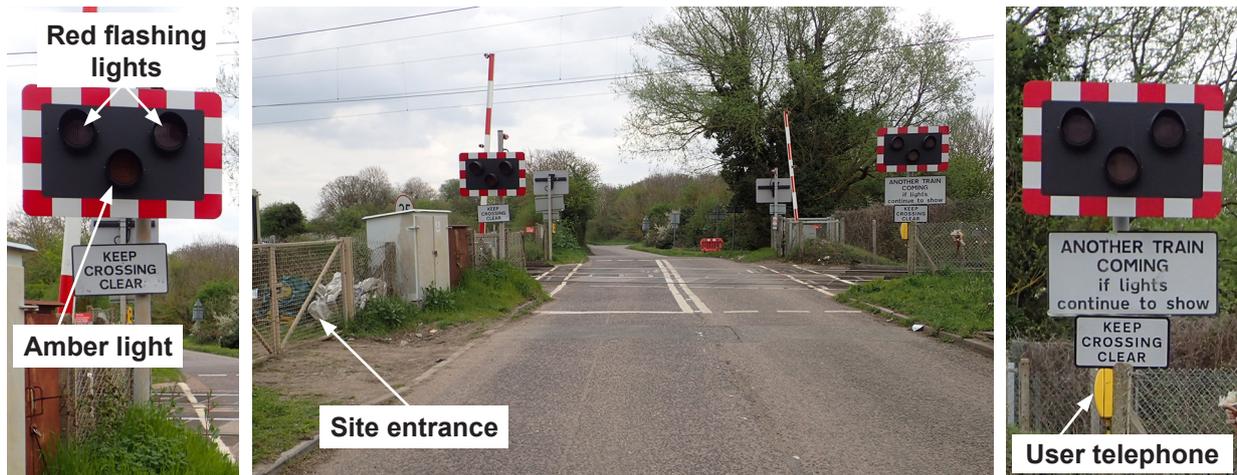
Figure 3: Mucking level crossing viewed from west side

- 17 Mucking level crossing is an automatic half barrier crossing equipped with one rising barrier on each side of the railway (figure 3 and figure 4). When lowered, each barrier extends across about half the width of the road and obstructs the side of the road from which vehicles normally approach the crossing. Exits from the crossing remain unobstructed at all times.

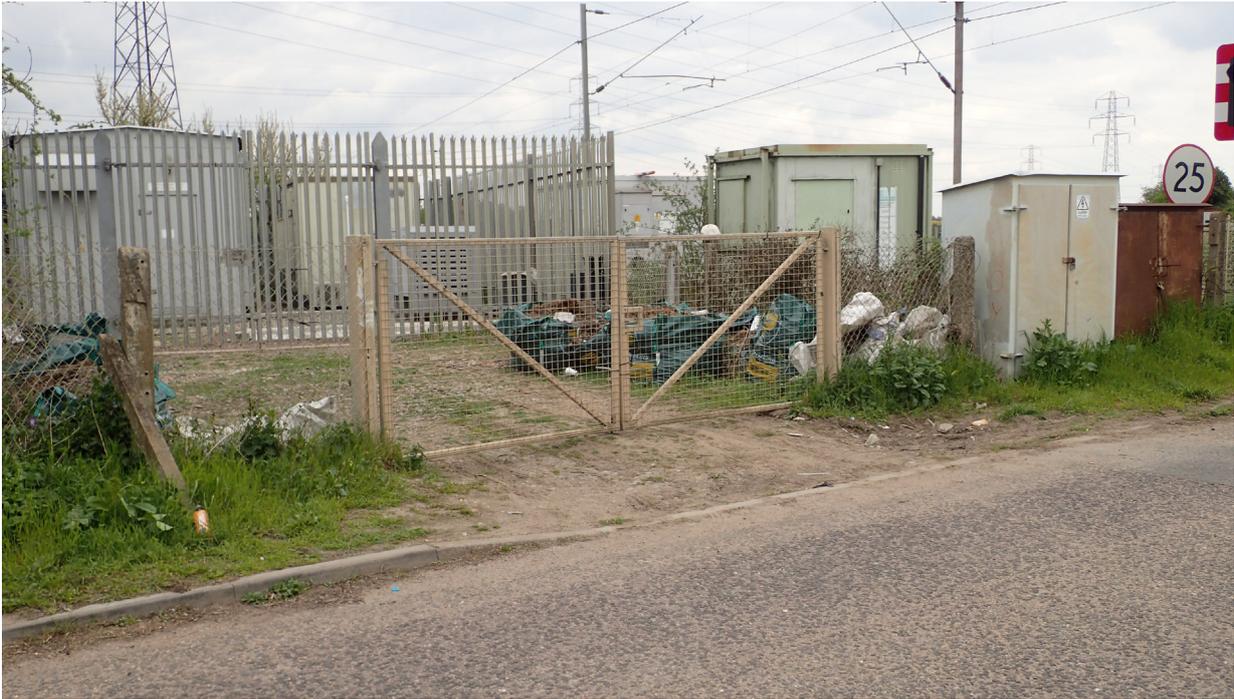
Figure 5: Mucking principal supply point compound

- 24 Construction work was being undertaken close to Mucking level crossing as part of a Network Rail project to upgrade the equipment supplying power to railway signalling equipment at 10 sites between London Fenchurch Street and Shoeburyness in Essex. The purpose of the project was to provide new uninterruptable power supply (UPS) equipment at existing electricity principal supply points to reduce the risk of signalling failures and train delays. The main office for the project was located at Grays, about 10 kilometres from Mucking.
- 25 The principal supply point at Mucking is located in the compound north-west of the level crossing and is within an inner compound surrounded by a substantial metal palisade fence. An outer compound, surrounded by a chain-link fence, provides space for storage of equipment and materials and is accessed by a double gate (figure 4 and figure 5).

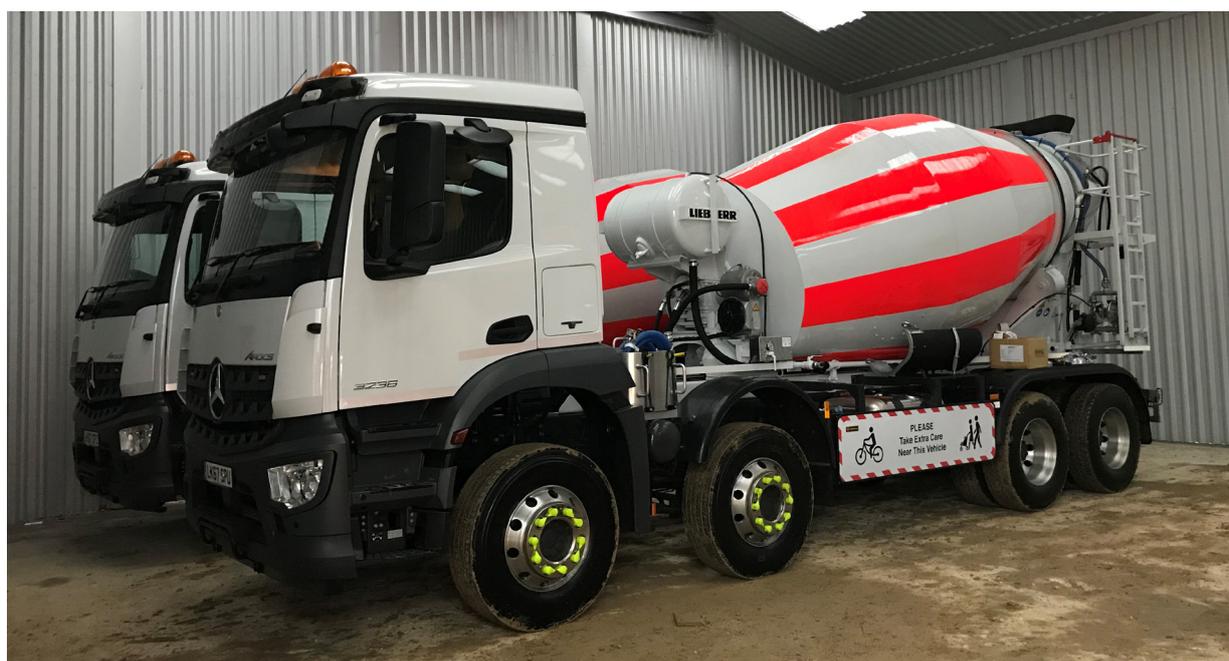
Figure 6: Concrete delivery vehicle of the type involved in the incident (courtesy of Euromix Concrete)

- 37 The supplier, Euromix Concrete, provided an 8m³ capacity vehicle. The lorry was larger than required for this delivery and was approximately 9 metres long with a gross vehicle weight of about 21.5 tonnes at the time of the incident (figure 6). This was the first large goods vehicle (LGV) to deliver to the site at Mucking.
