Rail Accident Investigation Branch

Rail Accident Report

Freight train derailment at Willesden High Level Junction, north-west London 6 May 2019

Report 07/2020
August 2020

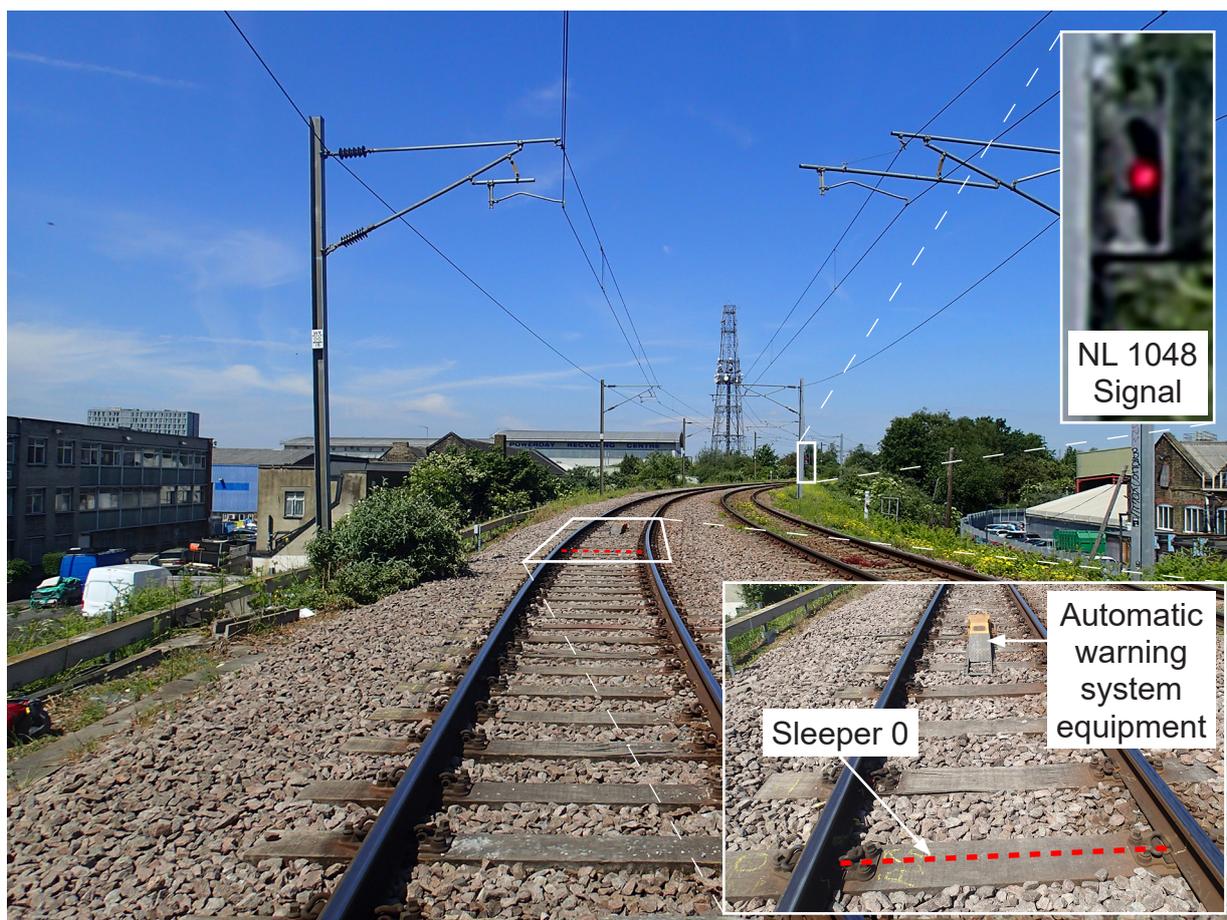
Figure 4: Up High Level line looking in the direction of travel of train 6L36, towards the point of derailment and Willesden High Level Junction. Sleeper 0 marks the designated point of derailment.

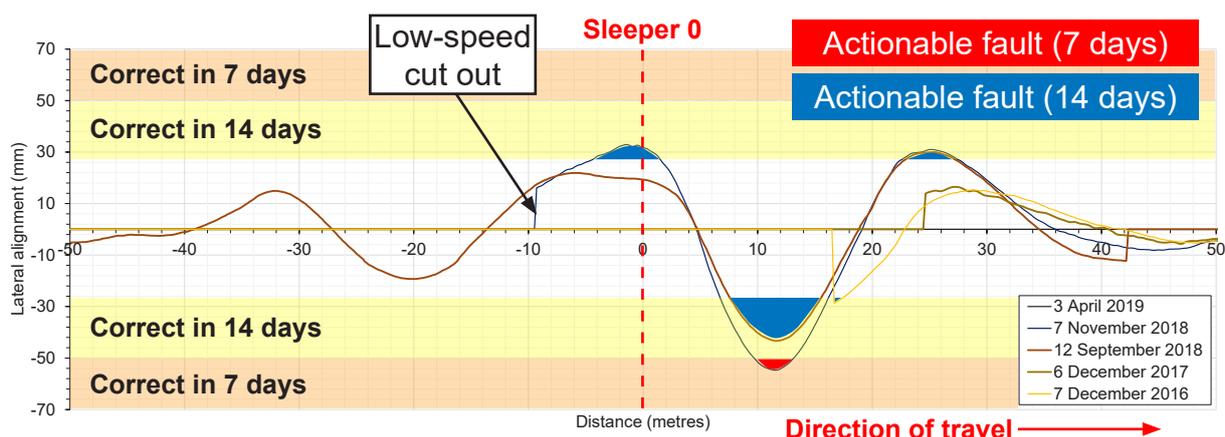
- 55 The last track geometry measurement run before the derailment was on 3 April 2019. It identified no actionable track twist faults and, again due to low-speed cut out effects, recorded neither track top nor lateral alignment in the derailment vicinity. The Camden TSM completed a cab ride through the site three days later. He reported that there was a need for ballast on the shoulder of the up High Level line between 0 miles 25 chains and 0 miles 27 chains.

Figure 8: Lateral track alignment recorded on various track geometry measurement train runs prior to the derailment. Locations where low-speed cut out resulted in data loss are highlighted. On 3 April 2019 no lateral track geometry measurement data was recorded in the vicinity of the designated point of derailment, identified as 'Sleeper 0'.

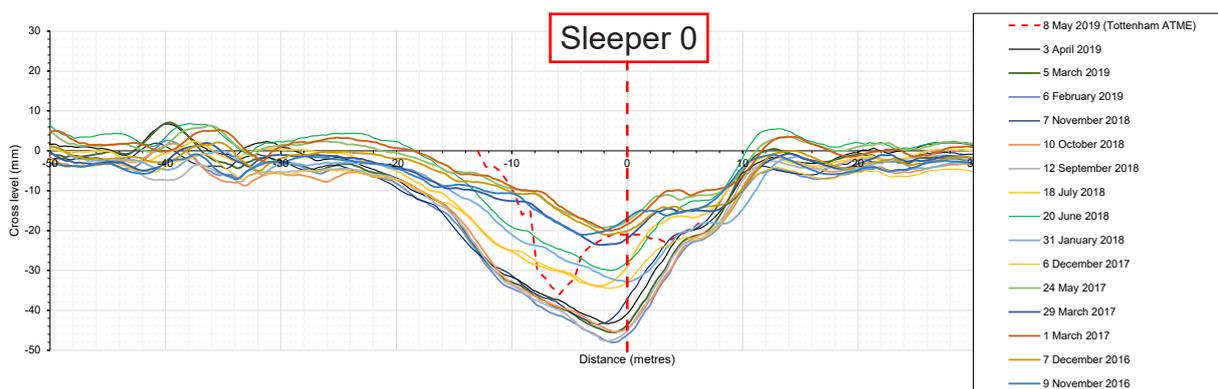
89 RAIB analysed the recordings from track geometry measurement train runs on the up High Level line dating back to November 2016. They showed that the level of the left-hand rail had been dropping and that an adverse cross-level²⁶ feature had gradually formed close to 0 miles 27 chains. The shape of the feature remained similar, but the magnitude increased. By the last pre-derailment measurement train run on 3 April 2019 the left-hand rail was nearly 50 mm lower than the right-hand rail.

90 However, the feature that the Tottenham ATME measured 35 days later (paragraph 38) was significantly different in terms of both magnitude and shape (figure 11), and therefore twist. This rapid track geometry deterioration is evidence of the poor condition of the track bed. The recurrence of top faults at the location is further evidence (paragraph 50).

Figure 11: Track geometry measurements showing the gradual formation of the cross-level feature close to 0 miles 27 chains on the up High Level line and how this compared with the feature that the Tottenham ATME measured after the derailment.

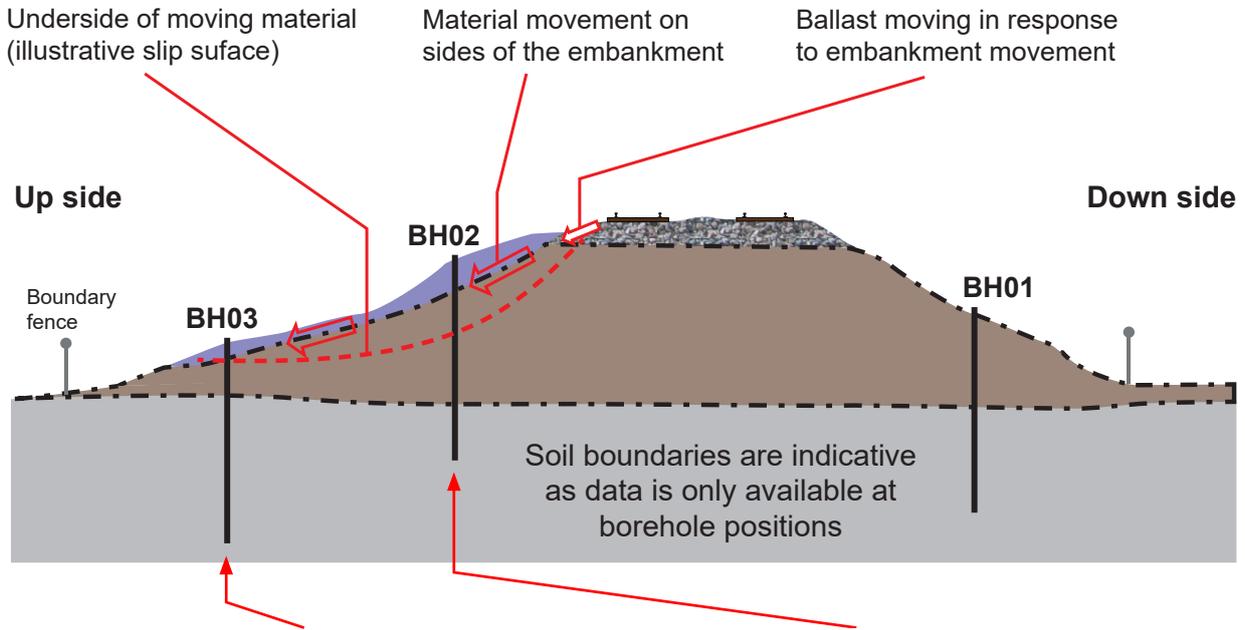
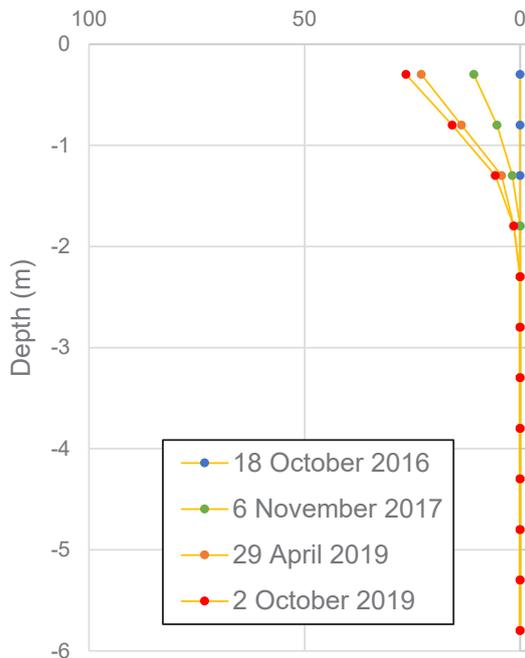
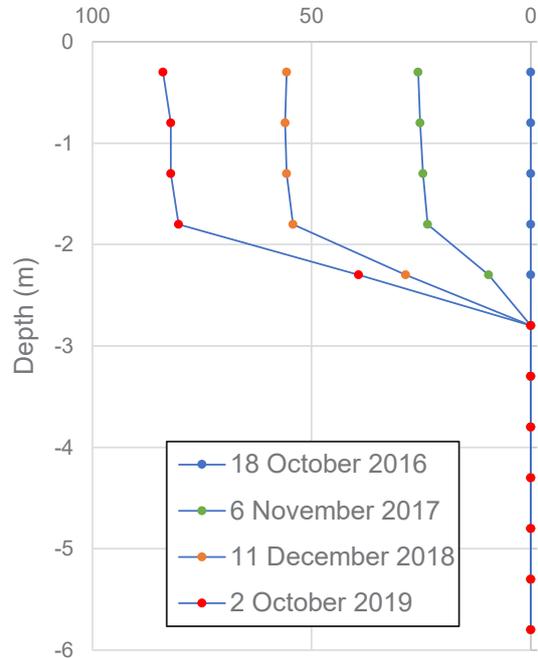
Figure 14: Cross-section of Mitre Bridge Curve embankment showing illustrative slip surface and simplified ground movement. Graphs show how the lateral movement measured at inclinometers BH02 and BH03 varied with borehole depth.

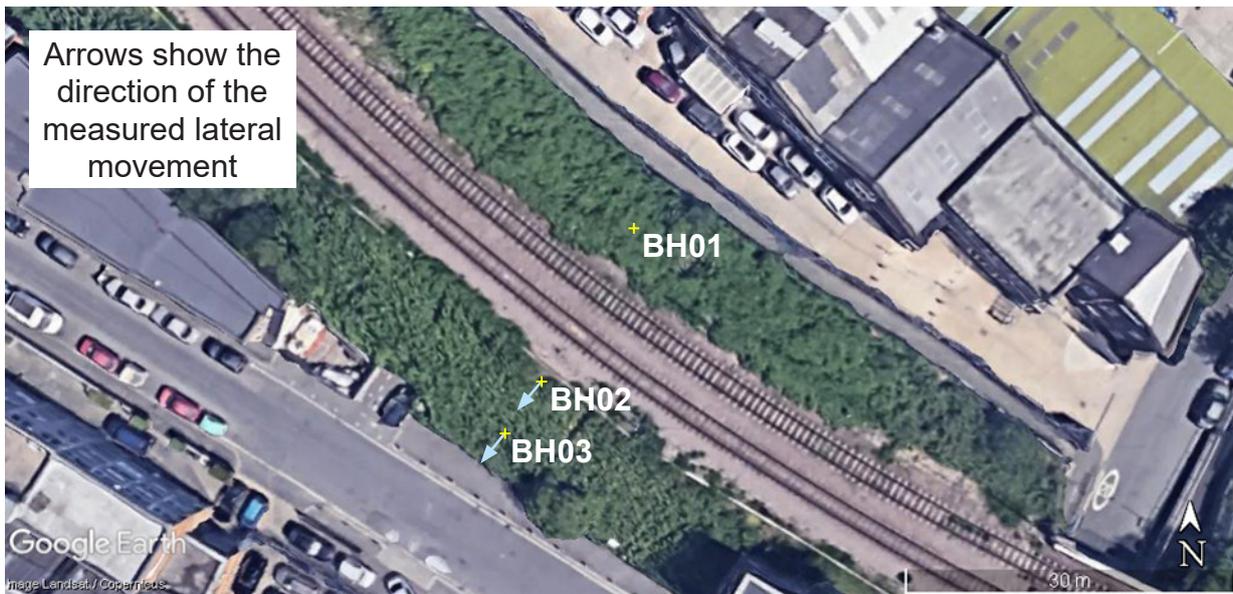
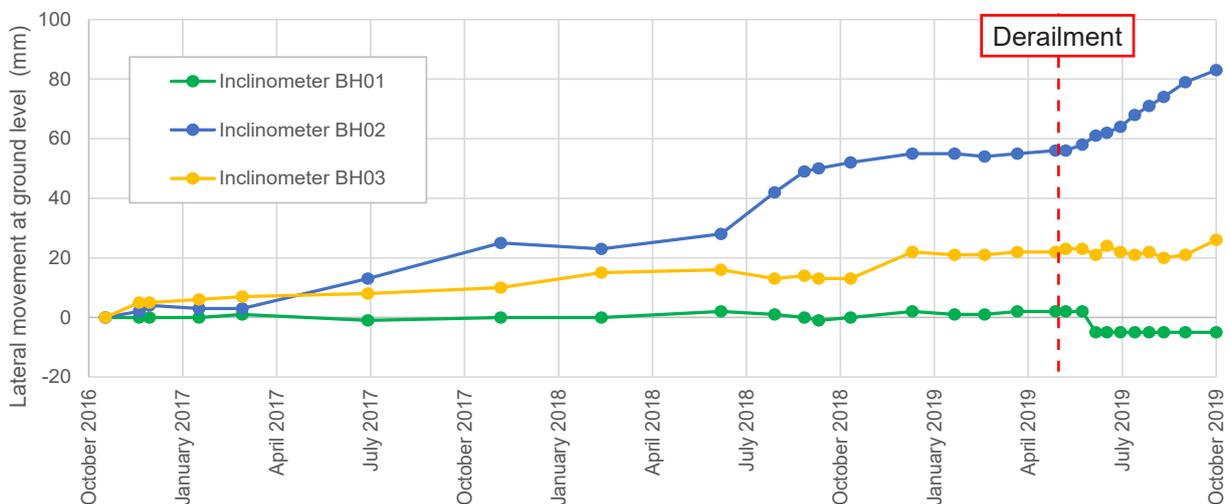
Figure 15: Lateral embankment movements measured at ground level by the inclinometers installed in the down-side slope (BH01) and the up-side slope (BH02 and BH03). Aerial image shows the location of the inclinometers.

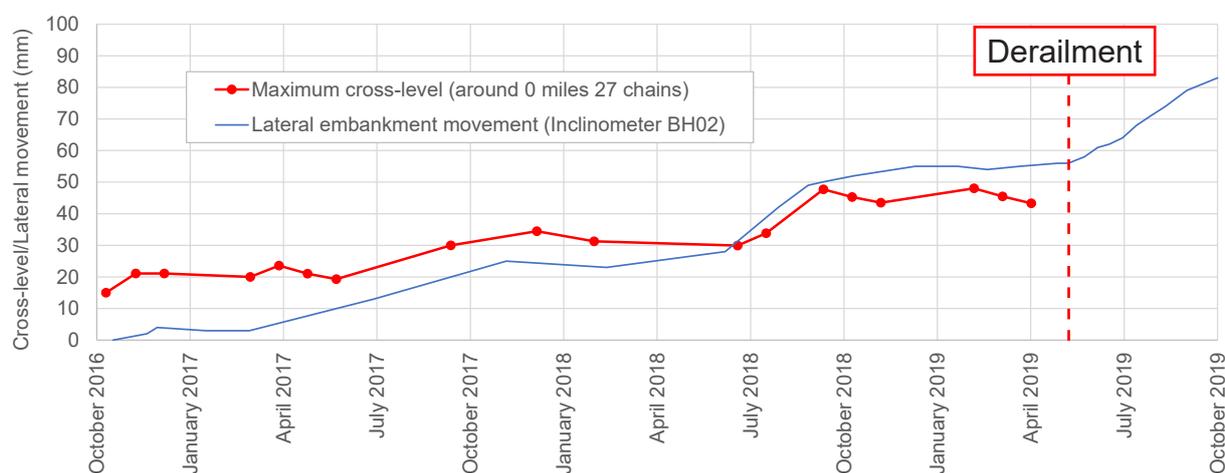
- 110 All the measurement train runs recorded the cross-level at the derailment location. Figure 17 compares the development of the maximum cross-level (paragraph 89) with the embankment movement recorded at inclinometer BH02 (figure 15). It shows that the main changes in cross-level occurred at a similar time to the progressive seasonal movement of the embankment, in late spring, summer and early autumn. This was an indication of the condition of the track bed, and that it was possible that the cross-level was about to significantly alter, and to abruptly produce a significant track twist.

Figure 17: Development of the maximum cross-level around 0 miles 27 chains compared to the lateral embankment movement measured at ground level at inclinometer BH02
