Rail Accident Investigation Branch

Rail Accident Report

Collision between mobile elevating work platforms at Rochford, Essex 25 January 2020

Report 08/2020
September 2020

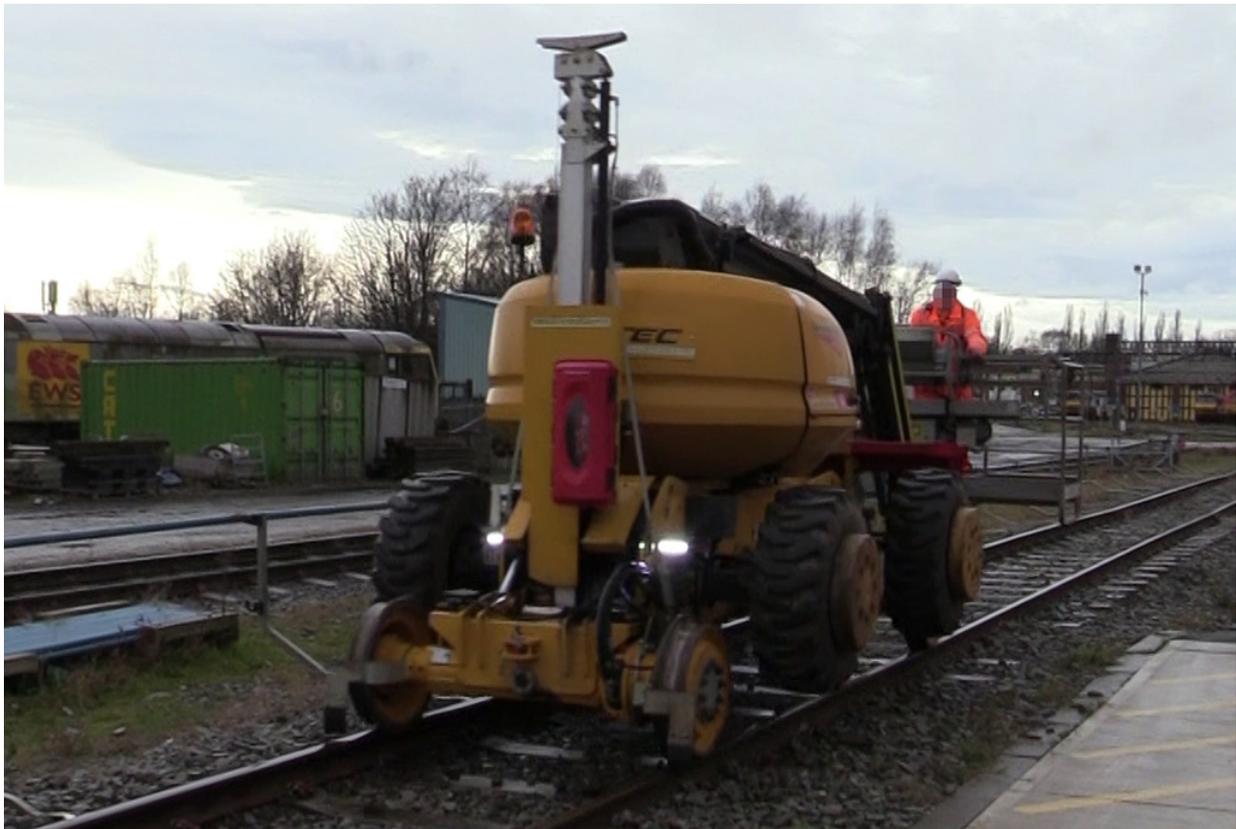
- 14 The work that was planned in work site D required nine on-track machines. Of these, eight were Skyrailer 440 MEWPs. When working on rails the Skyrailer 440 (figures 4 and 5) has four-wheel drive with independently driven wheels and a hydrostatic braking system. This is supplemented with drum service and parking brakes that are also applied when the emergency brake is deployed. The eight MEWPs were intended to work in four pairs of two, working back to back at each OLE stanchion. The remaining machine was a Giga crane.
- 15 Because of problems with documentation one MEWP could not be used, and the crane was found to be faulty when it was being put on the track. This left seven MEWPs available for the work, with one of these, MEWP 10, working on its own.

Figure 5: Skyrailer MEWP 10 involved in the accident

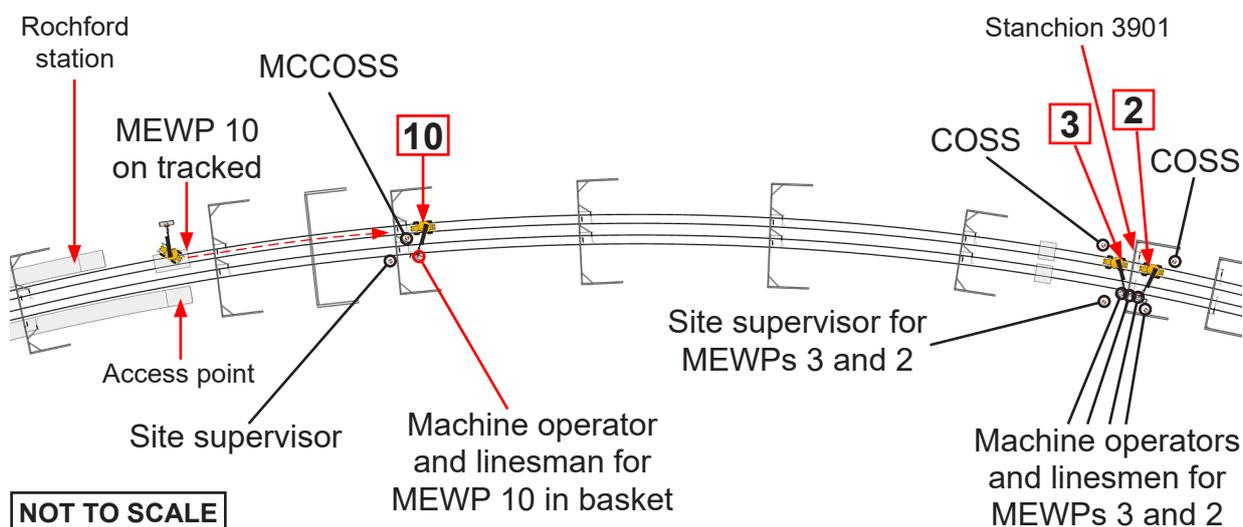
Figure 6a: Sites of work and locations of MEWPs 10, 3 and 2 with associated positions of the staff

- 25 The COSS briefing and the pre-work checklist for MEWP 10 were completed by MCCOSS. The associated paperwork was signed by the machine operator and endorsed by the POS representative. MEWP 10 then travelled a short distance from the access point towards Southend and commenced work (figure 6a).
- 26 At approximately 10:09 hrs, the machine operator working on MEWP 2 reported to his site supervisor that there was a fault with the platform sensor on the machine. The supervisor asked for the on-site fitter. The fitter arrived at the access point, and the site supervisor instructed the machine operator of the nearest machine, MEWP 10, to convey the fitter to the location where MEWPs 3 and 2 were working. The machine operator drove MEWP 10, with the fitter on board, for around 310 metres, travelling at a speed of 7 mph (12 km/h), until it had reached a point close to MEWP 2 (figure 6b).

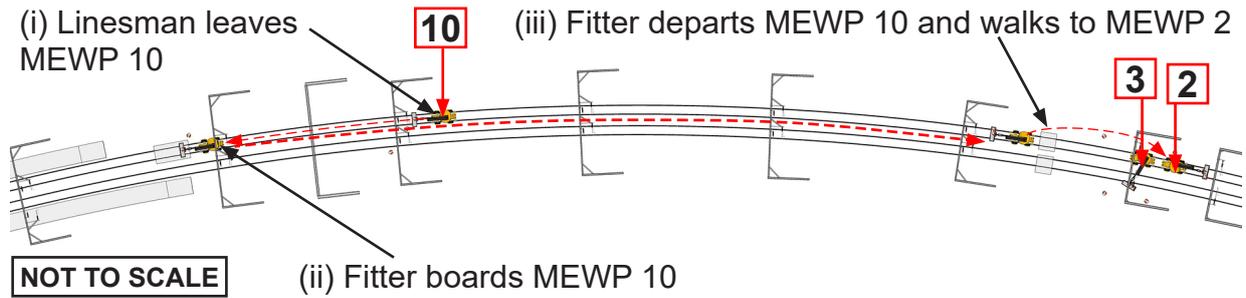
Figure 6b: Route taken by MEWP 10 to the access point to uplift and convey the on-site fitter to the site of work to attend to the fault on MEWP 2

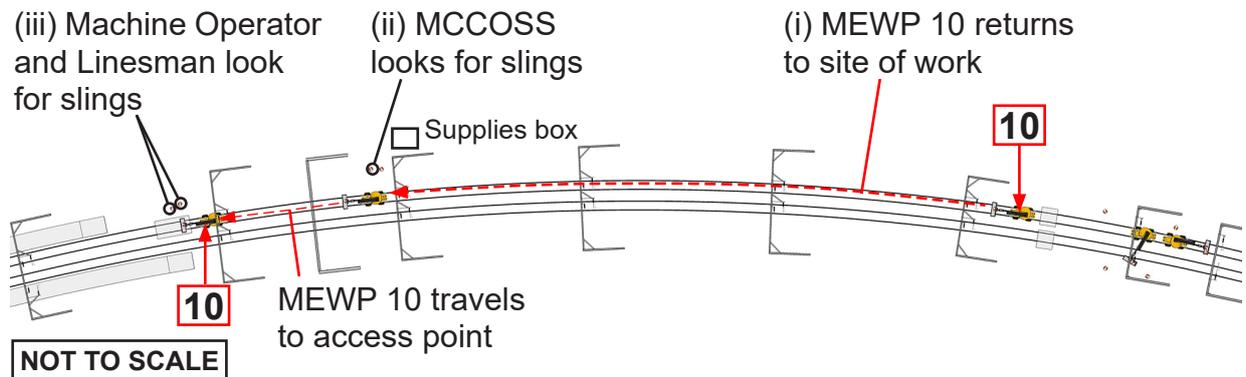
28 At approximately 10:50 hrs, the site supervisor for MEWP 10 told the machine operator and linesman to set up the machine for lifting OLE equipment. This task required two slings, which could not be found in the machine's basket. The machine operator, in company with the linesman, took MEWP 10 back to the access point, travelling at a speed of 6.4 mph (10 km/h). The machine operator and linesman then went separate ways to look for the slings. MCCOSS was aware that the site supervisor had made the request, but he decided to remain at the site of work (figure 6c).

Figure 6c: Route of MEWP 10 back to its original site of work and onward travel to the access point

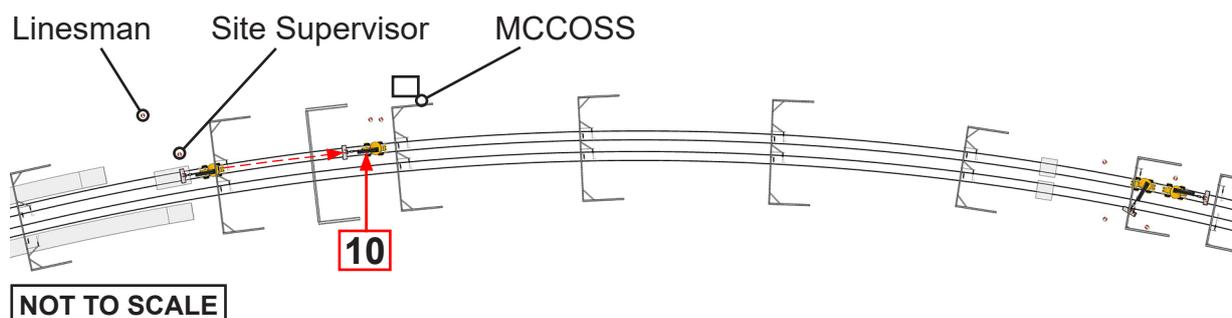
30 At 10:53 hrs, MEWP 10 travelled back to its site of work, a distance of approximately 120 metres, travelling at 10 mph (16 km/h). MEWP 10 was then stationary for between three and four minutes while the operator and MCCOSS looked for the slings (figure 6d).

Figure 6d: Route of MEWP 10 back to its site of work

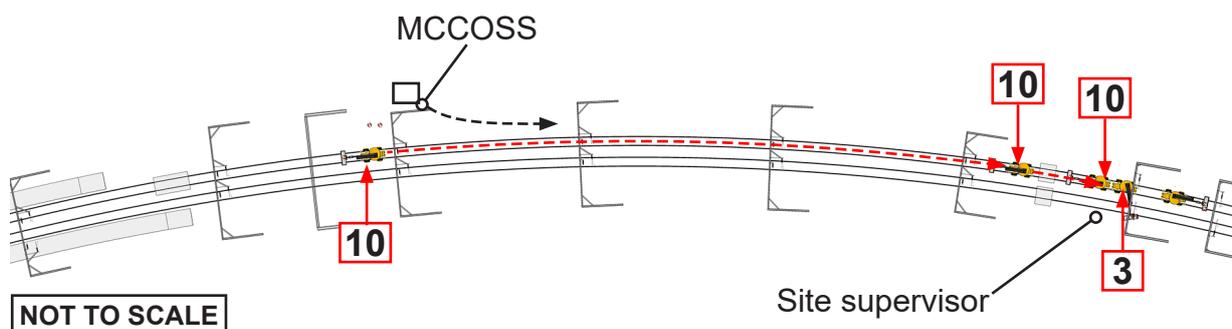
- 31 Around 10:56 hrs, the machine operator drove MEWP 10 away from its site of work to travel to the location of MEWP 3 and MEWP 2. The machine operator did not seek authority from MCCOSS, who was still looking for the missing slings. The horn was not sounded, and MCCOSS only became aware of the movement of MEWP 10 as the machine operator moved away from the site of work. MCCOSS has stated that, on hearing MEWP 10 moving off, he shouted several times at the machine operator to stop, and started to run after the MEWP, but he could not keep up (figure 6e) as it was now travelling at 10 mph (16 km/h).

Figure 6e: Route of MEWP 10 as it approached MEWP 3

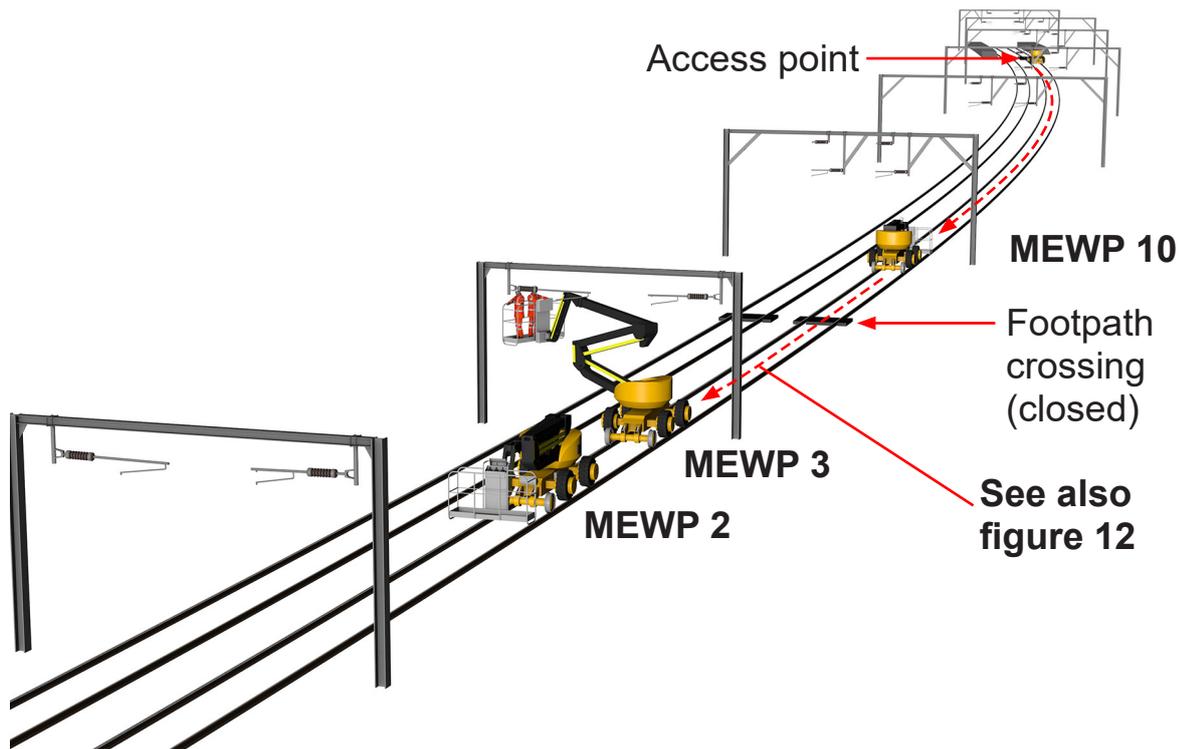
Figure 6f: Route of MEWP 10 to the collision with MEWP 3 (see also figure 12)

35 At 10:57 hrs, MEWP 10 collided with MEWP 3. Just before impact, the machine operator applied the brakes by releasing the MEWP's speed controller (figures 7 and 8). This produced a slight reduction in the speed of the MEWP before the collision, from 10 mph (16 km/h) to 9 mph (14 km/h). The machine operator of MEWP 3 (wearing headphones) and the linesman, who were working in the basket, did not hear any warnings (figure 6f).

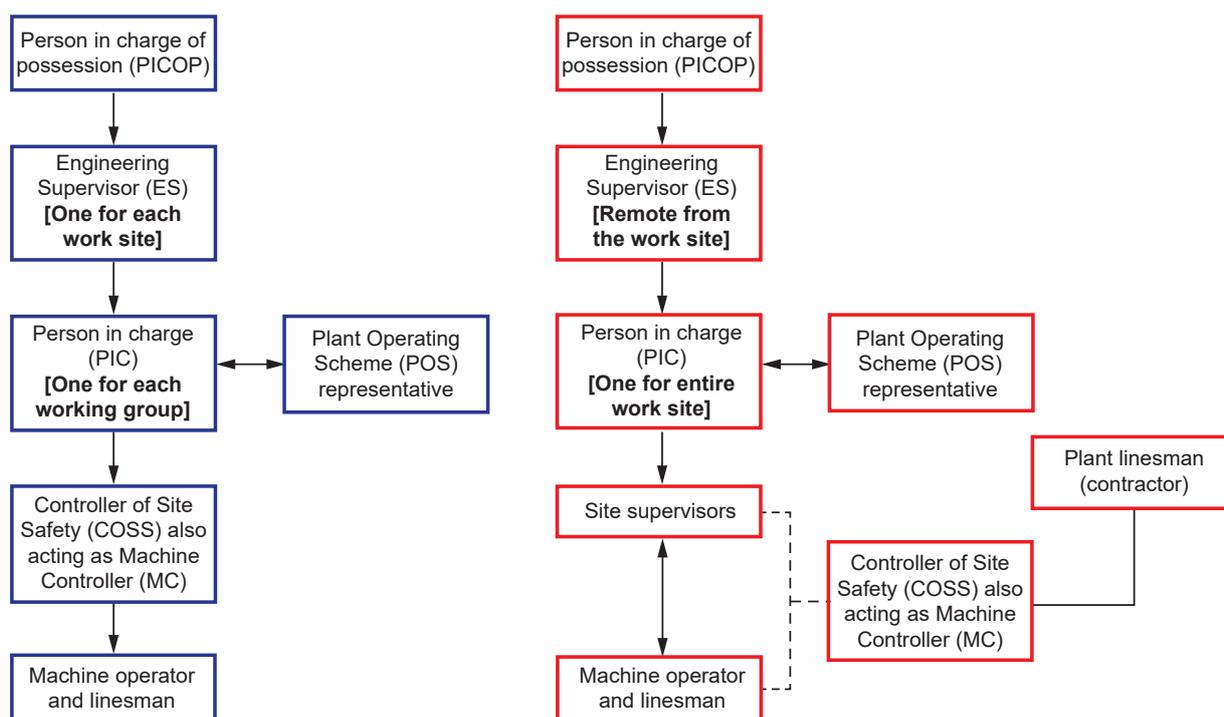
86 OCR rostered the PiC in a dual role as a site supervisor looking after two MEWPs, as well as the progress of the whole team's work. This practice is permitted by standard 019 and witness and documentary evidence show that this did not affect the safety briefings and documentation at the start of the work. The intention of standard 019, as explained by Network Rail to RAIB during a previous investigation, is that the PiC should only be supervising one work group.¹² As the machine controllers were not undertaking the role of PiC for the various sites of work, it is difficult to see how the appointed PiC could have undertaken his responsibilities for overall oversight and supervision of the work, supervising the safety of the work site and managing the site risks when also supervising the local work of two MEWPs. When the accident occurred, the PiC felt under pressure as he was now short of staff and machines to complete the work. As such, he did not feel he could relinquish his role supervising the remaining work. Rather than contacting the POS representative, the PiC asked the site supervisor to manage the situation and the accident scene, allowing him to continue his own work. Although the PiC had no further involvement in the accident, RAIB believes that OCR's decision to allocate the PiC in a dual role affected his ability to effectively monitor the work activities, and to manage the personnel, risks from the site activity and the movements under his control.

Figure 13: The standard structure of a possession (left) and the structure at Rochford (right)
