Rail Accident Report

Fatal accident at Tyseley depot 14 December 2019

Report 09/2020
v2 - March 2022

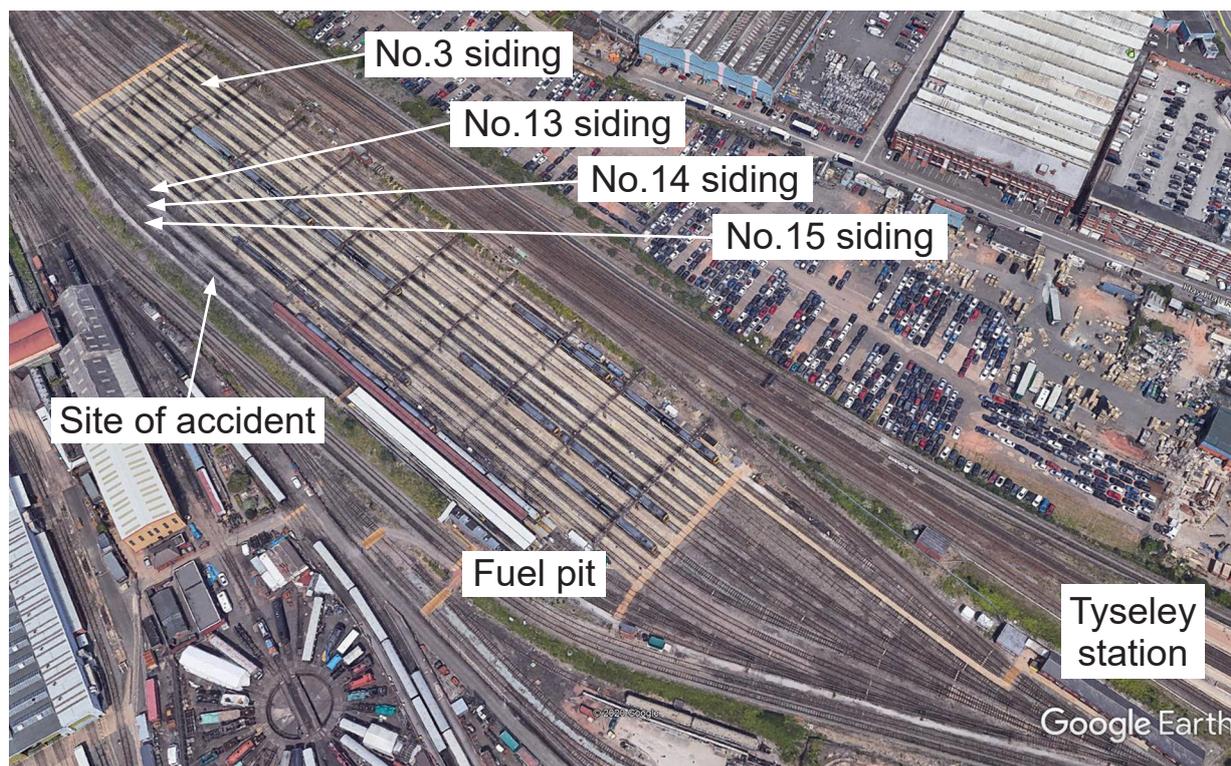
- 6 The carriage sidings at Tyseley depot consist of 15 parallel tracks (figure 3). These are numbered 1 to 15, with number 1 siding being closest to the main railway line. The sidings may be accessed from either end of the depot. Trains may enter or leave the depot at either its north (Birmingham) or south end.

Figure 3: The carriage sidings at Tyseley depot. Locations pertinent to the accident are indicated

- 35 Sidings 13, 14 and 15 serve an area of the depot known as the fuel pit (figure 3). In this area, trains are refuelled, water tanks replenished, and toilet systems emptied. Basic maintenance checks are also carried out on trains in this part of the depot. Once work is completed on a train in the fuel pit area, it will be moved, normally via the south end of the depot yard, onto one of the other carriage sidings (numbers 2 – 12) for cleaning and preparing for entry into service. If further maintenance or repair work is required, the train concerned will be moved to the factory building instead.

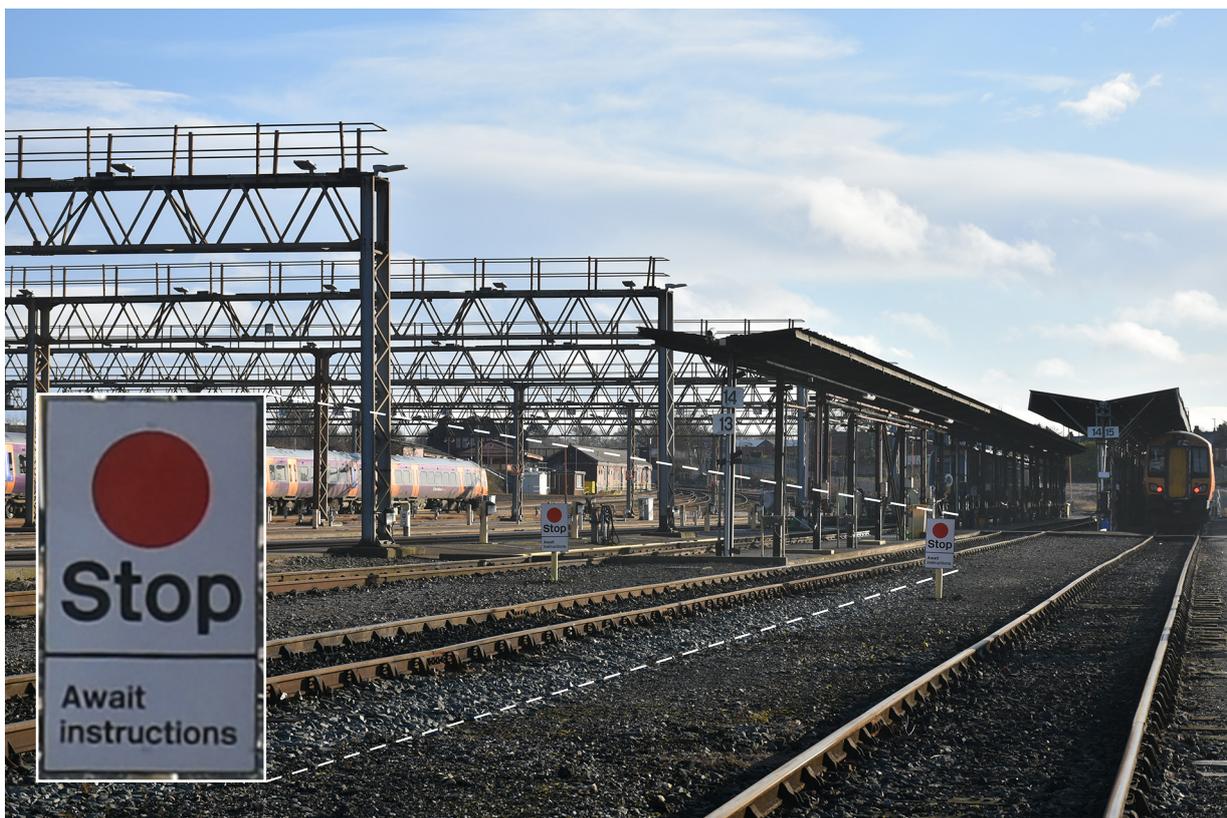
- 37 Almost all trains arriving at the depot pass through the fuel pit. Trains arriving onto numbers 13, 14 or 15 sidings are directed by the North End Shunter along one of these sidings using manually operated points. Once on these sidings, drivers are required to stop their trains at stop boards (figure 6) located to the north of the fuel pit. This is to ensure that trains enter the fuel pit in a controlled way. The boards are positioned to ensure that trains stabled on sidings 13, 14 or 15 do not interfere with movements on other sidings. Once stabled, only the designated person³ for the fuel pit can authorise a driver to bring a train into that area. In the event that the designated person does not immediately authorise an arriving train to proceed beyond the stop board, then the driver of an arriving train will normally stable their train adjacent to the stop board, and then leave the train cab. The area north of the stop boards, including that where the accident occurred, remains under the control of depot operations staff.

Figure 6: View looking south towards the fuel pit. Number 15 siding is on the right and a 'stop board' is indicated

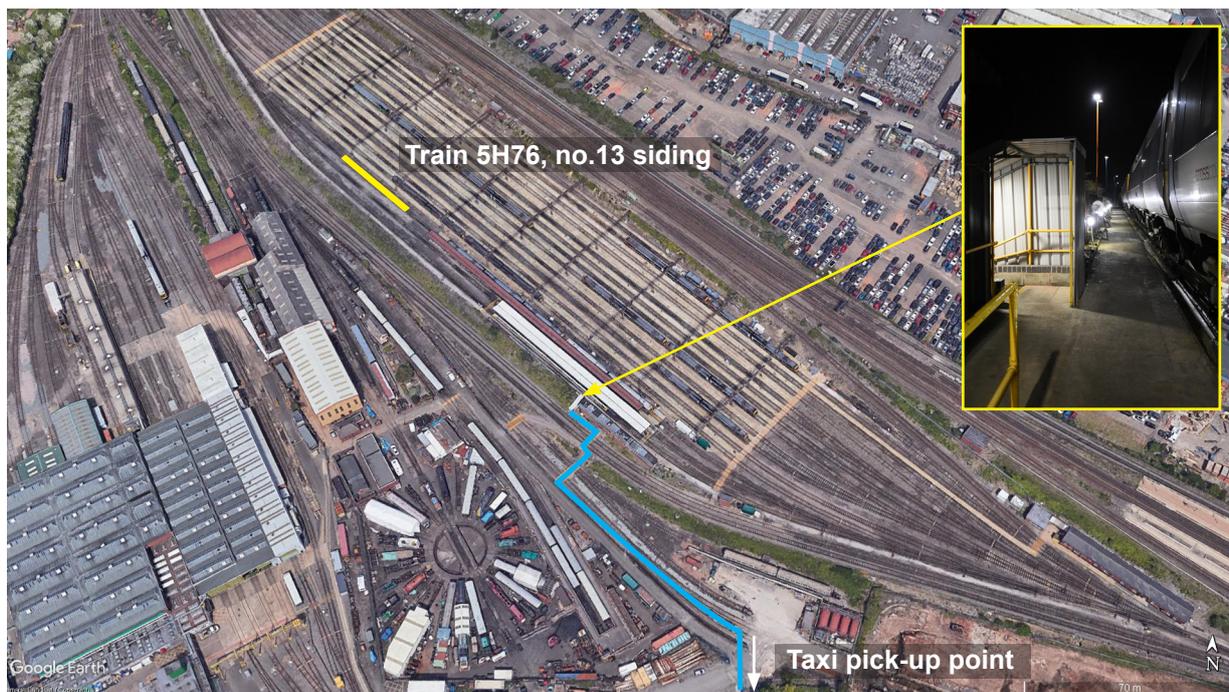
- 61 This pick-up location (figure 7) is some way from the carriage sidings at Tyseley and Driver A could have taken a number of possible routes to reach it. All of them involved first crossing the yard to reach the stairs (figure 8), which provided the only passage from the carriage sidings to the pick-up location.

Figure 7: Tyseley depot carriage sidings, showing the location of train 5H76, and the route from the fuel pit to the taxi pick-up location

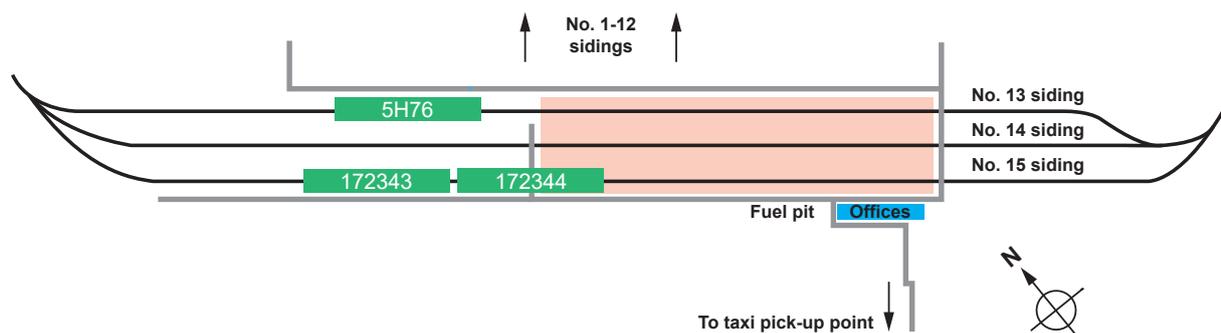
- 62 Three possible routes (figures 8a and 8b) were available to Driver A to cross the yard from the location on number 13 siding where he stabled train 5H76 to the top of the stairs. These were:

- a second, slightly shorter route, of 130 metres which mainly comprised AWRs. This route was not available to Driver A because the southern-most coach of unit 172344 was obstructing the authorised walking route where it crossed number 15 siding

Figure 8a: AWRs in the vicinity of the stabled location of train 5H76

64 Unit 172344 (paragraph 23) arrived at Tyseley depot at approximately 19:15 hrs on the night of the accident. The North End Shunter directed the train onto number 15 siding. However, because another unit was already occupying the fuel pit, unit 172344 was stabled in a way that meant it obstructed the AWR which crossed number 15 siding (figures 8a and 9). Although a gap remained between unit 172344 and this other train, there is an inspection pit⁶ immediately to the south of the obstructed AWR which would have prevented Driver A from crossing there.

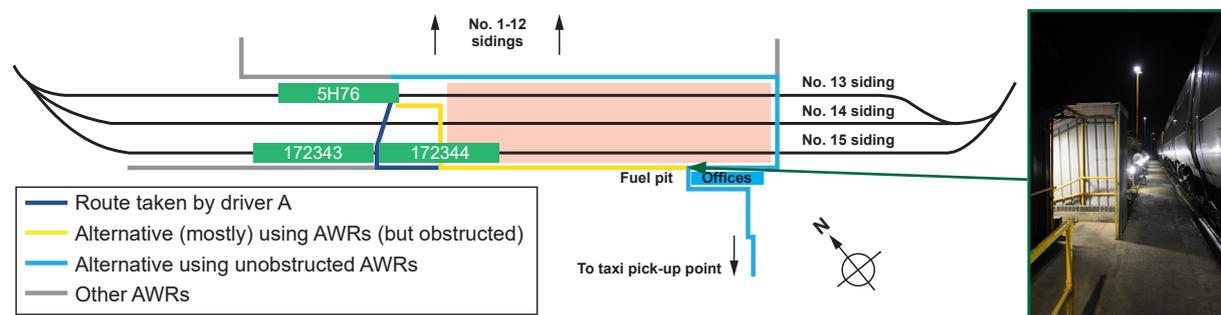
- the route which Driver A attempted to take (figure 8b) and which would have involved walking 135 metres to the top of the stairs. This route required the driver to pass between the two units involved in the accident before he could join an AWR

- a third route of 200 metres, which used only those AWRs which were not obstructed at the time of the accident. This route predominantly used an AWR between numbers 12 and 13 sidings.

Figure 8b: The various possible routes available to Driver A between his train (5H76) and the top of the stairs leading to the taxi pick-up location
