Rail Accident Investigation Branch

Rail Accident Report

**Track workers struck by a train at Margam,
Neath Port Talbot
3 July 2019**

Report 11/2020
November 2020

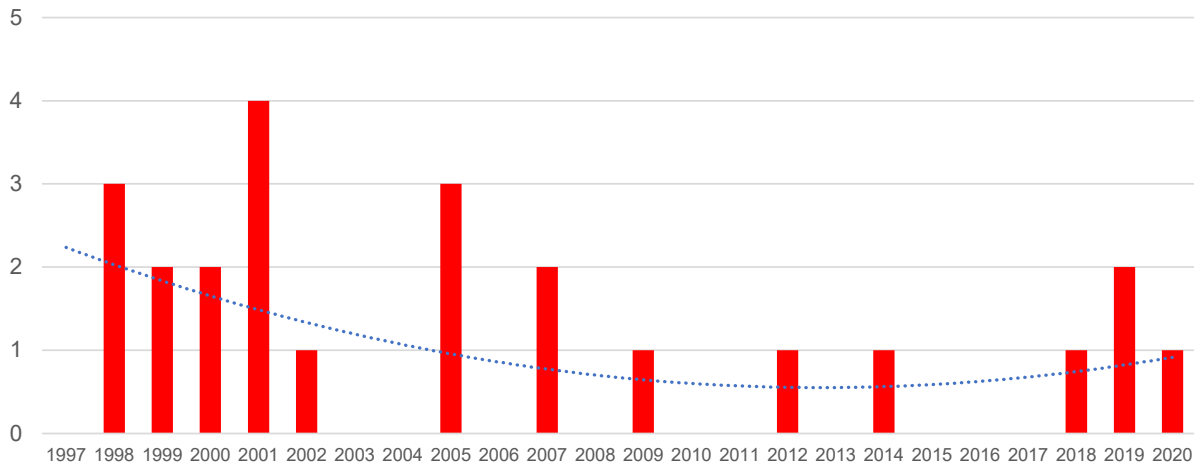
166 Figure 10 shows the number of fatalities as a result of track workers being struck by trains for each year between 1997 and 2020. This suggests a falling trend for most of that period. However, since 2018 there have been three fatal accidents resulting in four fatalities. Following a gradual decline in near misses to around July 2018, there has since been a gradual increase in such incidents, many of which have been judged to have had high potential for causing serious harm to one or more track workers (figure 11).

Figure 10: The number of fatalities as a result of track workers being struck by trains for each year from 1997 to the end of October 2020 (source: RAIB)

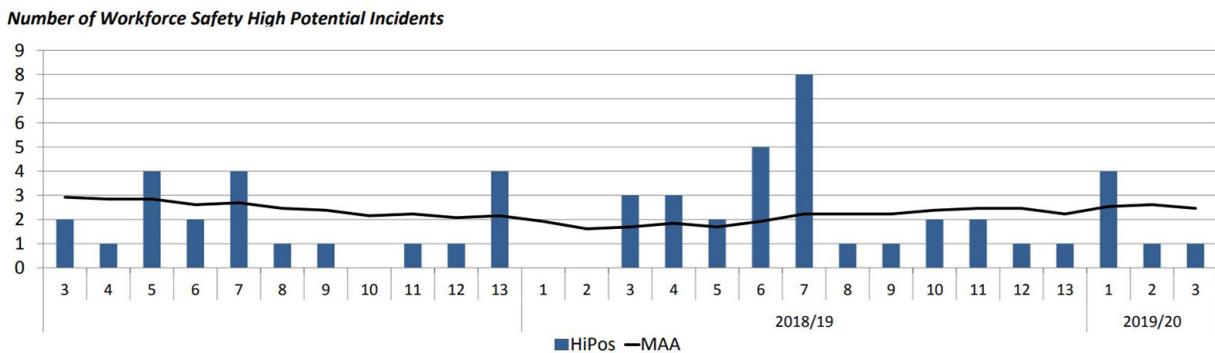
Figure 11: The number of workforce safety high potential incidents over the two years before the Margam accident (extracted from Network Rail’s Safety, Health and Environment Performance Report, Period 3, 2019/20)

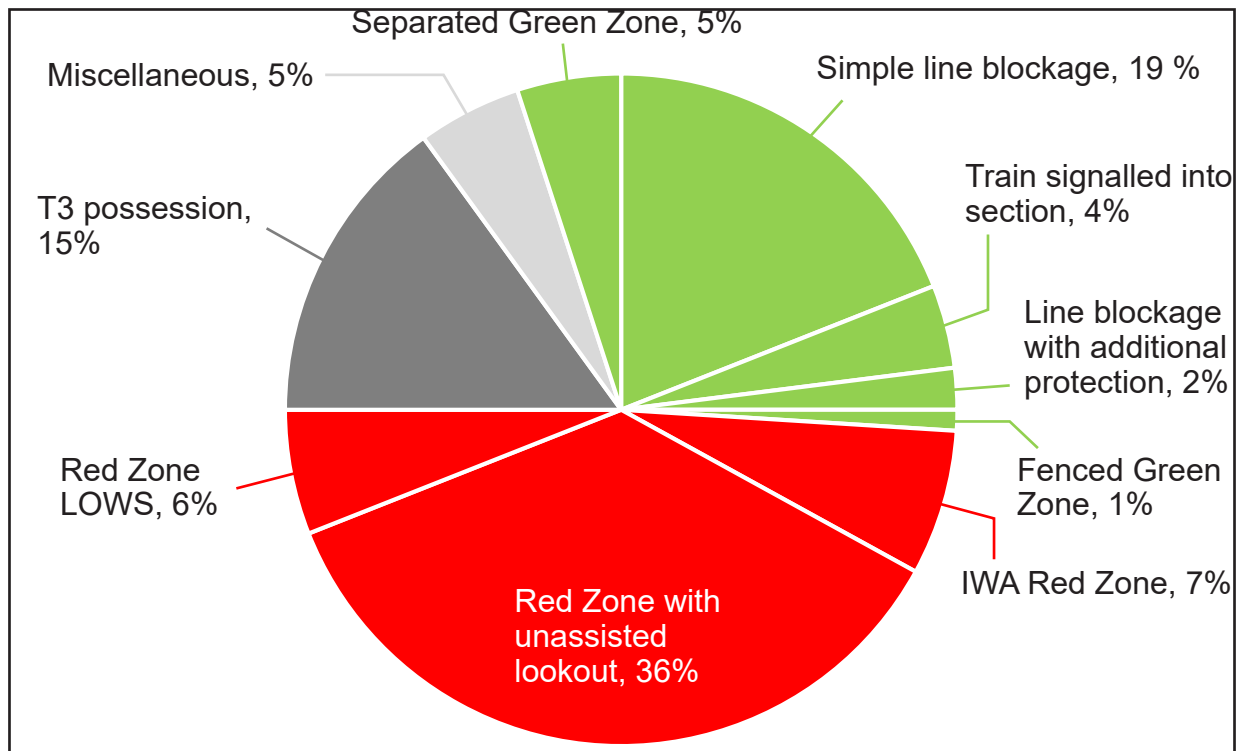
Figure 13: Near misses recorded for work planned using different Safe System of Work types; two years 2014/15- 2015/16 (source: Network Rail). The red coloured sectors show the proportion occurring under the 'warning' safe system of work

191 These figures indicate that the programmes for separating people from trains which have been implemented by Network Rail in recent years have yet to achieve a sustained reduction in the exposure of track workers to the risk of being struck by moving trains.

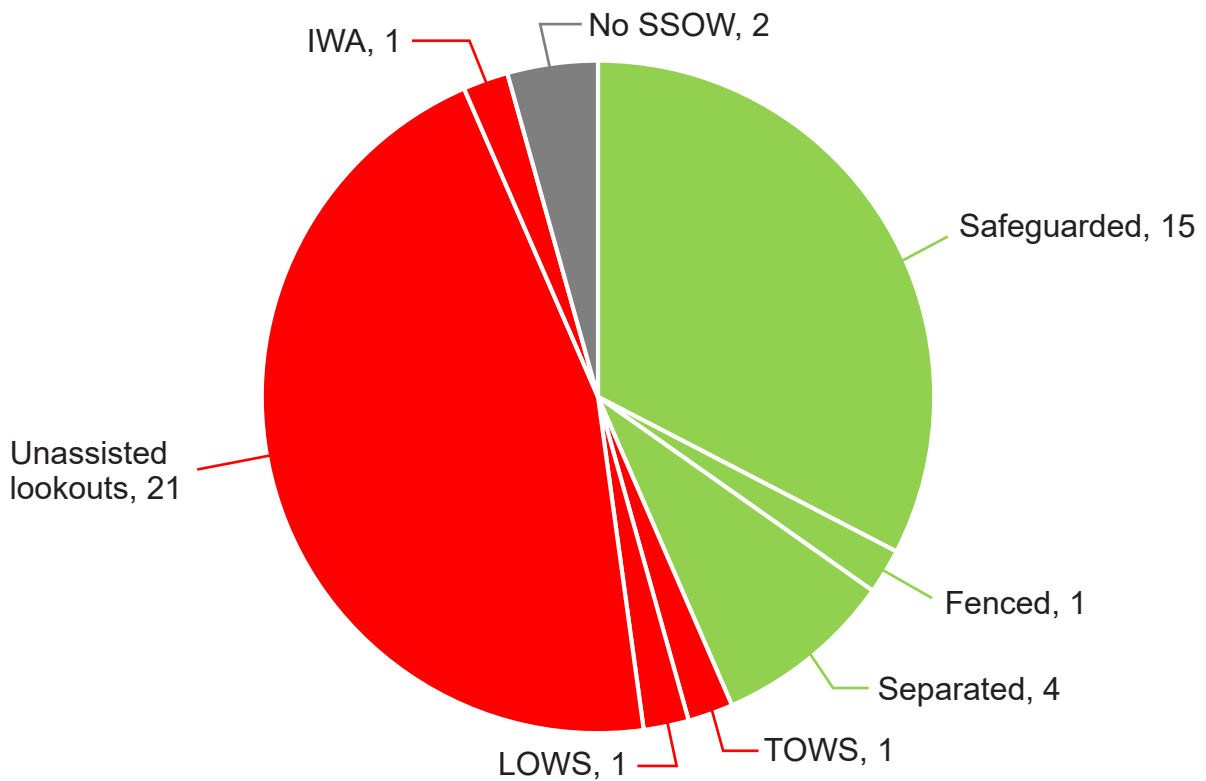
242 The analysis showed that almost half the accidents and incidents occurred while staff were working under an unassisted lookout warning system (figure 14). In standard 019 this method of work is considered to carry the highest risk, and should only be used as a last resort, being vulnerable to variability in human performance. However, this method of work is often preferred by track worker teams because it offers them greater flexibility and autonomy than using protection arrangements (paragraph 185).

Figure 14: Chart showing the planned Safe Systems of Work of the 45 track worker accidents and incidents for which RAIB has published an investigation, bulletin or safety digest (Note: The data set totals 46 data points. The Heathrow Tunnel investigation is included twice, as it covered two separate events).

243 The chart shows that 43% of accidents and incidents occurred when staff should have been protected from train movements (they were working in what was formerly called 'green' zone). Some of these incidents were due to signallers or site safety leaders making errors when establishing line blockages, but many involved staff working beyond the planned limits of their safe system of work, often due to a lack of local knowledge. In the incidents using line blockages, none utilised 'additional protection' in which the COSS, signaller or signalling technician uses a secondary engineered safeguard to minimise the risk from a signaller error.

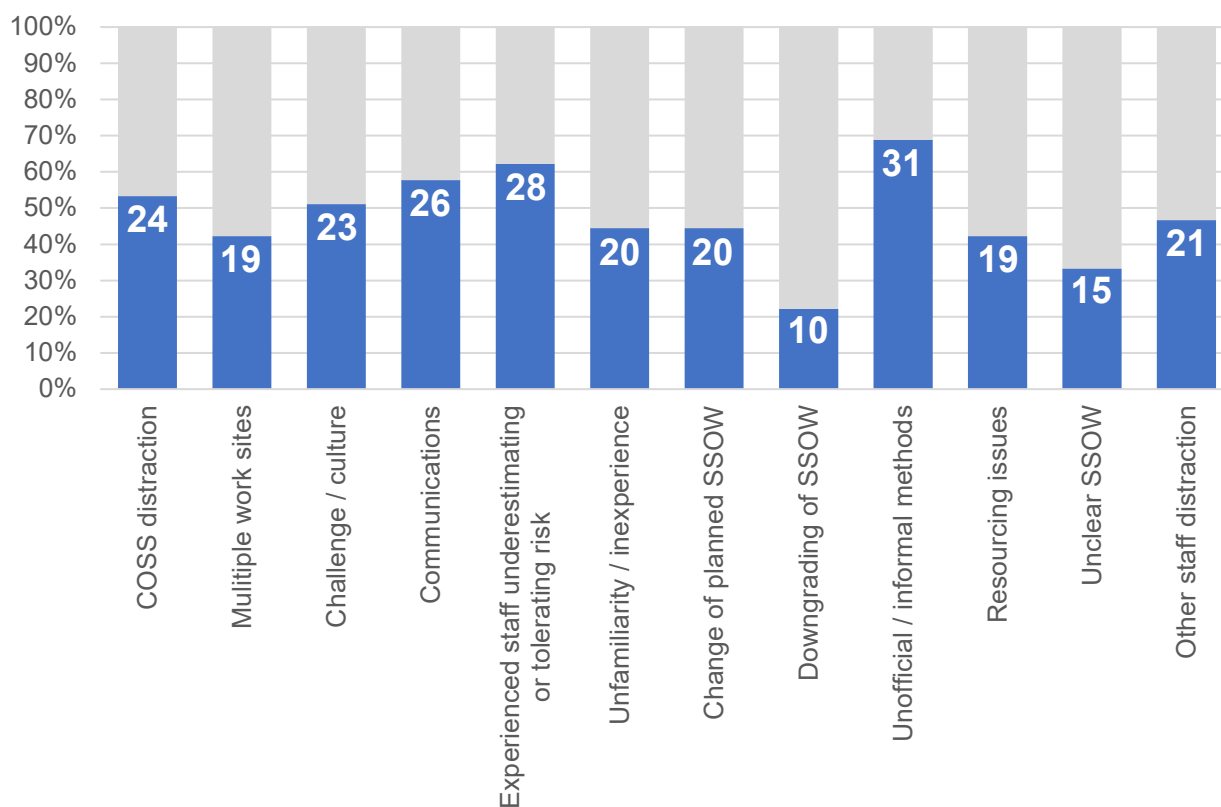
244 RAIB's review of the 45 reports listed in Appendix D revealed that there is no dominant cause of track worker accidents and near miss incidents (figure 15). Instead, there is a range of overlapping factors that are found to recur frequently. These include:

- use of unofficial working practices
- perception of risks by experienced staff
- poor safety critical communications
- COSS distraction
- unwillingness to challenge unsafe working or cultural issues.

Figure 15: Occurrence of common causal factors in 45 RAIB published track worker reports

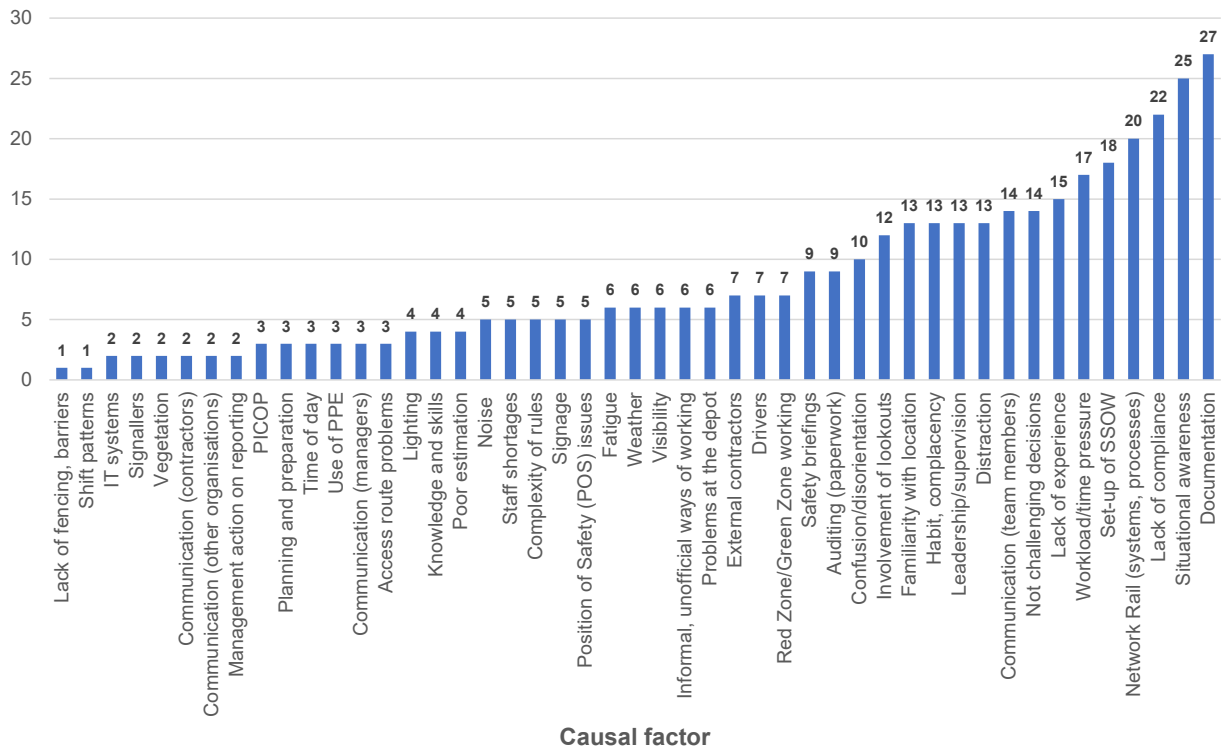
- 255 The list of factors from RAIB reports is shown in figure 16, ordered by frequency of occurrence. The most frequently occurring factor was 'documentation', and there was also evidence from the COSS focus groups that the increasing volume and complexity of site safety paperwork is becoming overwhelming. Part of this is associated with the experience and capabilities of the planners who produce the paperwork, which can vary between depots. COSSs saw value in planners having experience of being a COSS themselves, as well as knowledge of the location, to produce appropriate and usable paperwork.

Figure 16: Aggregated causal factors and frequency of occurrence in RAIB reports

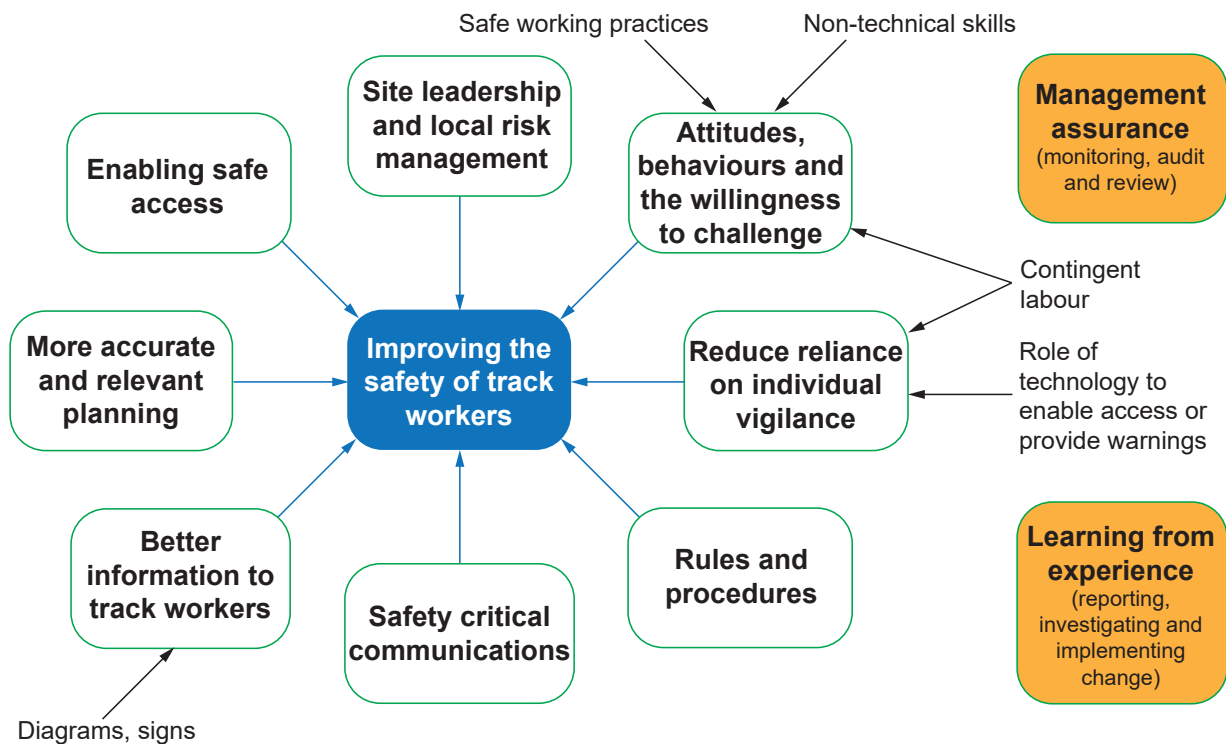
354 Between October 2005 and the accident at Margam in July 2019, RAIB had published 31 investigation reports, two class investigation reports and 14 safety bulletins/digests relating to track worker safety. Taken together, these evidence a range of the factors that have contributed to track worker accidents and near misses over this period. RAIB’s own analysis of the findings of factors has enabled it to map the key themes that need to be addressed if track worker safety is to be improved, as shown in figure 17.

Figure 17: Key track worker safety themes identified by RAIB 2005-20

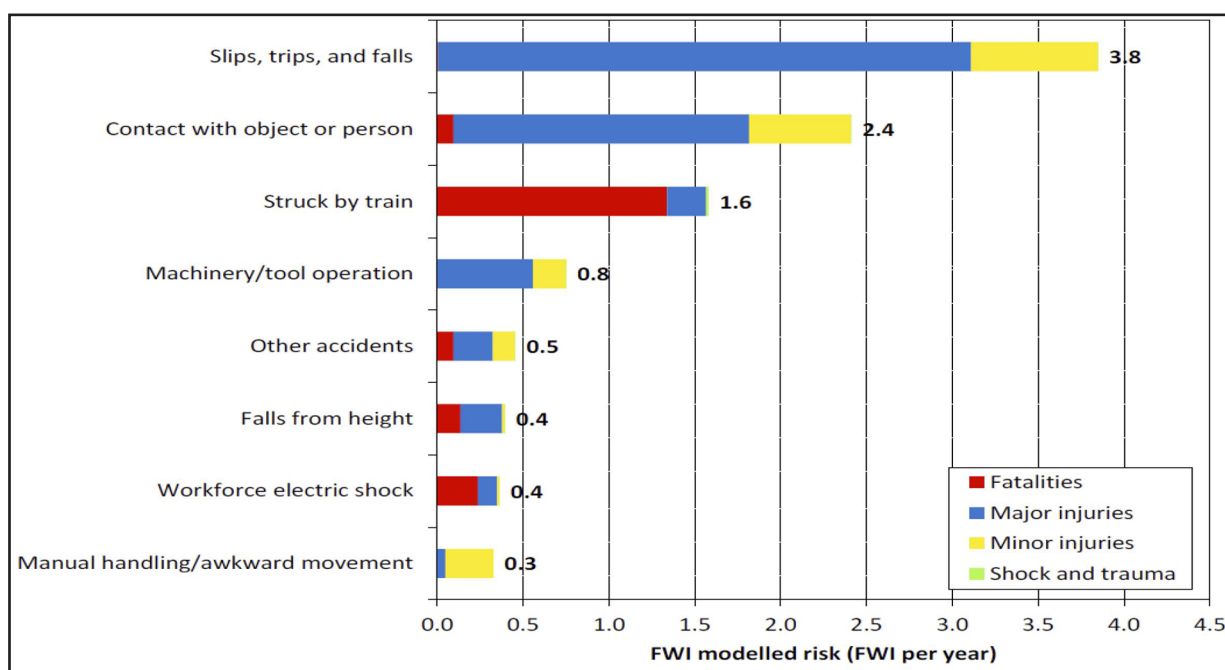
- H7 In September 2017, the chart shown in figure H1 was presented in a paper to the SHE committee. It showed that the biggest risk of harm to track workers was ‘slips, trips and falls’, with an FWI²⁶ of 3.8 per year, followed by ‘contact with an object or person’ with an FWI of 2.4 per year. The FWI for ‘struck by train’ was 1.6 per year. However, the chart also showed that the biggest risk of fatal accidents involving track workers on or about the line was being struck by a train (the data excluded road traffic accidents).

Figure H1: Chart presented in a paper to the SHE committee on 6 September 2017 (based on data in the RSSB Safety Risk Model)
