AAIB
Air Accidents Investigation Branch

AAIB Bulletin

12/2020

Aircraft Type and Registration:	Bombardier BD-700-1A10 Global 6000, 9H-VJM
No & Type of Engines:	2 Rolls-Royce BR710A2-20 turbofan engines
Year of Manufacture:	2013 (Serial no: 9630)
Date & Time (UTC):	11 December 2019 at 0550 hrs
Location:	Liverpool Airport
Type of Flight:	Commercial Air Transport (Passenger)
Persons on Board:	Crew - 3 Passengers - 1
Injuries:	Crew - None Passengers - None
Nature of Damage:	None
Commander's Licence:	Airline Transport Pilot's Licence
Commander's Age:	53 years
Commander's Flying Experience:	11,506 hours (of which 3,864 were on type) Last 90 days - 104 hours Last 28 days - 48 hours
Information Source:	AAIB Field investigation

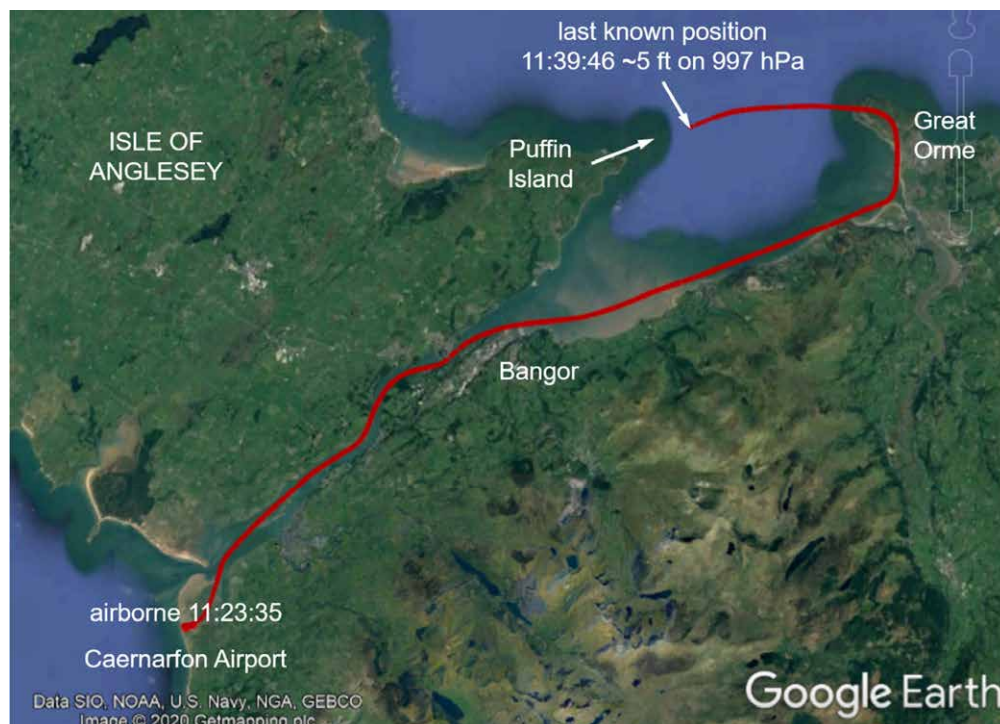
Figure 1
ADS-B³ track of G-CBXJ

The aircraft flew up the Menai Straits at about 1,400 ft amsl² and passed abeam Bangor at about 1130 hrs (Figure 1). The aircraft continued to follow the mainland coastline and climbed to 1,500 ft amsl as it turned left towards Great Orme, before turning left again towards Puffin Island.

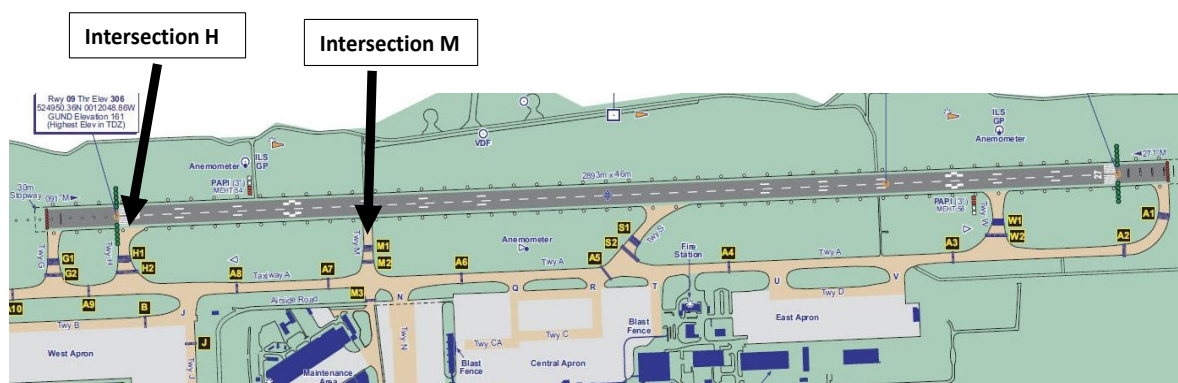
Figure 1

At approximately 120 kt, the commander recalled a transitory reduction in airspeed of between 10 and 15 kt. He called this to the co-pilot but, as the acceleration resumed, decided to continue. The commander stated that approaching V_1 (134 kt) the aircraft deviated dramatically from the centreline to the right. He estimated the deviation was between 20° and 30° of heading. The commander saw a large downtrend on his airspeed indication and felt that the co-pilot's attempts to control the heading were ineffective. He stated to the investigation, "as PM, my instant snapshot was that indicated airspeed was reducing and we were below V_1 , so I called Stop." During this sequence of events both pilots recalled hearing the automated V_1 callout. The commander took control in accordance with Standard Operating Procedures (SOP), the RTO actions were carried out and the aircraft stopped on the runway centreline between M and H taxiways (Figure 1), with approximately 600 m remaining.

East Midlands Airport Diagram
