Considerations on cracking of the Hammersmith Bridge pedestals

Prof. Norman A Fleck FREng FRS

6 November 2020

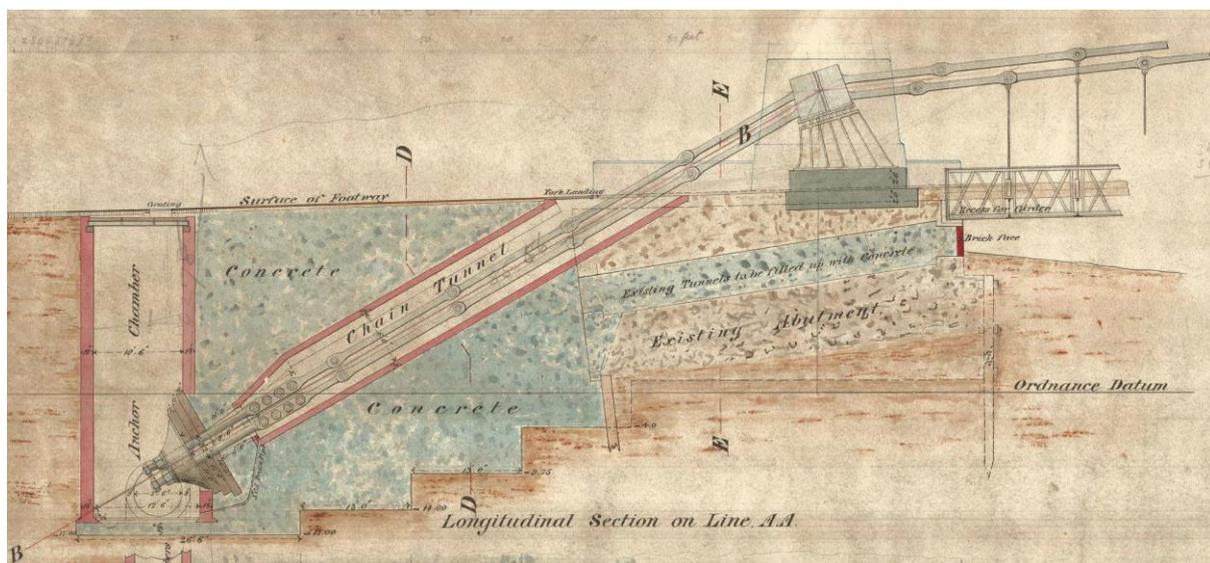
each side of the deviation saddle (due to temperature changes associated with summer peak temperatures) gives rise to a resultant force with a line of action that runs close to the toe of the pedestal – see Fig. 2. A small rotation of the pedestal about the toe will alleviate the tension imbalance in the chains: this is beneficial as it leads to a reduced level of stress in the pedestal. Likewise, any small displacement of the pedestal towards the river will relax the imbalance in chain tension.

It is difficult to envisage that a large shear component of restraining force from the foundation onto the tip of the pedestal can develop (not least as the pedestal is close to the embankment wall of the river – see Fig. 3). If a large shear force were to develop at the toe of the pedestal, then there is no clear reason why tension would develop in the vicinity of crack NE10. An alternative scenario is that a small rotation and/or slip of the pedestal takes up any clearance gap between the foundation anchor bolts and the pedestal base plate; this shear force induces tension in the pedestal the vicinity of crack NE10. This explanation is sketched in Fig. 2.

Fig. 2. The direction of the reaction force from foundation to pedestal dictates the level of tension at the location of the crack NE10 near the right-hand (river-side) toe of the pedestal. A free-body diagram of the forces on the right-hand toe of the pedestal due to a net chain force towards the river at high temperature (summer).
