Rail Accident Investigation Branch

Rail Accident Report

Freight train derailment at Eastleigh, Hampshire 28 January 2020

Report 02/2021
March 2021

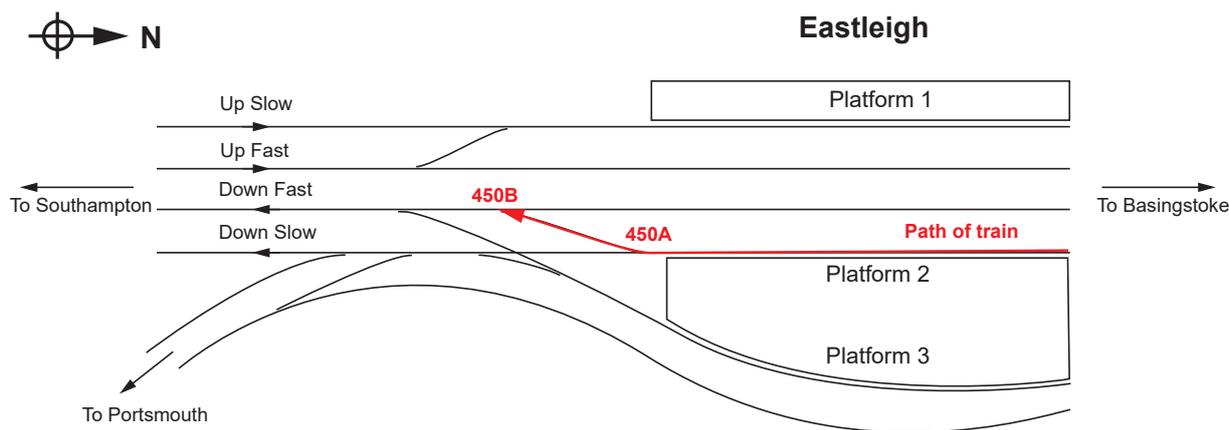
Figure 3: Track layout at Eastleigh station

- 7 The derailment occurred at the south end of Eastleigh station platform 2, as the train traversed 450A points. These form part of a crossover² with 450B points. At the time of the accident, both 450A and 450B points were set for trains to travel from the down slow line to the down fast line (figure 3). The maximum permitted speed for trains to pass over the crossover is 15 mph (24 km/h).
- 8 Although the railway is level and generally straight at this location, trains need to negotiate tight radius curves when travelling over the crossover.

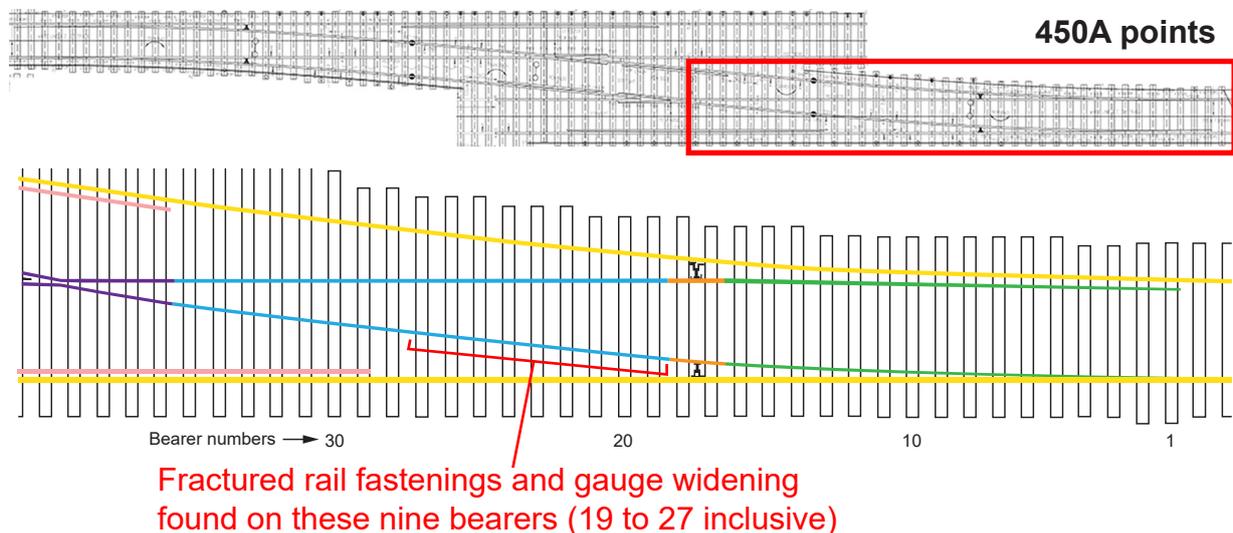
- 25 The train had reached 12 mph (19 km/h) as it arrived at the crossover. The front bogie of the locomotive passed over the switch rails⁵ (figure 5) of 450A points without incident. As the locomotive passed over the closure rails,⁶ the lateral forces it exerted (see paragraph 78) caused the rails to spread apart, and the failure of additional fastenings (figure 5). This caused all of the locomotive's wheels to drop into the now-widened gap between the rails and to derail. One of the fastenings flew out as it failed and almost struck one of the infrastructure maintenance staff.

Figure 5: Overview of crossover formed by 450A and 450B points and (below) 450A points showing the switch rails (green), stock rails (yellow), check rails (pink), switch heel on baseplates (orange), closure rails on cast iron wedges (blue) and crossing on baseplates (purple).
