SAFETY DIGEST

**Lessons from Marine
Accident Reports
1/2021**

SAFETY DIGEST
Lessons from Marine Accident Reports
No 1/2021

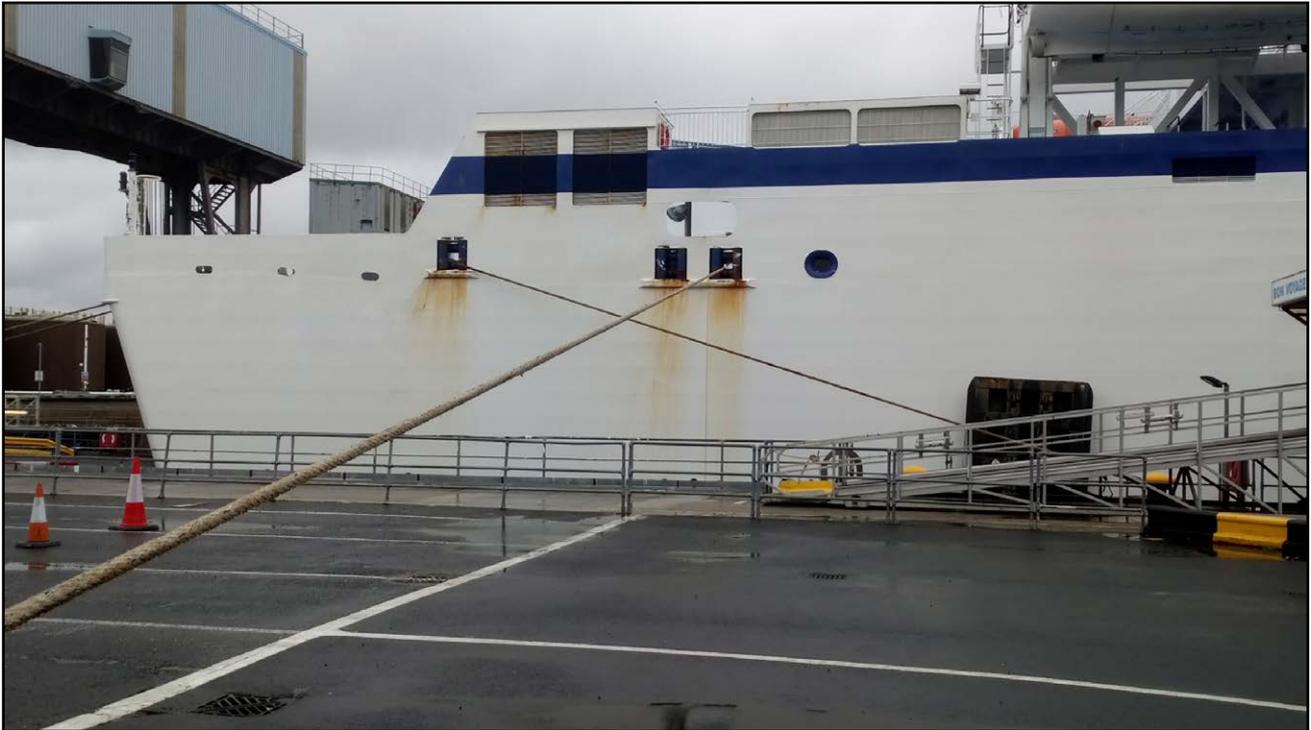
Figure 1: Breast, spring and stern lines

1. Self-tensioning winches are designed to work at a constant tension, and will heave in if tension is less than set and pay out if tension is greater. They are designed to keep a ship alongside in varying tidal or draught conditions. Here, in response to a sudden increase in wind speed, and a corresponding increase in forces on the ship and tension in the line, they payed out, operating as designed. If using winches in the self-tension mode, expected conditions for the period alongside must be carefully assessed, and if there is a chance that limits will be exceeded then use of higher tension settings, or holding on the brake with manual monitoring as the tidal height varied, could be considered.

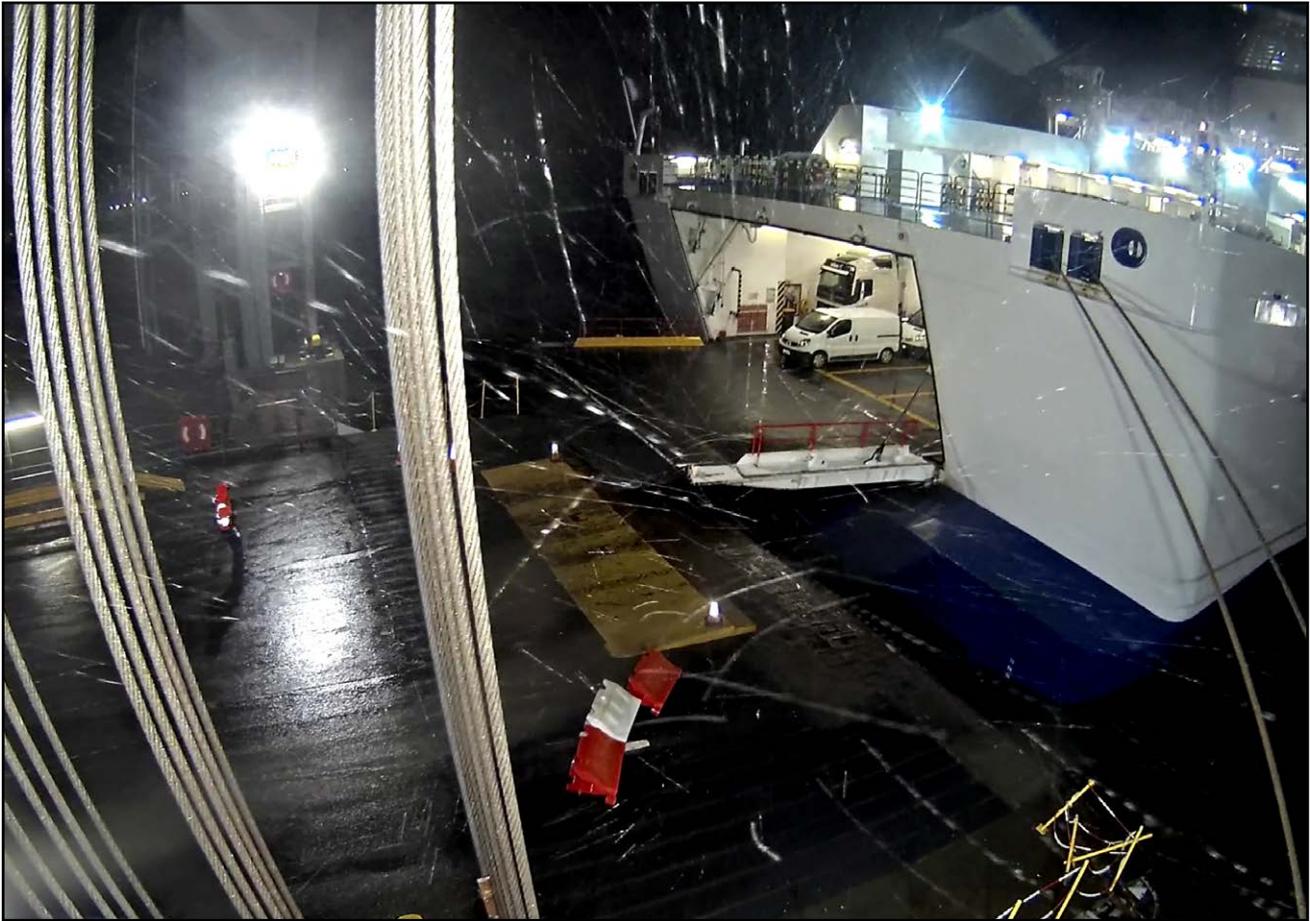
Figure 3: View of stern of ship being blown across linkspan

As the stern moved away from the berth, the stern vehicle ramp hit two guardrail posts on the edge of the linkspan, carrying them away (Figure 3). The chief officer, present on the vehicle deck, reacted quickly, stopped any further loading, and ordered that the stern ramp be raised. He also ordered the mooring party to heave on the mooring winches, arresting the swing with the ship's quarter around 12m from the berth.

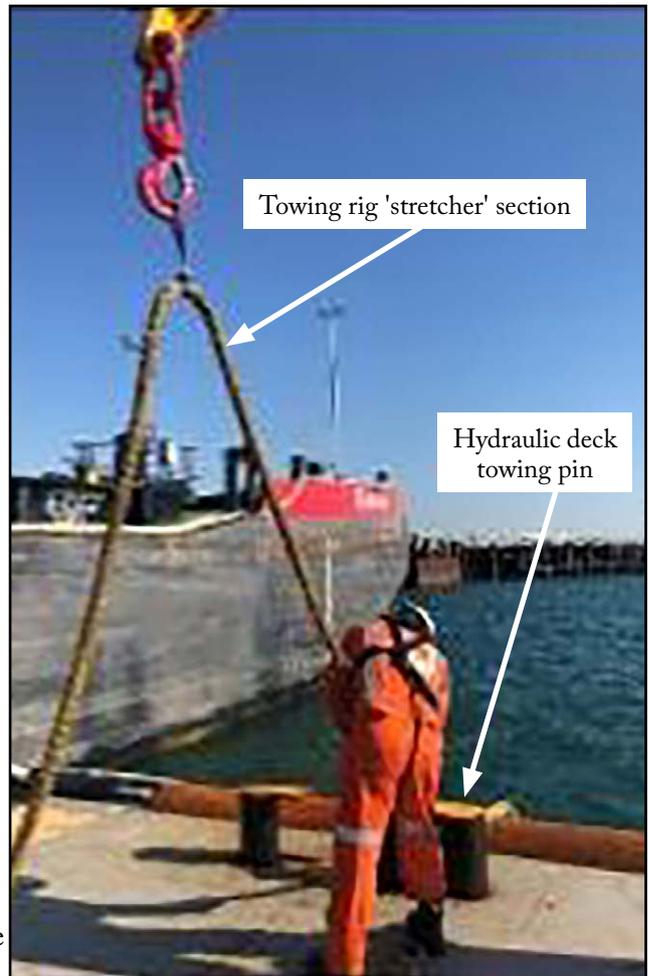
The crew of a tug were rigging the towing gear in preparation for a seagoing tow. Two crewmen were working on deck to attach the bridle to the main tow wire using a length of rope known as the 'stretcher'. The rope stretcher had been lifted into place using a crane and was suspended above the deck as the crew threaded it through the hydraulic deck towing pins (Figure 1).

Figure 1: Reconstruction of the suspended rope stretcher being held above the deck

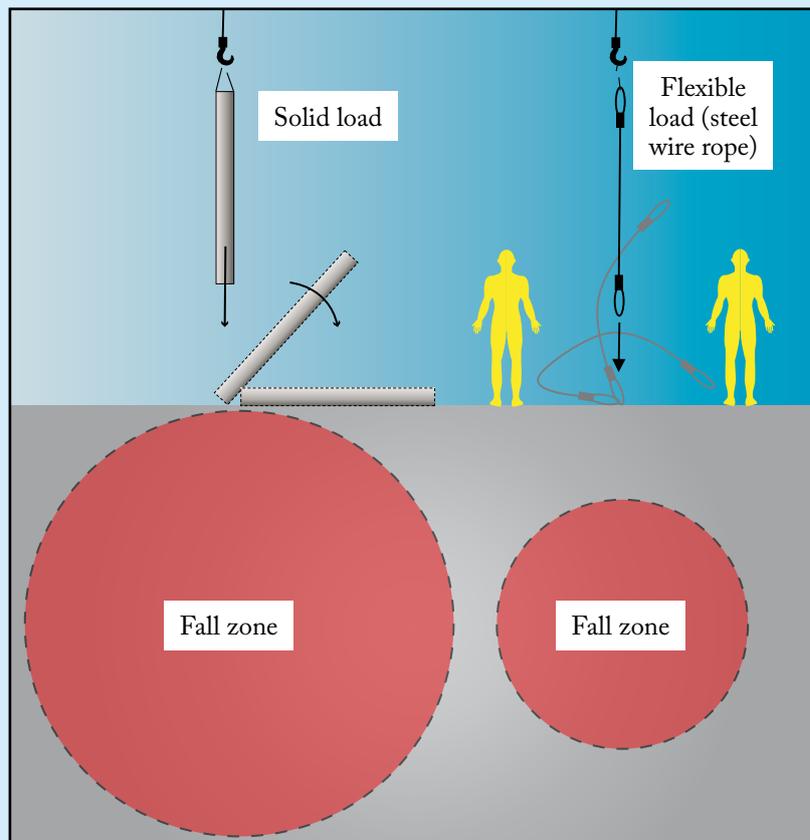
1. During lifting operations, it is vital that crew avoid the hazardous fall zone under the suspended load. This is not just the area directly under the suspended load; it extends to the entire area where it is reasonably foreseeable that a load could fall (Figure 1).
2. All lifting operations should have a safe plan, ideally a task specific risk assessment and method statement. In this accident, the ABs were struck because they were standing in the fall zone, which had not been assessed as a dangerous area. At safety briefs or toolbox

Figure 1: Illustration of the danger zone under a suspended load

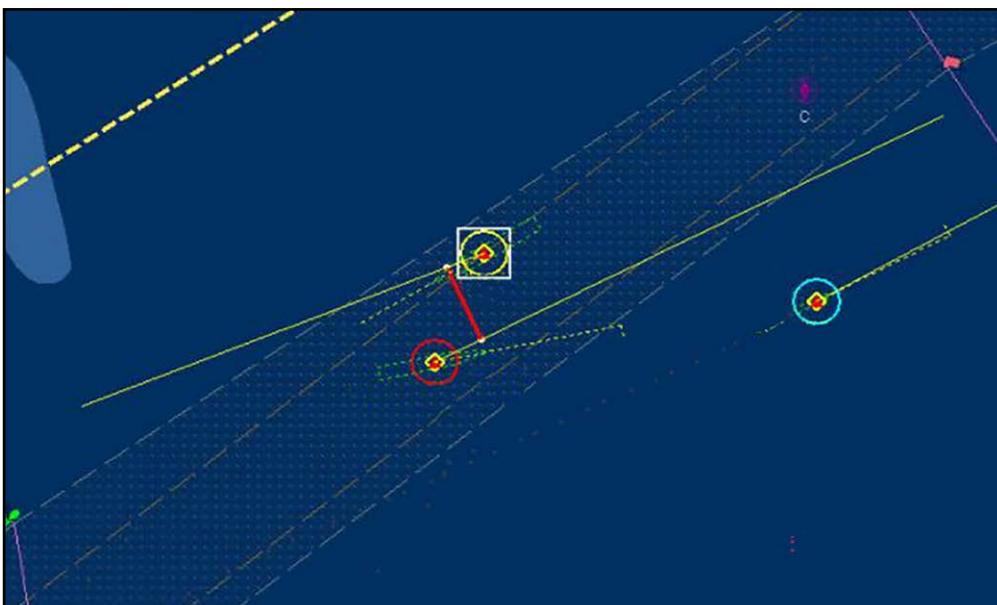
Having appreciated the proximity of the bulk carrier, the ferry's master confirmed to both VTS and the bulk carrier his intention to alter course back to starboard. After the course alteration, the ferry and the bulk carrier passed at approximately 1 cable (Figure 3).

Figure 3: Passing at 1 cable

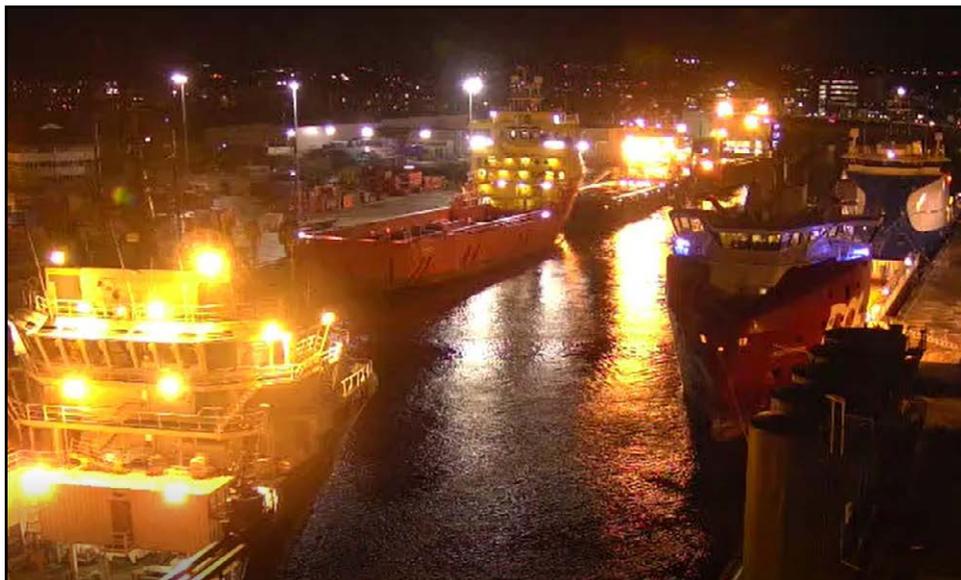
Figure 1: The support vessel approaching the berth (port side alongside)

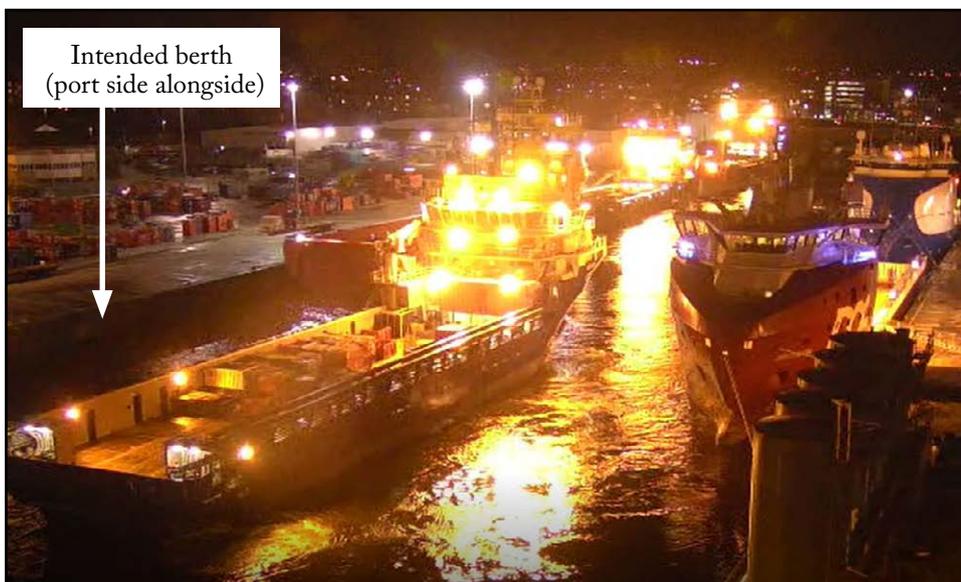
Figure 2: The support vessel overshoots the berth

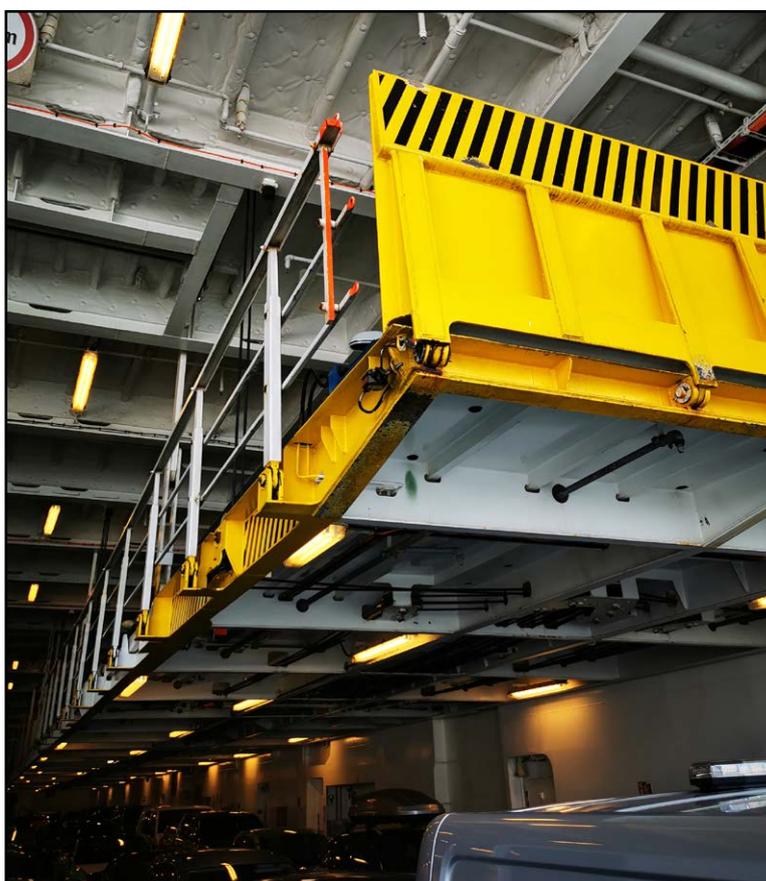
Figure 1: The loaded mezzanine decks in the raised position with the vehicle ramps in the vertical (safe) configuration

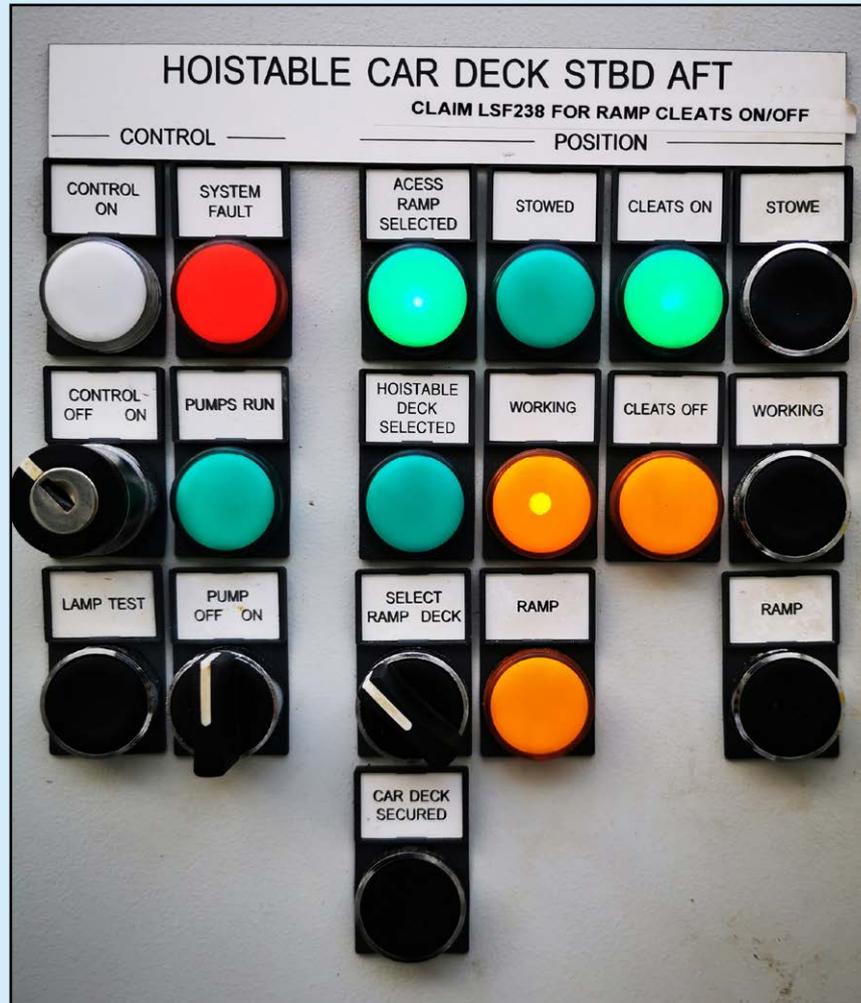
Figure 2: The hoistable car deck control panel

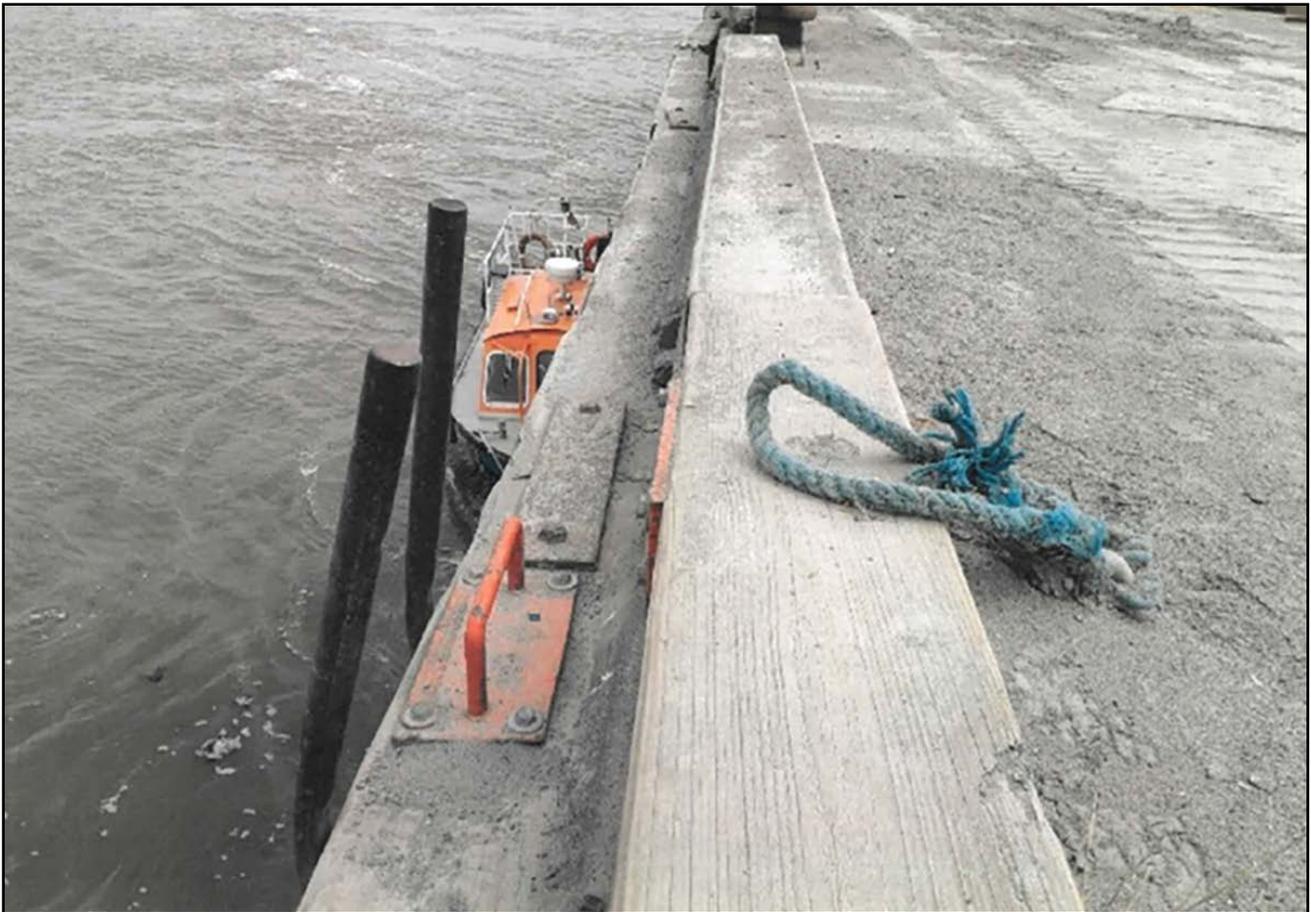
loose aggregate (Figure 3) and fell backwards between the barge and the quayside, and into the river, where his lifejacket immediately inflated.

Figure 3: Quayside showing ladder and loose aggregate

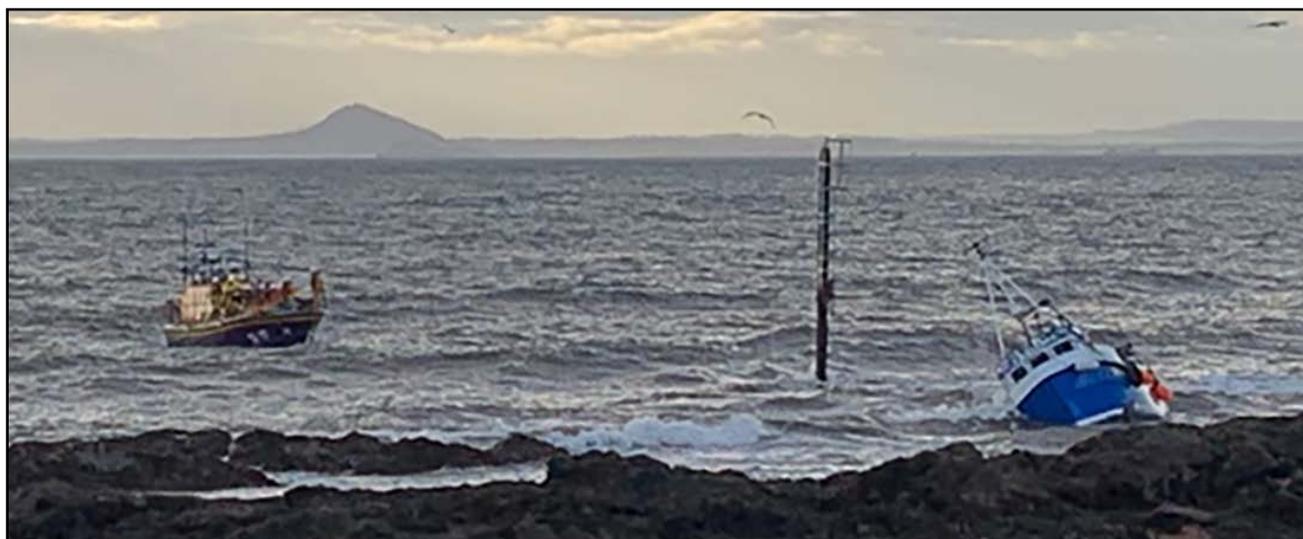
At low water, the skipper and the lifeboat crews tried to patch the hole in the hull, but by that time the damage was too great and the attempt to recover the vessel had to be abandoned as the tide rose again. The vessel was totally engulfed, and with an onshore swell still running it broke up on the rocks (Figures 1 and 2), with its fuel causing some minor pollution.

The fishing vessel's propeller was almost certainly fouled by a line from an unmarked creel fleet that had been laid close to the harbour entrance. The propeller wound this in tightly, jamming the shaft and stopping the engine. With no way of quickly clearing the fouled propeller, and poor holding ground for an anchor, there was little more the skipper could do.

Figure 1: Fishing vessel aground on rocks

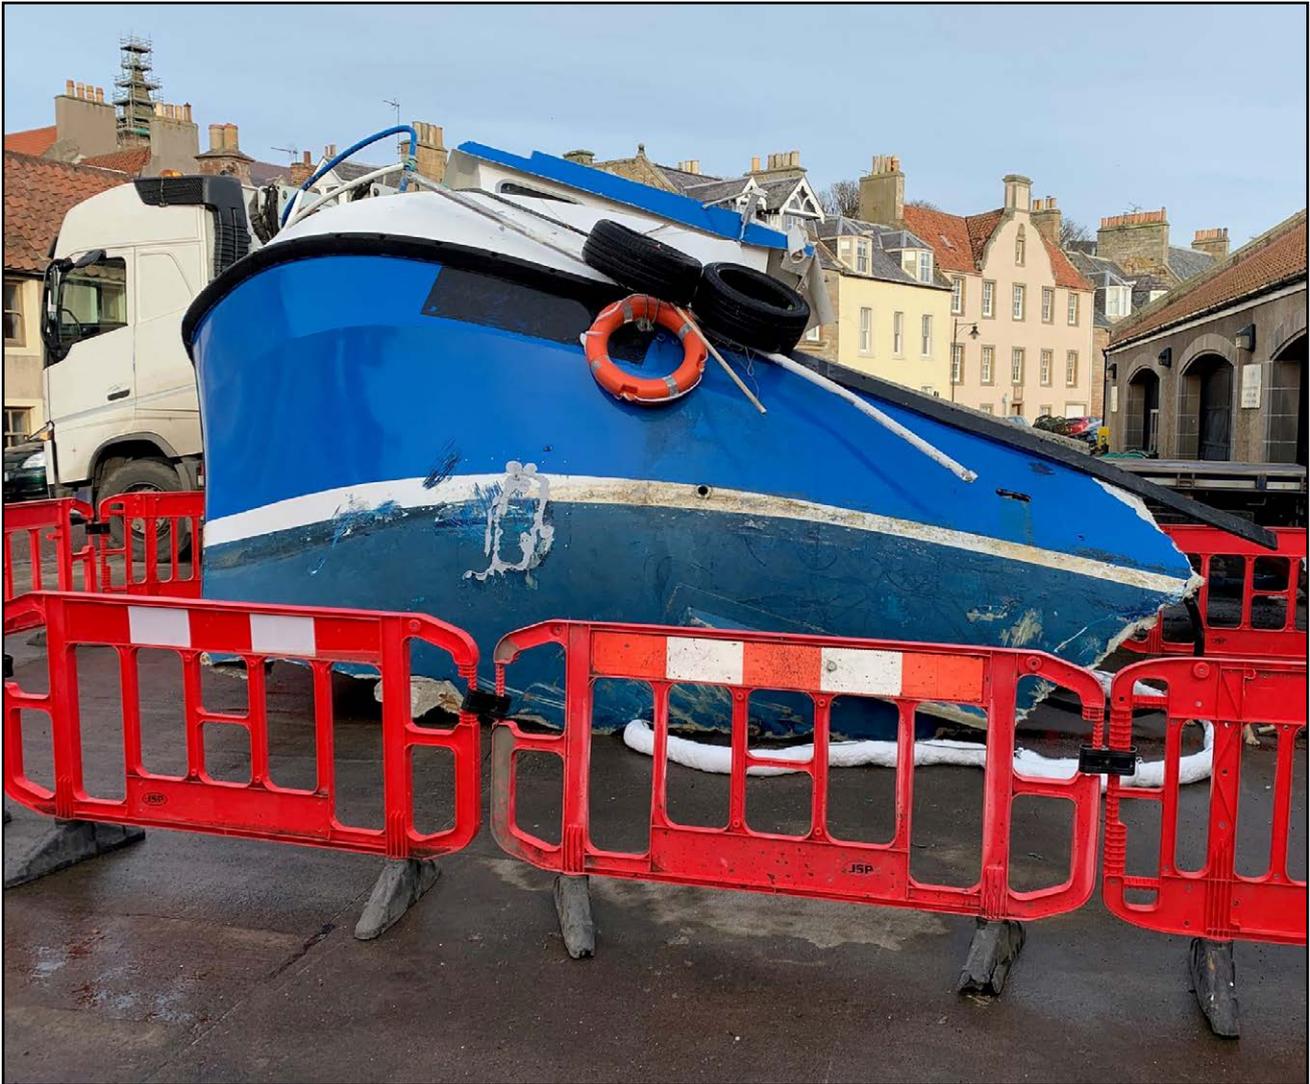
Figure 2: Bow section ashore

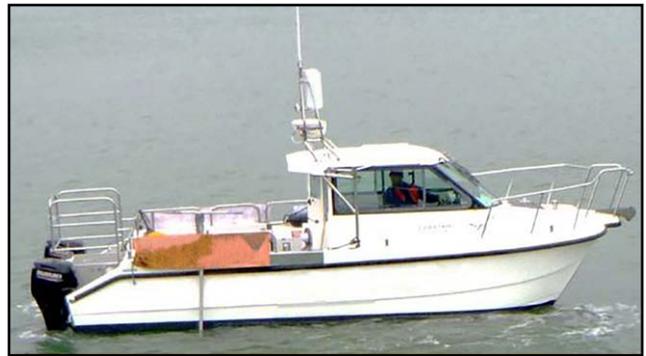
Figure 1: The catamaran fishing vessel (not at the time of the accident)

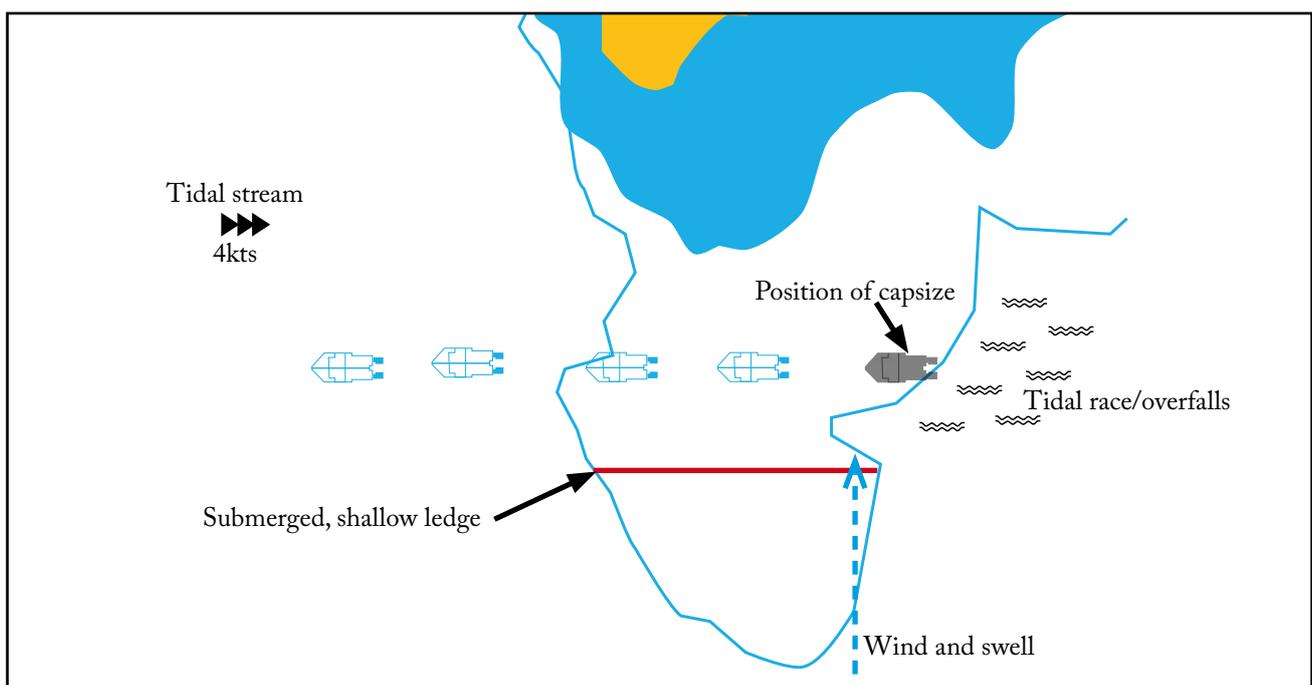
When they arrived at the fishing grounds, the skipper positioned the boat about a mile upstream from the race, then let the boat drift with the wind and tide as they fished (Figure 2). As the boat approached the overfalls, the crew reeled in their lines and repositioned to start fishing again; this process was repeated three times without incident. However, on the fourth occasion, just as the two fishermen had returned to the wheelhouse to reposition, the boat was struck by a large wave and capsized. After the capsizing, the boat floated upside down (Figure 3).

Figure 2: Overview of the fishing vessel's track showing the position of the capsizing

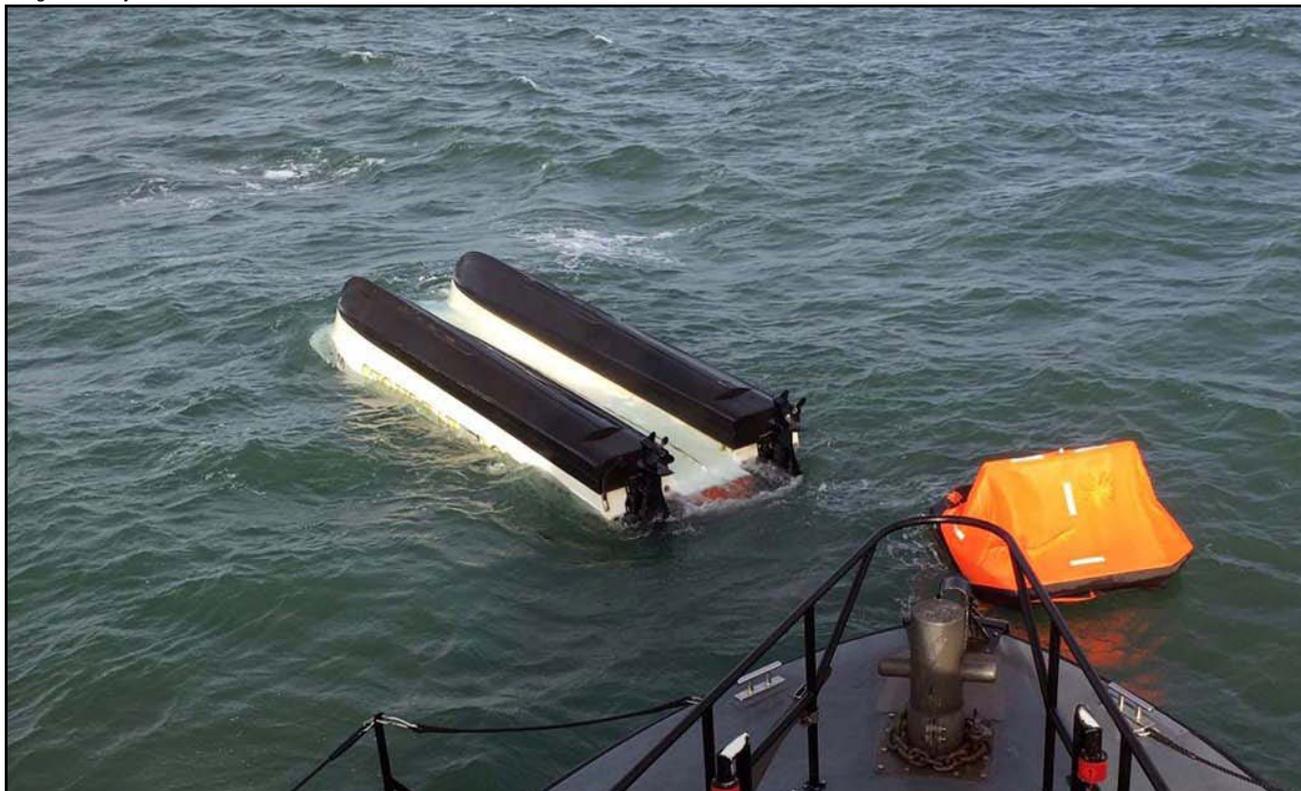
Figure 3: The catamaran fishing vessel capsized and the inflated liferaft

1. This accident almost certainly happened because the skipper underestimated the hazard associated with operating the boat in the strong tidal rips and overfalls. Extreme care should be taken when navigating in the vicinity of such dangerous areas. Given that the crew were familiar with the area, it is reasonable to conclude that repeated previous exposure to this hazard had normalised their fishing in potentially hazardous waters.

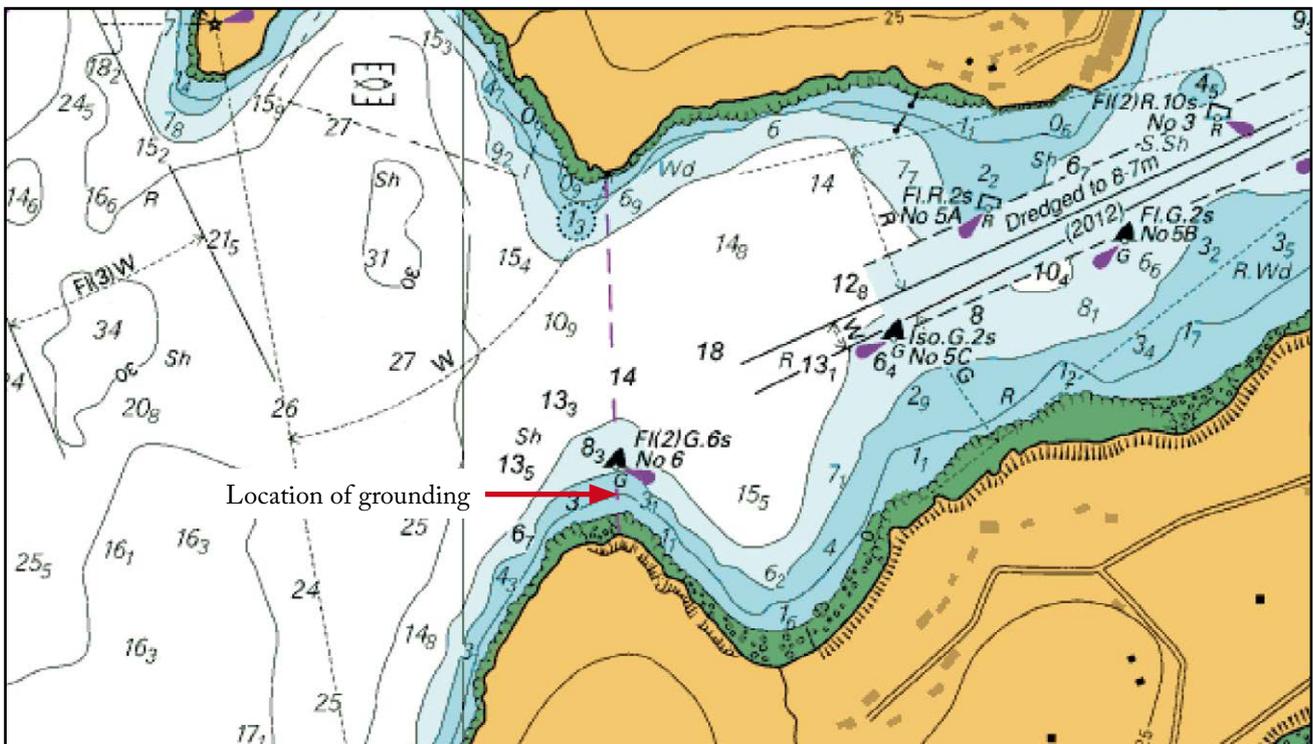
Figure 1: Chart of the fishing grounds showing narrow channel

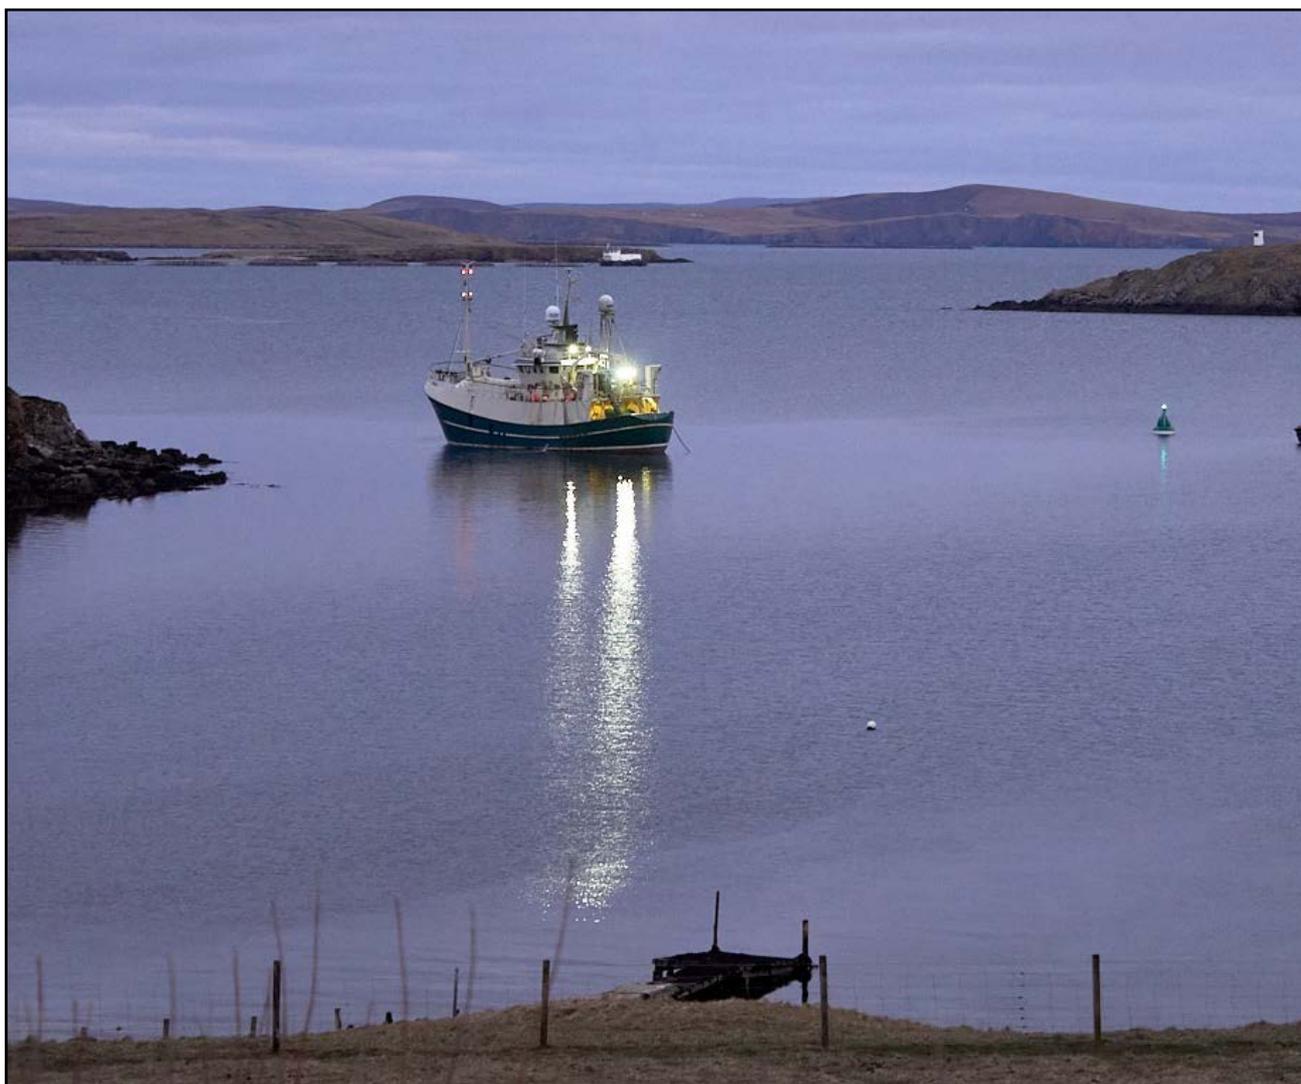
The vessel suddenly took a heel to starboard and rapidly came to a stop; the main engine continued to run. The skipper looked up from the electronic chart and realised that the vessel had sailed the wrong side of the starboard marker buoy and had run aground (Figure 2).

Figure 2: Vessel aground

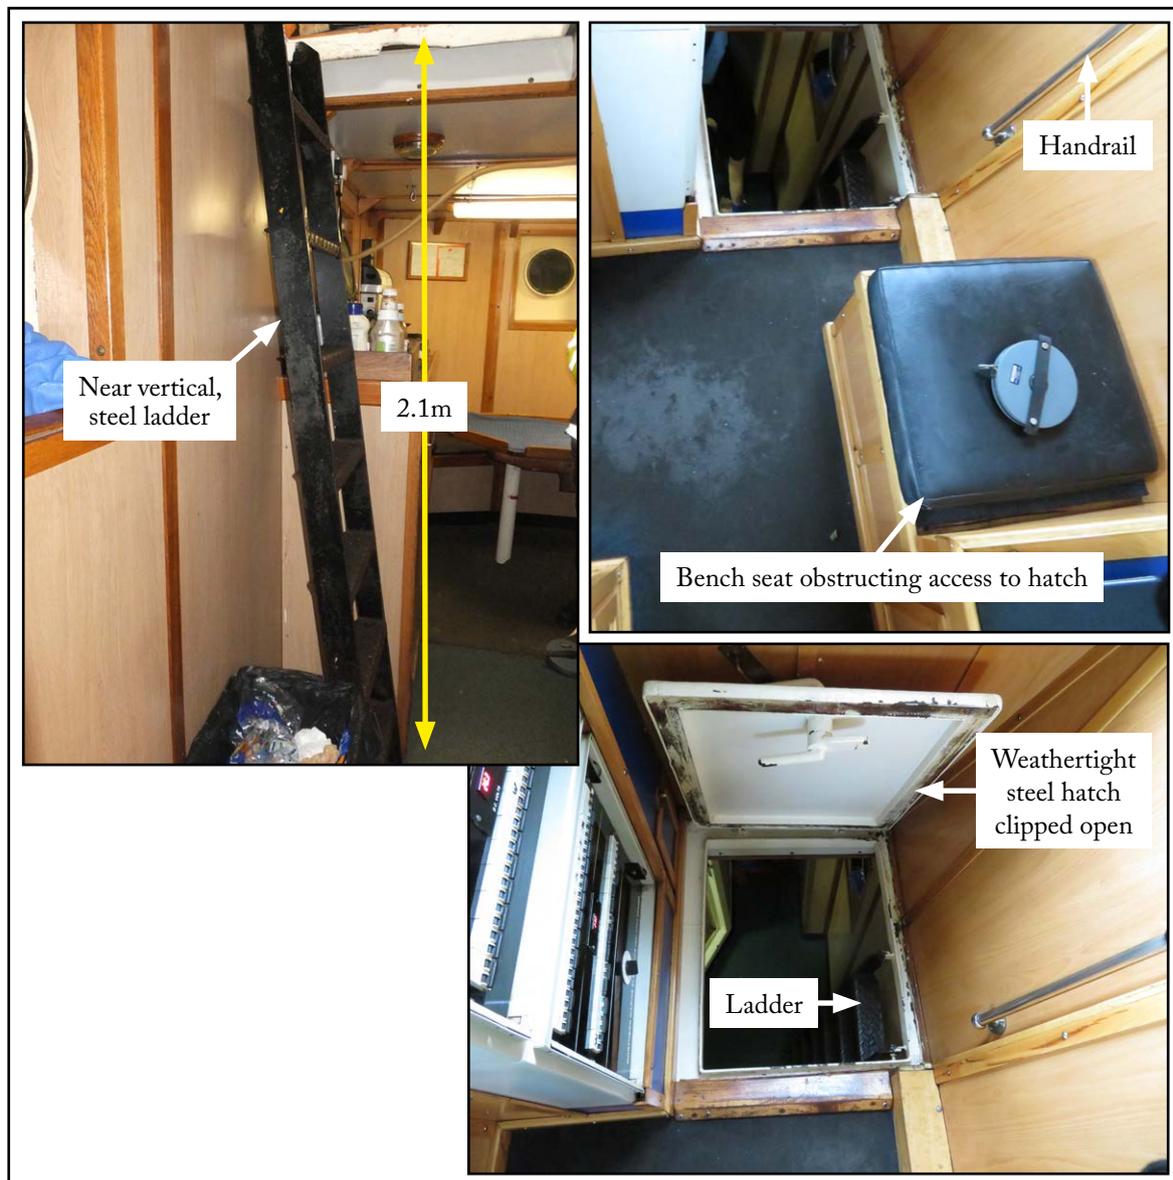
mess area. However, as he lent across the hatch to grab a hand-hold, he lost his balance and fell head-first through the hatch opening. The crew member in the mess deck heard the fall and rushed to attend to the skipper, but could find no sign of life. He then swiftly climbed the ladder to the wheelhouse and raised the alarm on VHF radio.

Figure: Access via the wheelhouse hatch

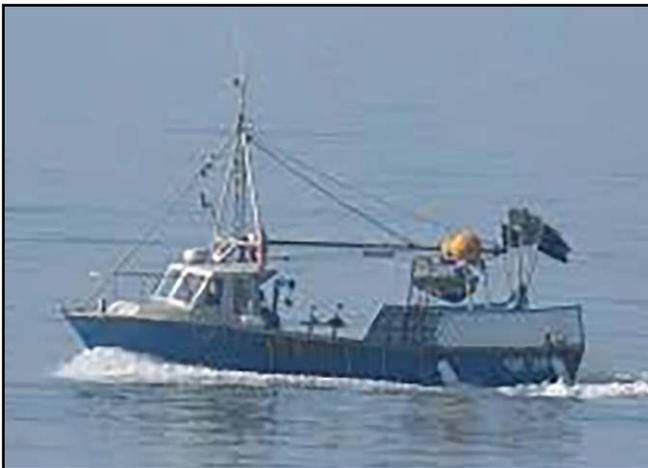
starboard derrick struck the upperworks of the gill netter. Fortunately, although shaken the skipper was not injured, but his boat suffered significant damage to its A-frame and mast. The radar dome was shattered and its VHF aerials were ripped out.

Figure 1: The gill netter

3. Finally, small vessels, especially those constructed from wood or fibreglass, can be difficult to detect on radar, even in good conditions. To ensure this type of vessel is more easily visible on radar they should be fitted with a radar reflector – is your vessel fitted with one?

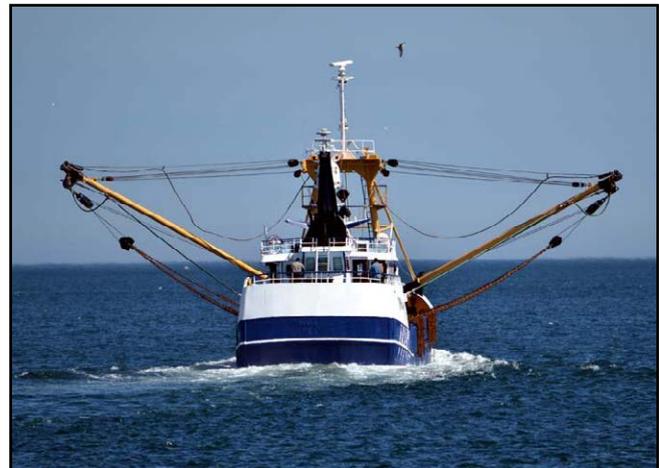
Figure 2: The scallop dredger, steaming with the derricks extended

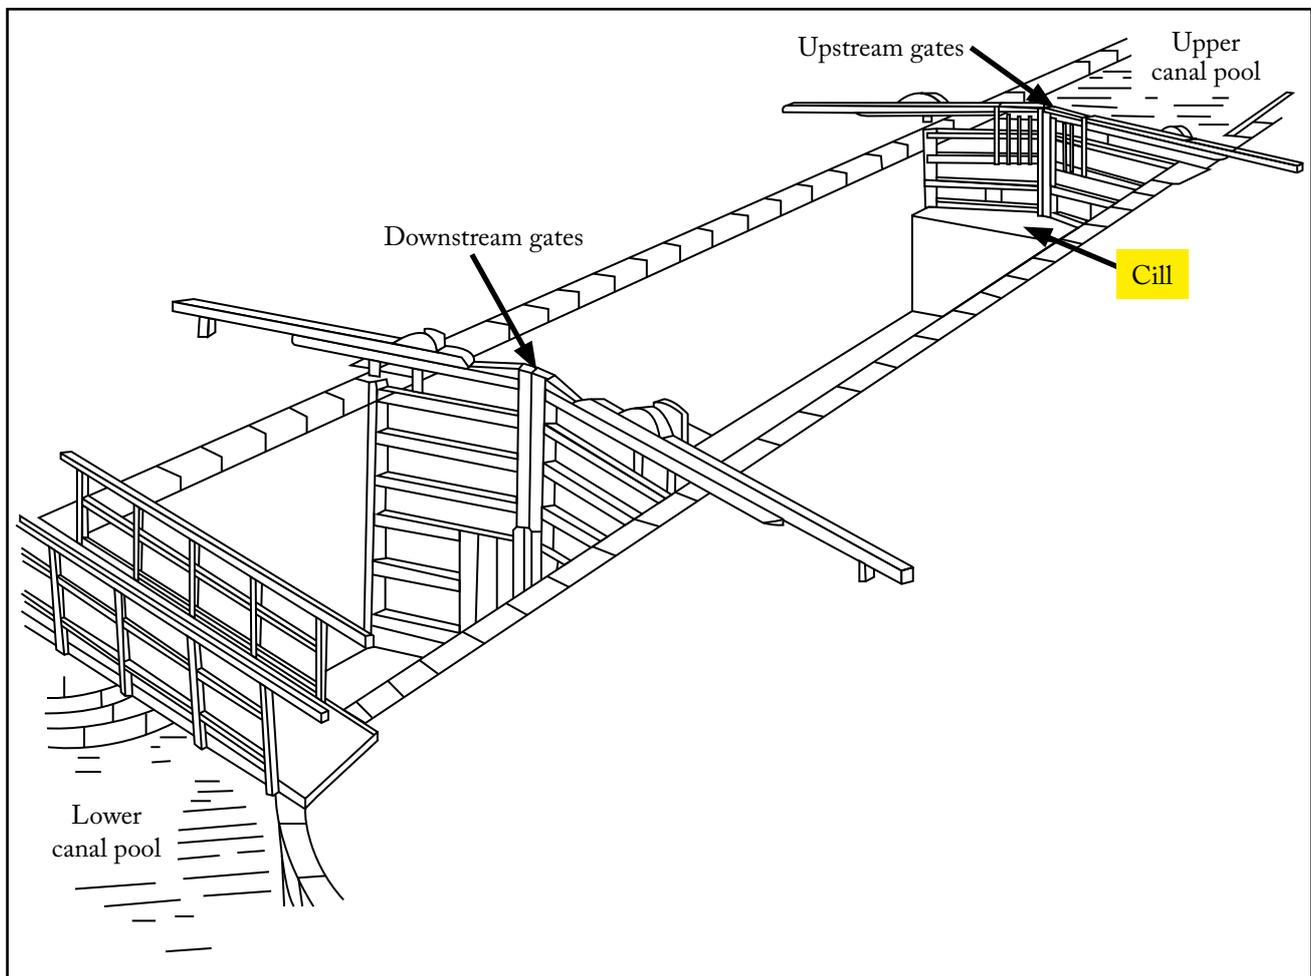
the canal. They passed through the first lock uneventfully and a short while later entered the second lock. They opened the paddles (sluices) of the down gate to lower the water level (Figure 1), and as the water level in the lock reduced, the boat drifted towards the up gate. Soon the cill¹ was exposed and the stern of the boat came to rest on it (Figure 2).

Figure 1: Diagram of a typical lock arrangement showing the cill

2. When locks are being emptied or filled, water moves in or out, and this can generate turbulence and cause your boat to move about. Ensure that the boat maintains a steady position in the lock and let water in or out gradually by controlling the paddles.

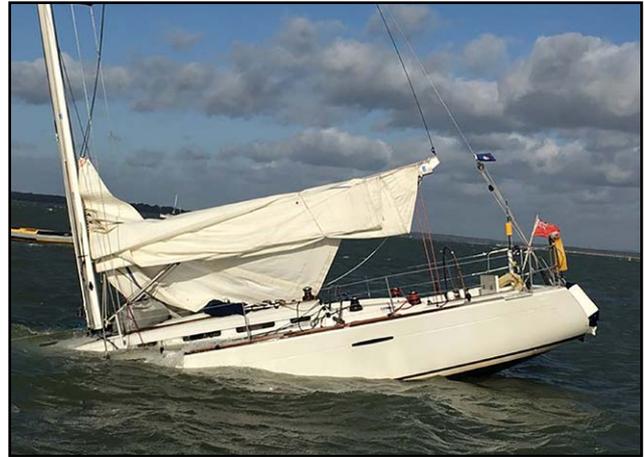
The mainsail was eased out in an attempt to recover control of the steering, however this was ineffective and the yacht's starboard bow struck the red buoy with considerable force. The collision caused the yacht to ricochet off the buoy, swing round, and the rudder then hit the buoy and was torn off. The helmsman realized that the rudder had become detached as he saw it floating away from the yacht.

Figure: The yacht
