AAIB Bulletin

4/2021

Published 8 April 2021.

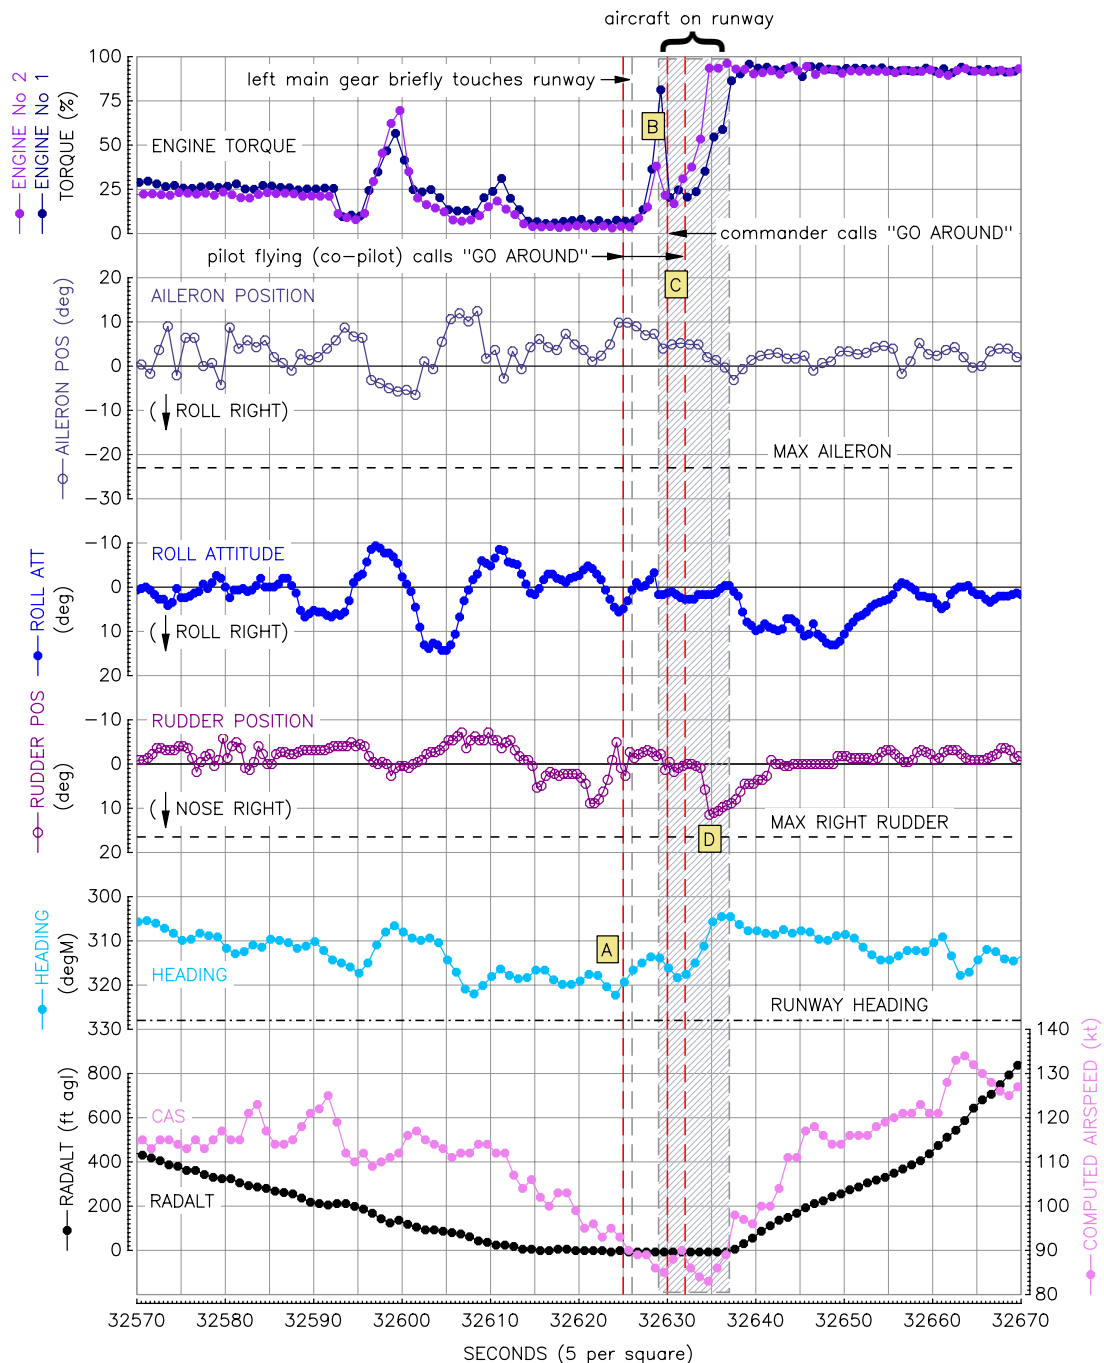
Figure 1

1. The co-pilot (PF) called "GO-AROUND" just as the aircraft was about to touch down briefly on the left main gear [A] (and Figure 2). The aircraft heading was about 8° to the left of the runway heading and increasing. The rudder deflection varied around zero and just under half left aileron was being used.
2. During the next three seconds the aircraft veered away from the runway heading while the commander was heard to say "LAND IT LAND IT LAND IT". The engine torques increased from idle to about 80% and then back to about 25% just as the aircraft touched down [B]. At touch down, the aircraft's heading was 15° left of the runway.

3. Shortly after touchdown, the commander called "GO-AROUND" which the co-pilot acknowledged [C] whilst advancing the power levers.
4. The aircraft remained on the ground for about eight seconds during which a small amount of right rudder and left aileron was initially used. The aircraft's heading responded to the right rudder before veering away to the left. About 75% of full right rudder was then applied [D]. The aircraft's heading was 24° left of the runway as the aircraft became airborne (Figure 3).

Flight data for the go-around

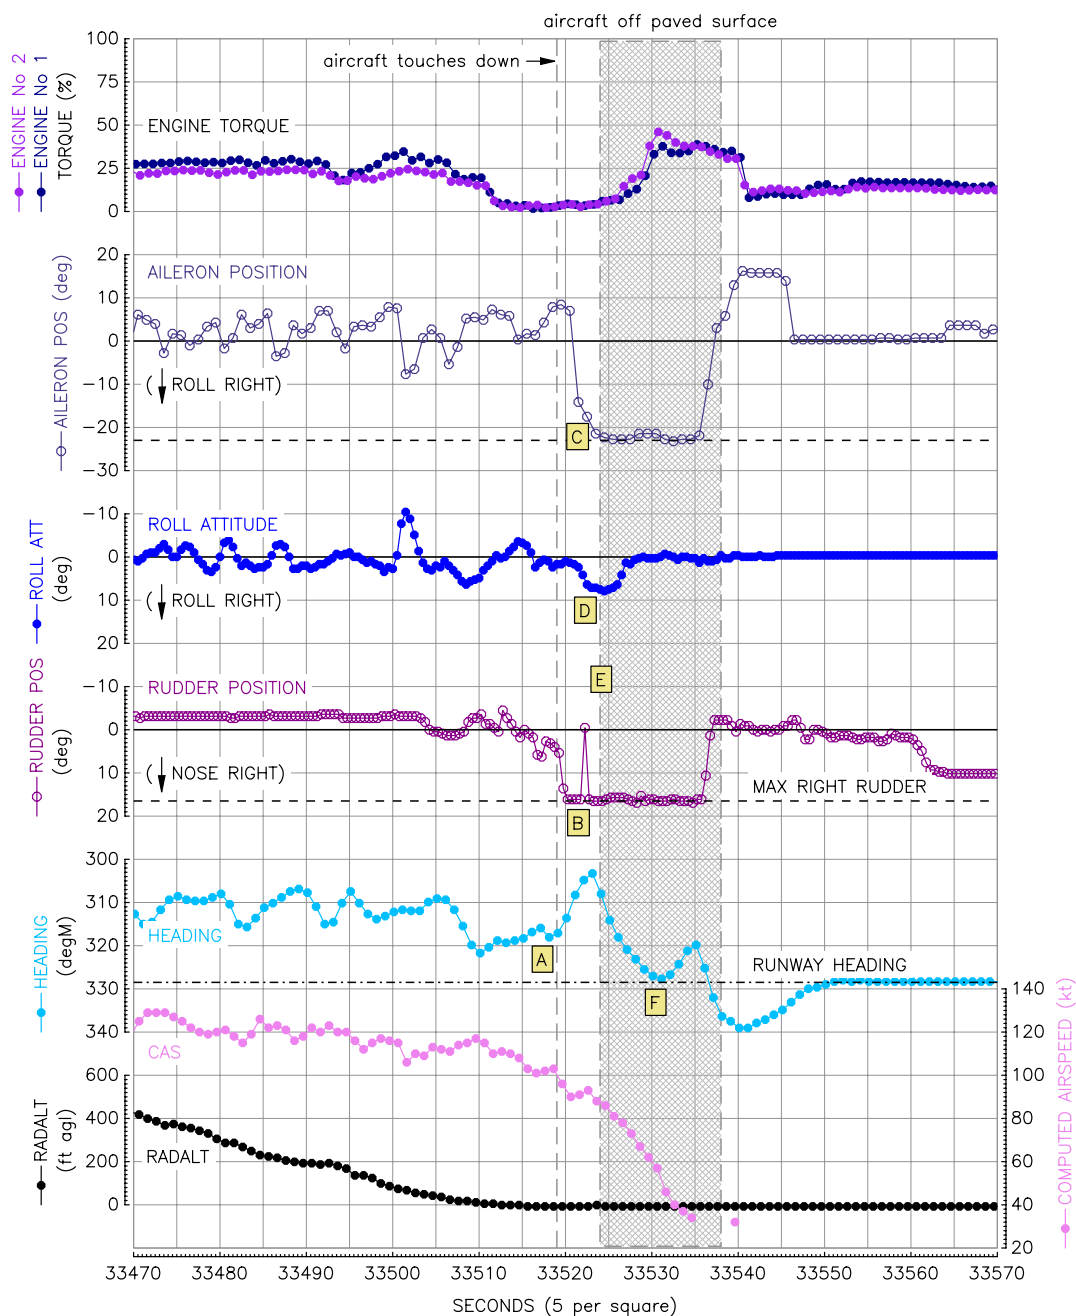
Figure 4
Flight data for the landing

1. At touchdown, the aircraft heading was about 10° left of, and veering away from, the runway heading [A] (and Figure 5).
2. Full right rudder was immediately applied [B] and slowed the veering to the left, which peaked at 24° nose left.

3. Full right aileron was applied [C] causing the aircraft to bank 8° left wing up [D] and lift the left main gear off the runway (Figure 6).
4. About five seconds after touching down, the aircraft left the paved surface to the left [E] (and Figure 7) but in a right turn on the nose and right main gear.
5. Seven seconds after leaving the paved surface, the aircraft turned onto the runway heading [F], but on a parallel track to the left of the runway, before veering a little to the left again then back right, re-joining the runway another seven seconds later (Figure 8).

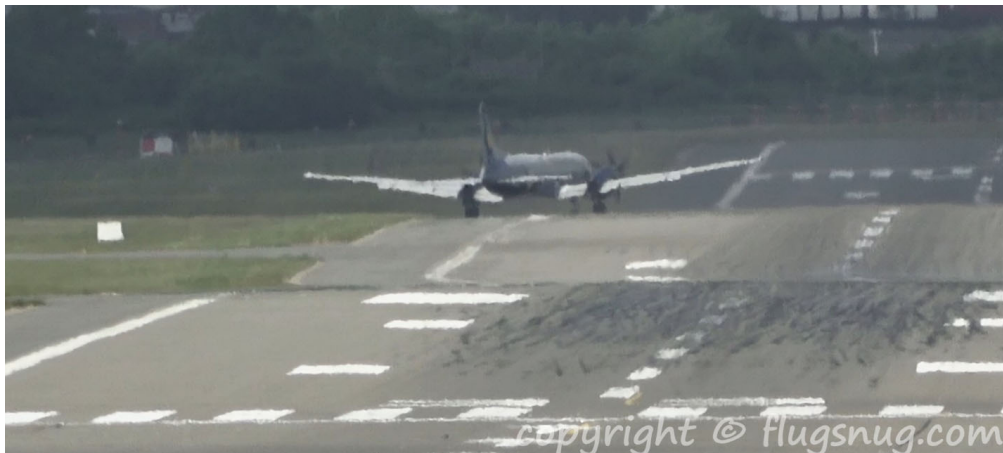
Figure 8

Image showing Point F from Figure 4 – SE-MAO returns to the paved surface

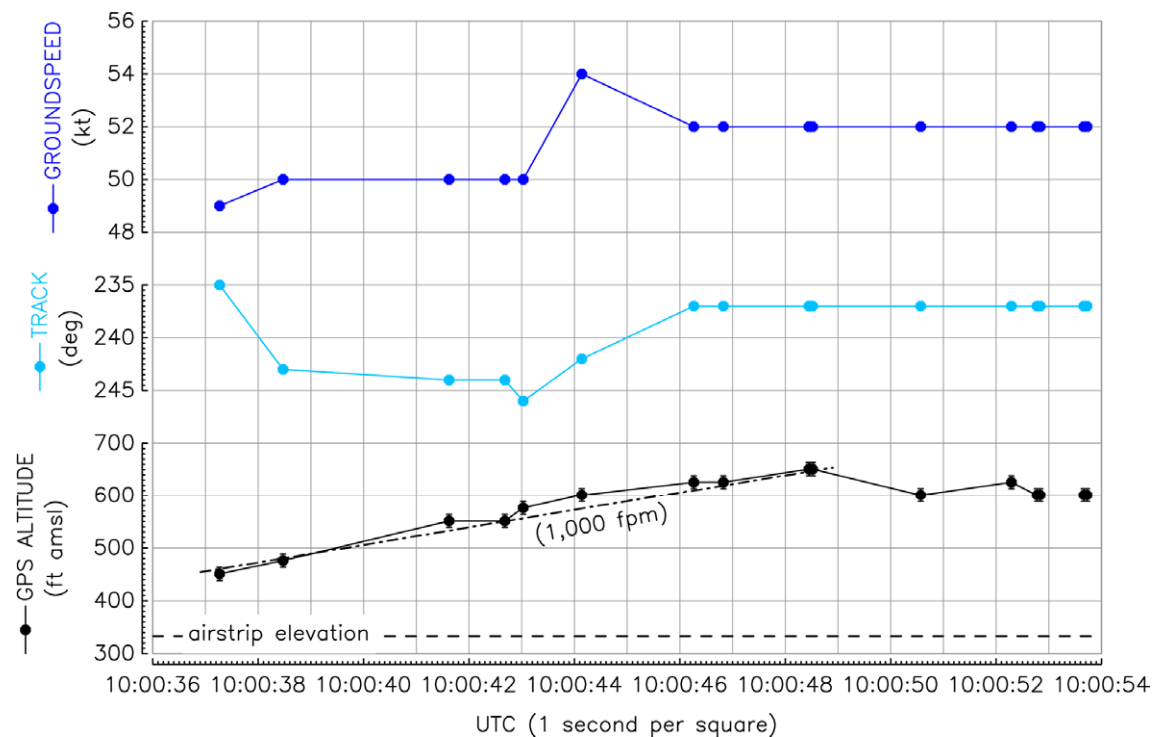
Figure 2
ADS-B Out flight data

As the aircraft passed over the south-west corner of the airstrip it was about 220 ft above the airstrip elevation and climbed a further 100 ft over the next six seconds. The climb rate of the aircraft was, on average, approximately 1,000 ft/min (consistent with normal climb performance information provided by the manufacturer for this aircraft type at a mass of 544 kg). It then descended at about 1,000 ft/min to 270 ft above the airstrip elevation before the recordings stopped. The last recorded point positioned the aircraft about 200 ft above and 130 m north of the accident site.

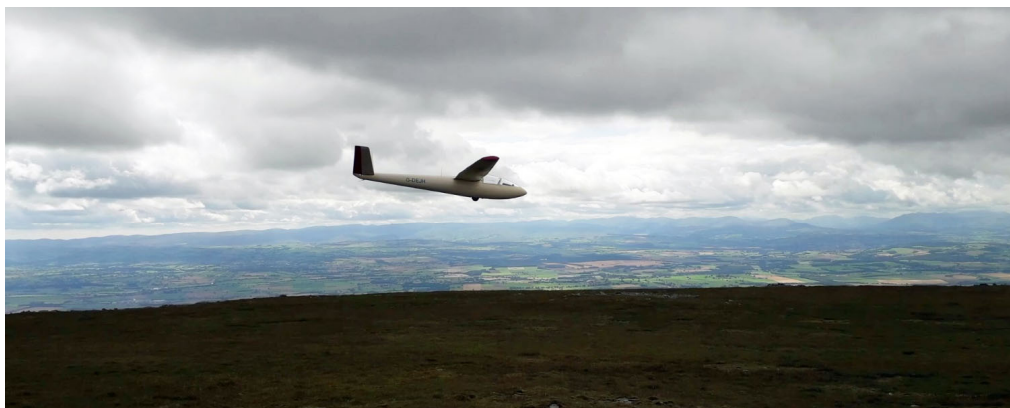
Figure 2

heard a crack and the tail then separated from the glider. The glider pitched nose-down with the right wing hitting the ground first. One of the hill walkers ran to attend to the pilot, who was severely injured and unconscious, while the other walker called the emergency services.

Still taken from video of the second pass (Image used with permission)

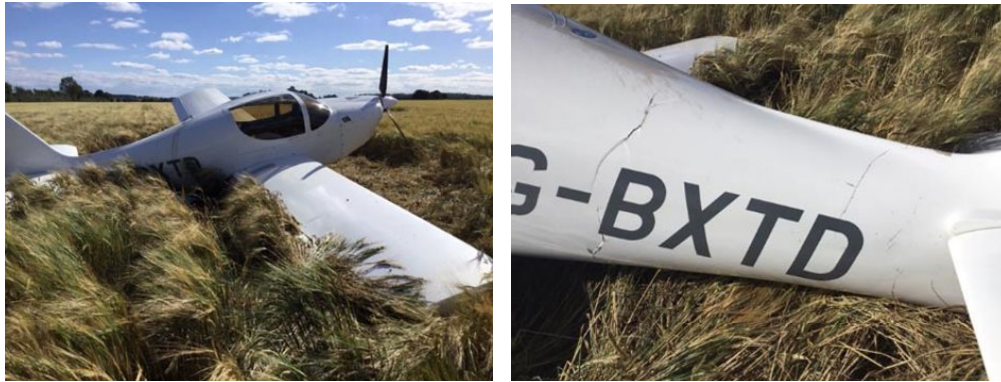
Figure 1

Aircraft final resting position and cracks evident in the rear fuselage section

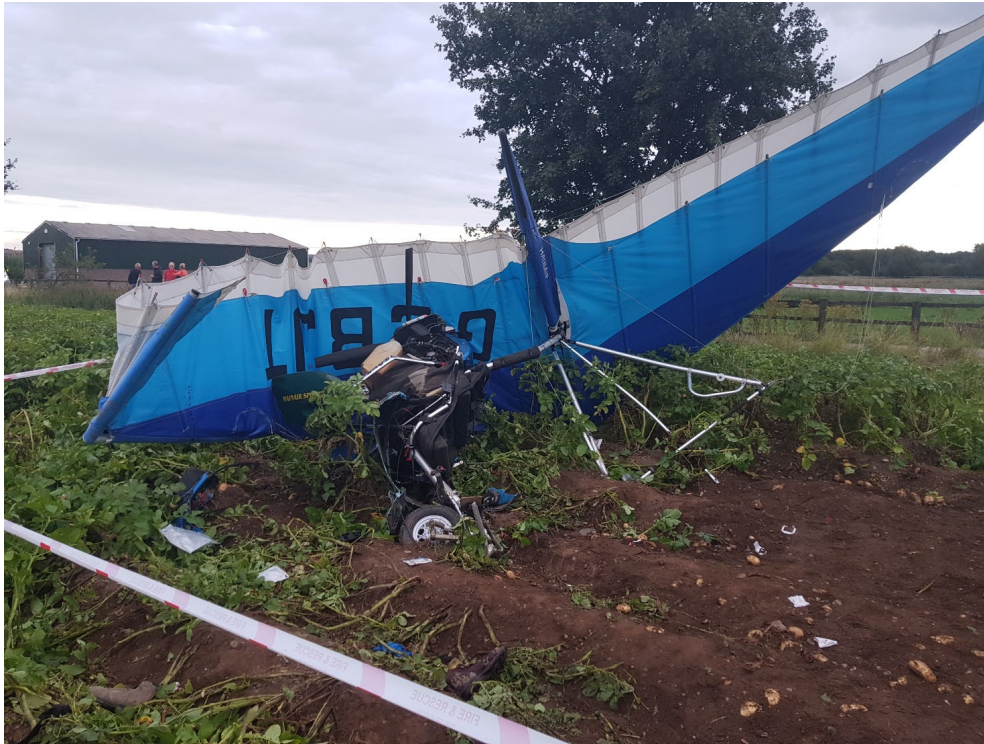
Figure 2

Aircraft after the forced landing

As a result of the increased rate of descent, the aircraft could not reach the intended touchdown point and was extensively damaged during the impact sequence. As a result of the fuselage disruption, the student suffered serious injuries and had to be rescued by the emergency services.

The cause of the engine failure was not determined.
