Rail Accident Investigation Branch

Rail Accident Report

Wagon derailment at York station 18 January 2006

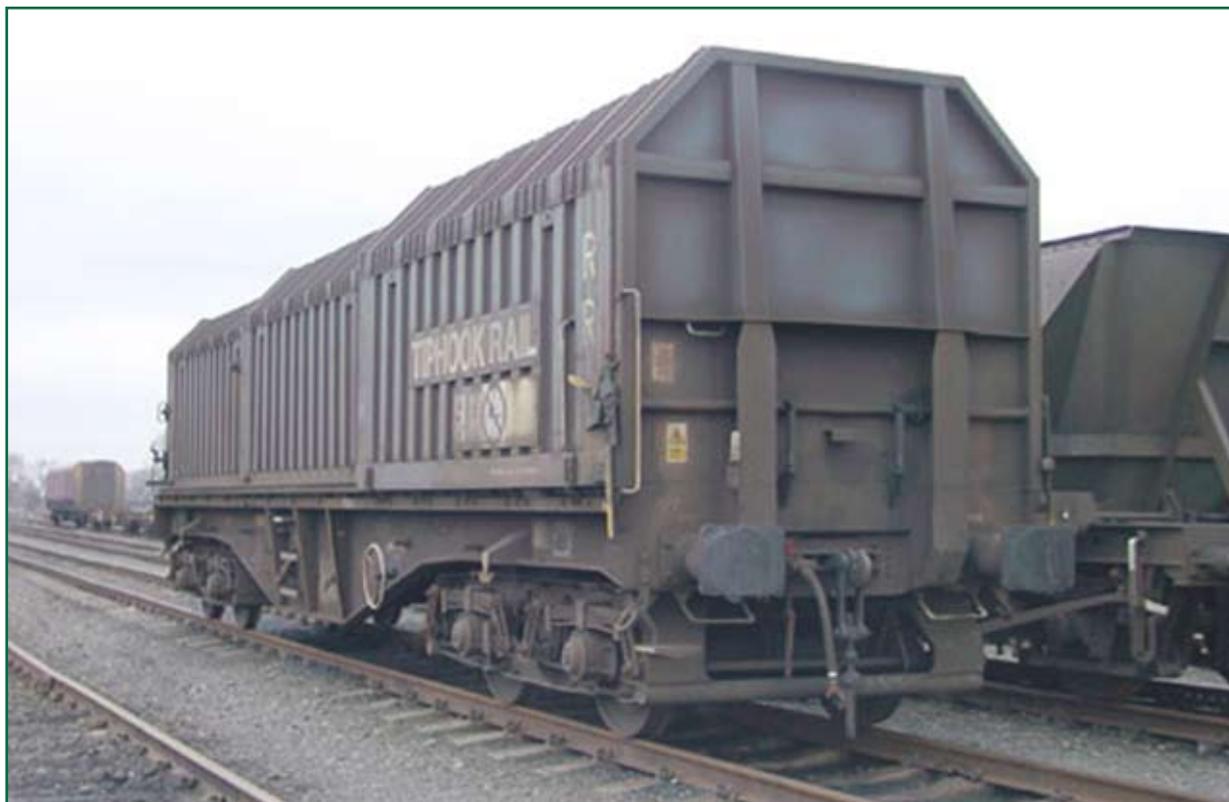
Figure 2: Wagon 7008990380

- 14 Wagon 7008990380, empty at the time of the incident, was the fifteenth wagon from the locomotive. A photograph of the wagon is shown in Figure 2.
- 15 The wagons were designed and certified for international traffic in accordance with the *Regolamento Internazionale Veicoli* (RIV) regulations of the *Union Internationale des Chemins de Fer* (UIC). The design of the wagons was scrutinised for compliance with UIC codes (standards) rather than Railway Group Standards. By this process, compliant wagons are considered to have satisfied the requirements of Railway Group Standard GM/RT2000, Engineering Acceptance, and are approved for use on Network Rail Infrastructure.

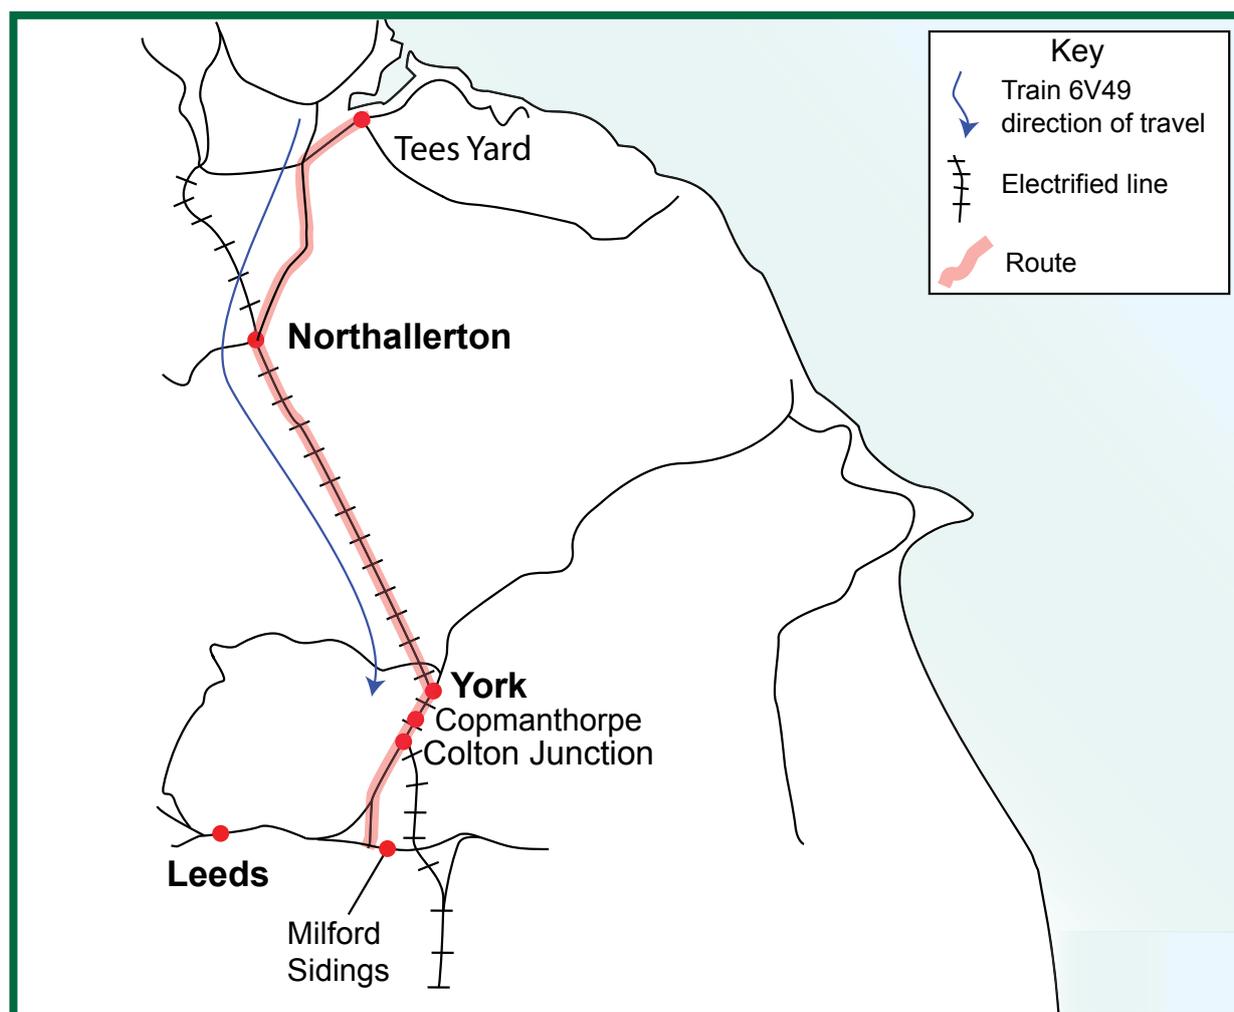
Figure 4: Route taken by 6V49 on 18 January 2006

26 The planned route for the train from Tees Yard to York is shown in Figure 4, along with the location at which the train was stopped - Copmanthorpe - and the location at which the wagon was detained for examination and test - Milford sidings. The route is straight for several miles to the north of York then turns through an ‘S’ curve to reach York station. The route speed is progressively reduced from 125 mph (200 km/h) on the straight, to a minimum of 30 mph (48 km/h) at the north end of York station, platform three.

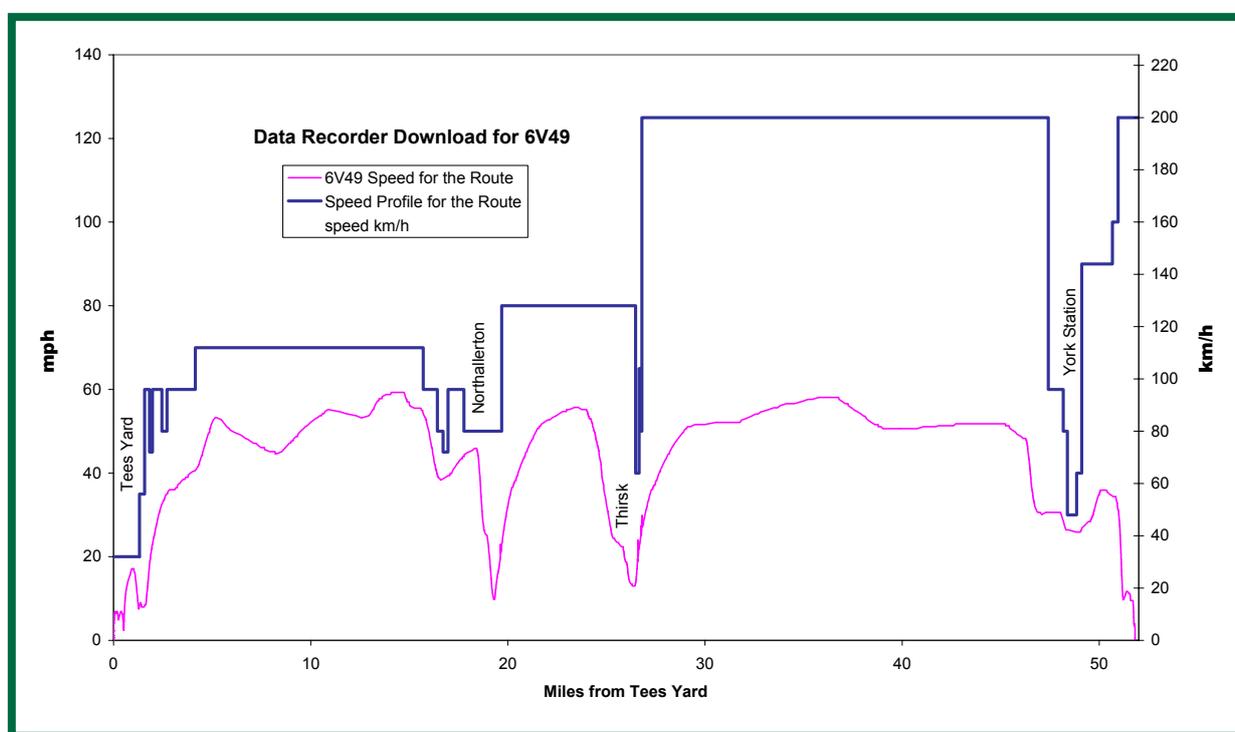
Figure 5: Train speed compared with permitted speed for the route

- 27 On the day of the incident, train 6V49 departed Tees Yard on time. The train travelled via Northallerton at a maximum speed, determined from the locomotive’s data recorder, of no more than 60 mph (96 km/h). The train speed was within the permitted speed for the route and the wagons throughout.
- 28 The train entered York station at 27 mph (43 km/h). A comparison between train speed and permitted route speed is given in Figure 5.

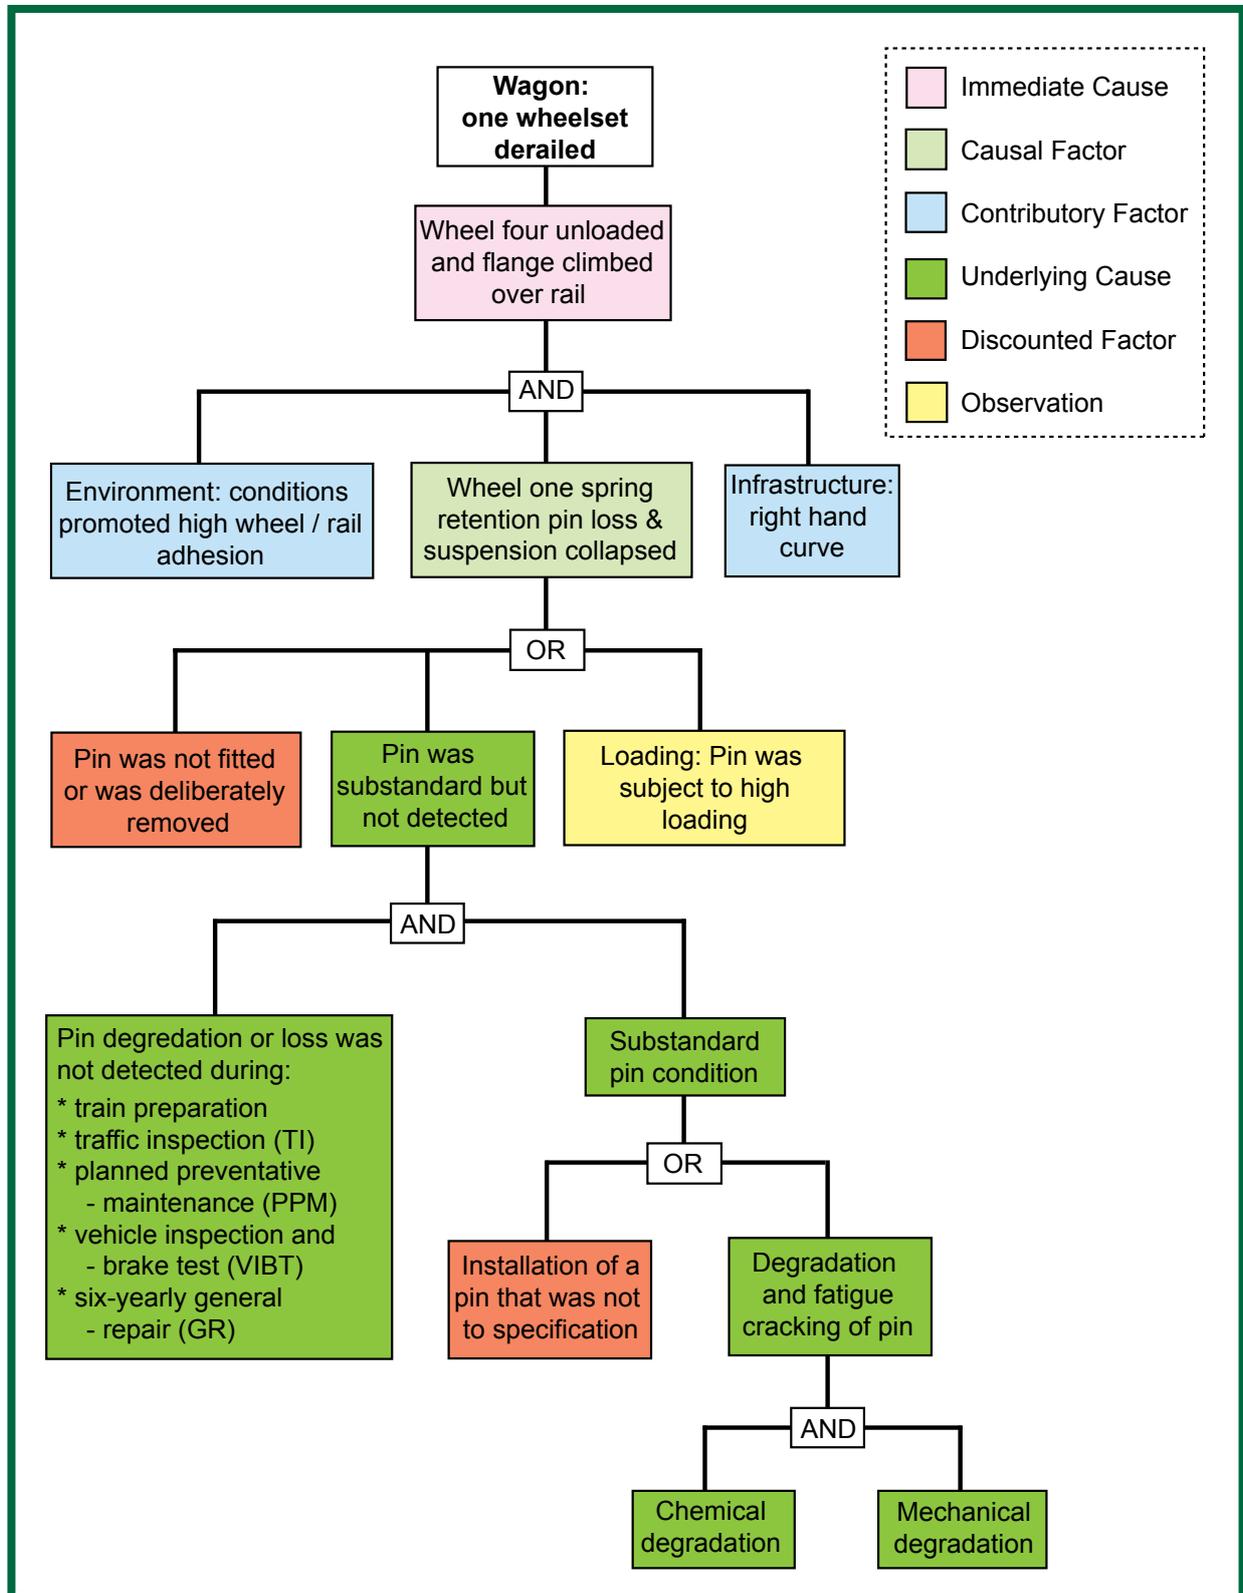
Figure 11: Causal Analysis

- 7 The immediate cause of the incident was *flange climb* of an unloaded wheel onto the railhead. The displaced *wheelset* then fell outside the railhead and in the direction of the adjacent platform.

- 8 The causal factor was the loss of a suspension spring link pin. The subsequent collapse of the suspension at one wheel caused the diagonally opposite wheel to become significantly unloaded and thus susceptible to flange climb.

- 9 The contributory factors that promoted flange climb at the particular location were (i) high adhesion at the wheel-rail interface and (ii) right hand horizontal track curvature. Both were normal conditions that, when combined with wheel four's significantly reduced vertical wheel load, increased its susceptibility to flange climb.

- 10 The likely underlying causes were: (i) the loss of the link pin due to degradation, fatigue cracking and rapid overload and (ii) the inability of the maintenance and inspection regime to detect link pin degradation and fatigue cracking sufficiently early in its inception to avoid failure between scheduled examinations. However, the likely underlying causes could not be proved conclusively as the missing link pin was not located.

42 The incident was analysed to determine the immediate cause, causal factors, contributory factors and underlying causes - see Figure 11.
