Boeing 747-286B, EP-IAH

AAIB Bulletin No: 5/2003

Ref: EW/ C2002/06/09

INCIDENT

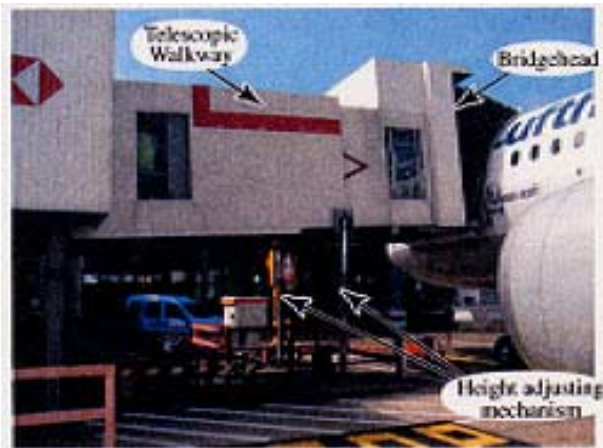
Plate 1 Rail-drive airbridge

This type consists of a relatively short, telescopic pedestrian tunnel which projects from a fixed access walkway and is orientated at right angles to the centreline of the aircraft stand which it serves. The inner end of the airbridge is hinged on the fixed walkway to allow the airbridge head, which abuts the aircraft, to be raised or lowered to suit the door sill height of any aircraft type permitted to use the particular stand. The telescopic portion extends beyond the height adjusting mechanism, which is mounted on a fixed base on the apron, and, when fully retracted, is well clear of the fuselage of an aircraft on the stand. This type of airbridge cannot be moved laterally relative to the aircraft's side and so, on stands with this type of airbridge, aircraft must park in a precise position, according to their specific type and model. The airbridge extension and head height are controlled from a console at the airbridge head which is orientated in the same direction as the airbridge.

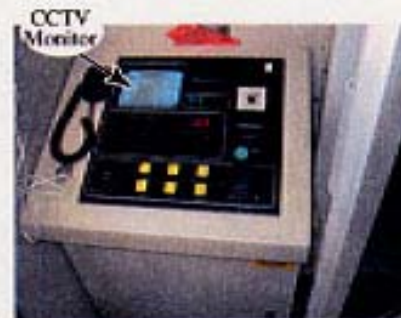
Plate 2a Control console on older type apron-drive airbridge (faces forwards)

Of the 'Apron-drive' airbridges in Terminals 2 & 3, where the controller involved in this incident worked, all of those in Terminal 2 and the majority in Terminal 3 are of one make and have been in service for several years (see Figure 1 Plates 2 & 2a). These are controlled from a console in the airbridge head and have the steerable drive axle and height adjusting mechanism just behind the airbridge head; the drive axle steering has limiting switches fitted in the mechanism. The control console faces forward, which gives the controller a direct view out of the front of the bridge towards an aircraft on the stand; there are no side windows. The drive and/or steering can be operated manually, from ground level, if power to the bridge is lost or disabled.

Airbridge movement across the apron is controlled by a joystick, which causes movement of the bridgehead in the same direction that the stick is deflected, and there are pushbutton controls for bridge head slew and height. There is an axle position indicator which shows, clearly, the orientation of the drive axle relative to the axis of the airbridge and the direction of 'forward' drive. There is a monitor with adjustable brightness and contrast, but no zoom, to view the image from an apron surveillance CCTV camera. This is mounted on the underside of the airbridge walkway, back near the pivot, and allows the controller to see any obstructions on the apron area around the drive axle and is used to position the airbridge wheels in their parking 'box' when it has been drawn back from an aircraft on the stand. This was the type of airbridge with which the controller involved in this incident was familiar.

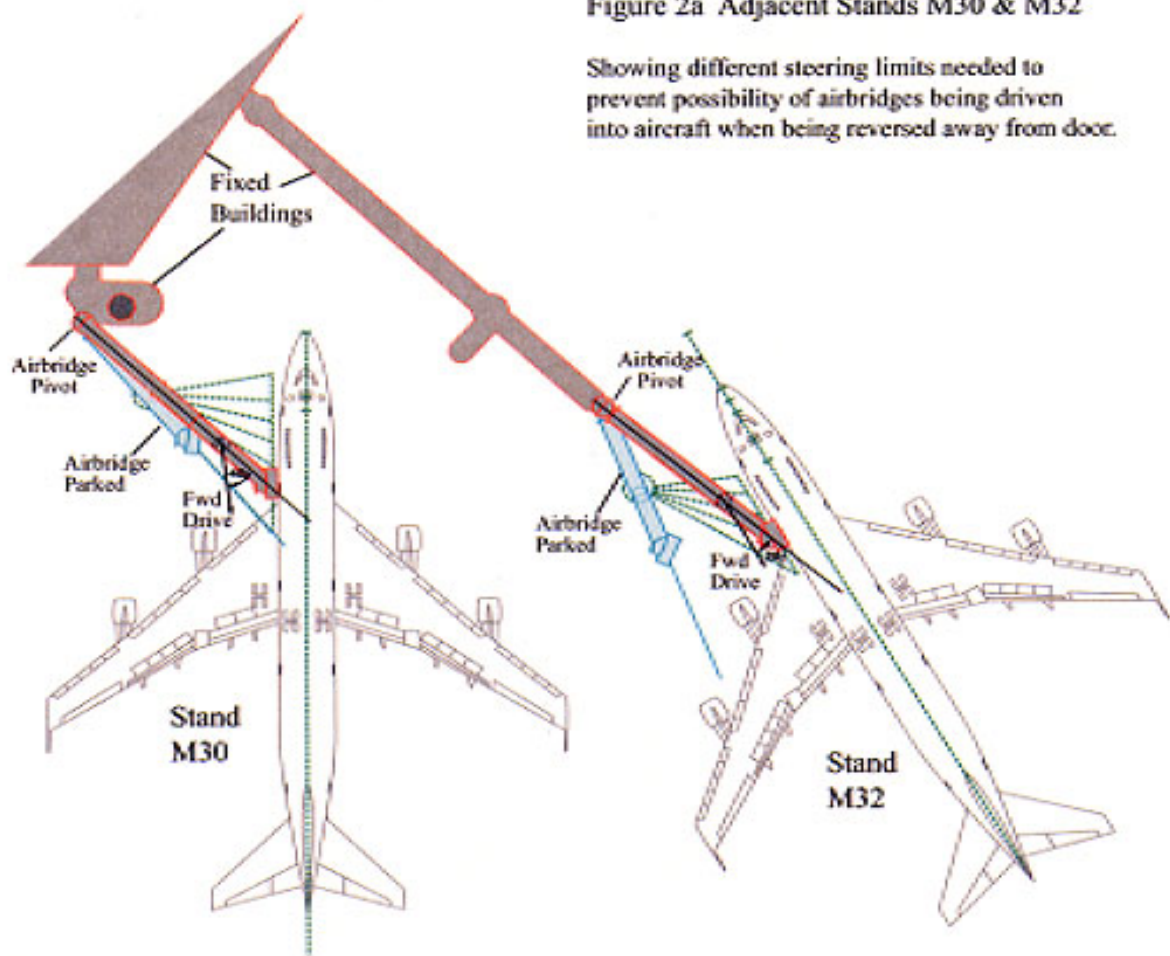
Figure 2b View showing accessibility of limit switches

If steering limitation were to be used as an additional means of preventing airbridges from colliding with aircraft on the stand, the limits set would need to be unique to each stand. An examination of the geometry of Stand M30 showed that to avoid reversing into the side of an aircraft whilst retracting the airbridge from its furthest permitted extension, it would be necessary to limit the steering angle to the right to about 40° (see Figure 2 Diagram 1). On the adjacent stand, M32, the different relative alignments of the Stand centreline and airbridge pivot indicate that a much smaller steering angle to the right, of the order of 5°, would be all that was permissible.
