Air Accidents Investigation Branch

**Report on the serious incident to
BAe 146-200, registration EI-CZO
at London City Airport
on 20 February 2007**

Air Accidents Investigation Branch**Aircraft Accident Report No: 5/2009 (EW/C2007/02/06)**

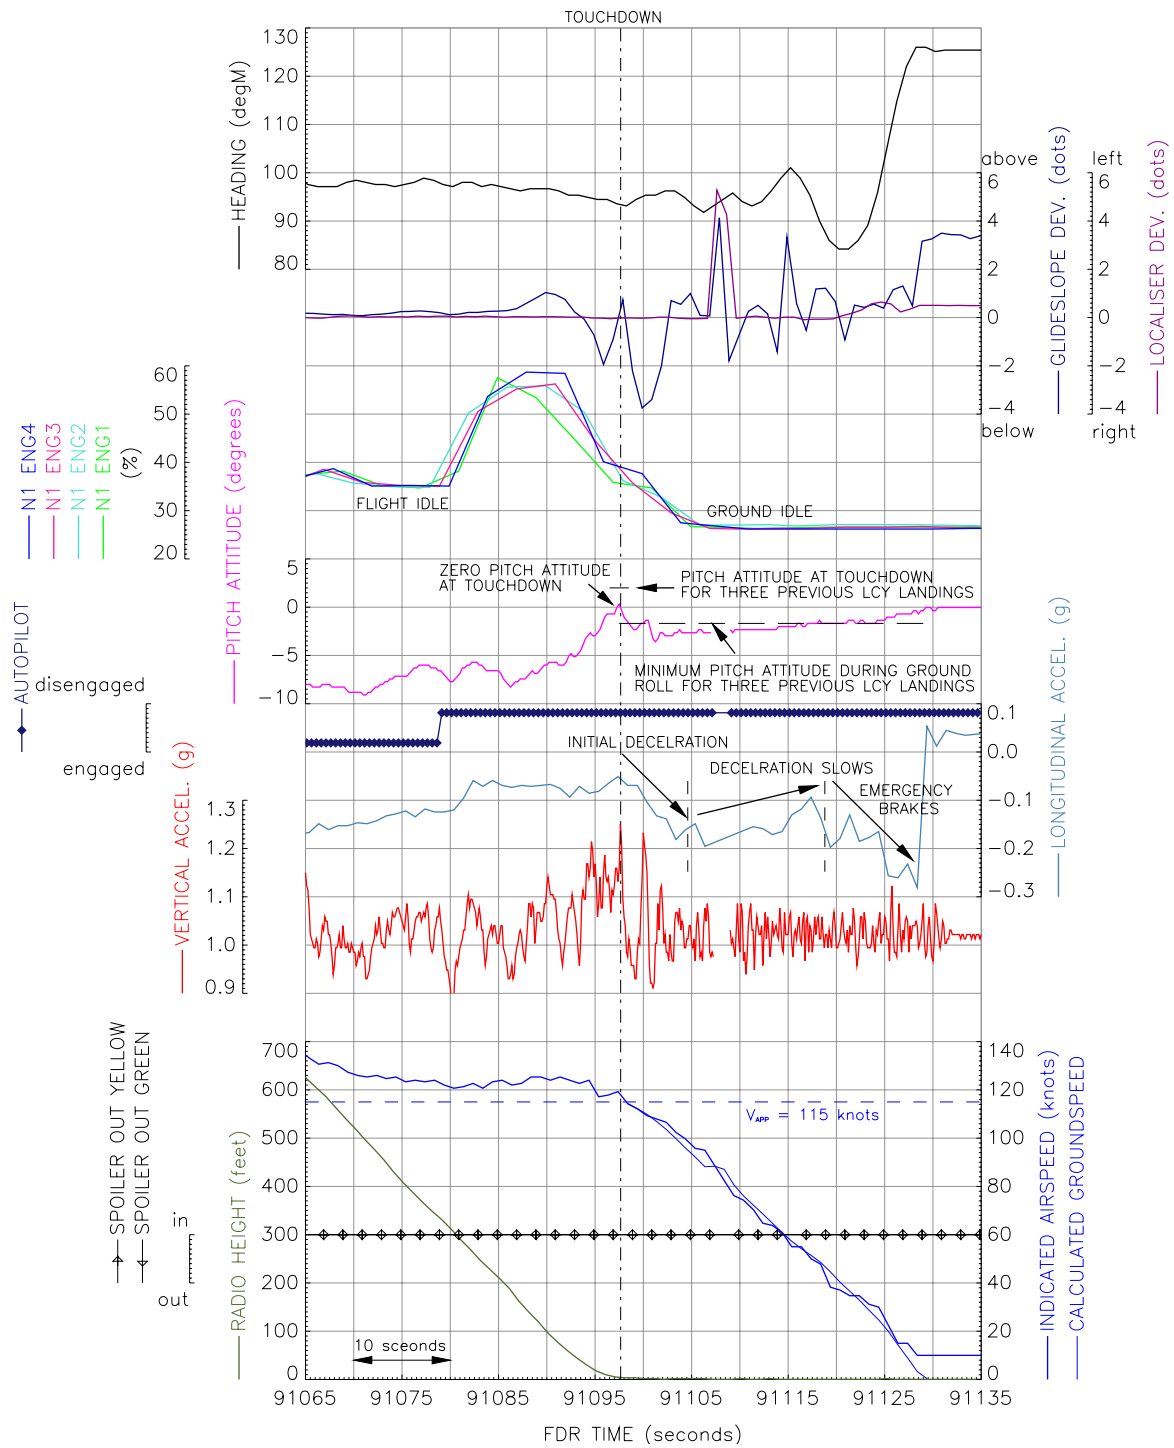
Figure 7
Salient FDR Parameters

A time history of the relevant parameters during the incident is shown at Figure 7. The data presented begins with the aircraft at 620 ft agl, with the autopilot engaged, on the ILS approach to Runway 10. At this point, the aircraft's descent rate was approximately 1,250 ft/min, the airspeed was reducing through 136 kt, the pitch attitude was 8° nose-down, the flaps were set at 33°, the landing gear was down and the airbrakes were fully extended (60°). The thrust from each engine throughout the descent from 1,600 ft agl remained constant at just under 35% N_1 (flight idle), until 900 ft agl, where it increased slightly before reducing back to flight idle by 480 ft agl.

At 380 ft agl, with the airspeed at 124 kt (ie, $V_{APP} +9$), the autopilot disengaged while the engine thrust increased. The thrust reached between 55% and 59% N_1 eight seconds later, as EI-CZO passed through 200 ft agl, before reducing back to about flight idle just before touchdown⁵. As the thrust decreased, the pitch attitude increased (at a rate of no more than 1°/second) until touchdown.

From initial touchdown, the aircraft slowed to a halt over a period of 31 seconds during which it veered to the left and right with increasing amplitude, until finally veering off to the right on a heading of 126°M. Three distinct phases of deceleration were noted:

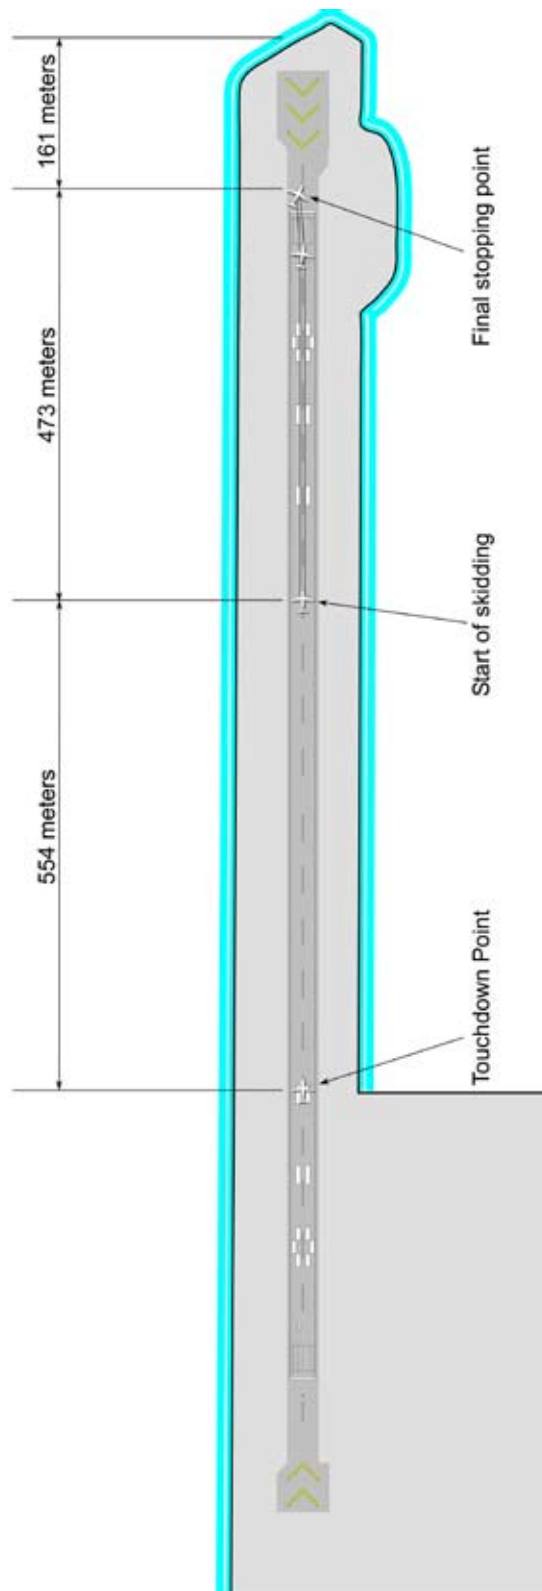
Figure 9

The aircraft came to rest in the undershoot area of Runway 28, 161 m short of the dock edge. Based on witness evidence, it touched down at the end of Runway 10 touchdown zone and, on this basis, the aircraft travelled 554 m prior to the start of the skid marks. These were evident for each of the four main wheel tyres over a distance of 473 m. Toward the end of the skid, the aircraft tracked to the left of the runway centreline, but with the aircraft heading to the right, before coming to a halt on a heading of 130° . During the skid, the four main wheel tyres had been worn through, causing all to deflate, and all the tyre carcasses to start to roll over the rims of their wheel hubs.

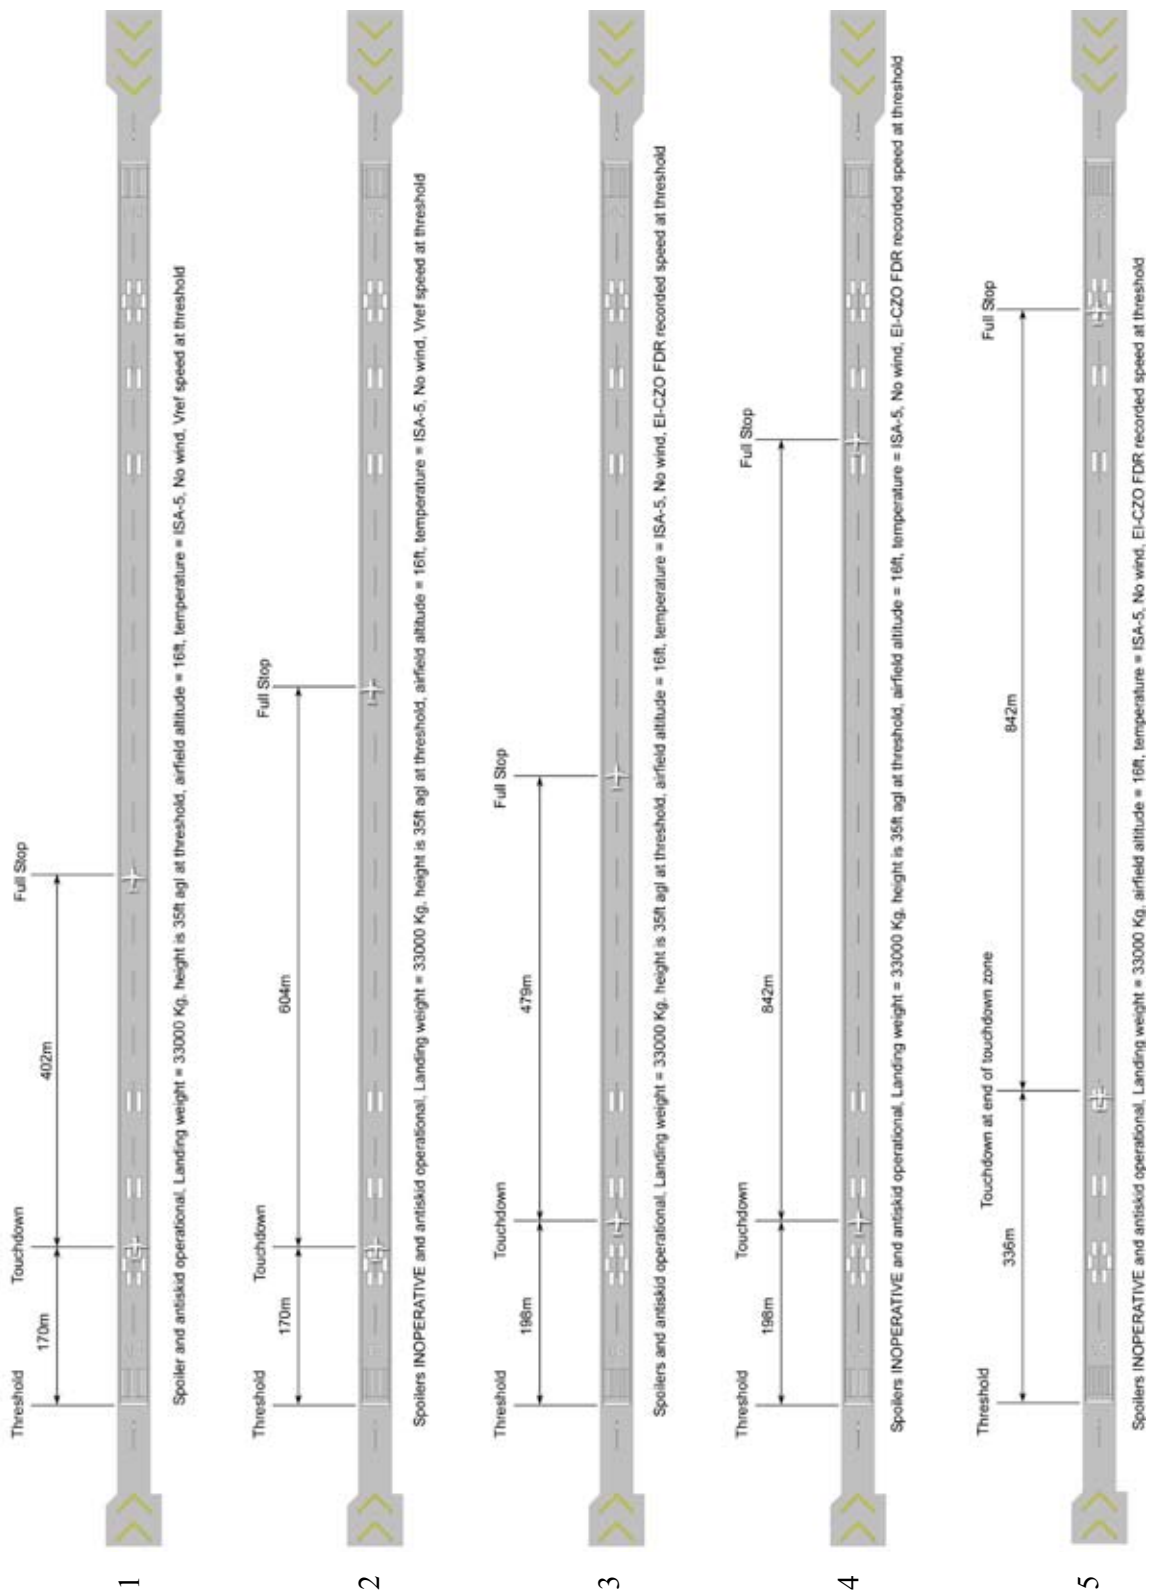
Figure 12

The aircraft manufacturer calculated the stopping distances for the BAe 146-200 based on parameters taken from the incident to EI-CZO but with a landing weight of 33.0⁸ tonnes. The calculated distances for a dry⁹ runway surface under the various conditions, are shown in Figure 12, (1)-(5). They also assume that the correct braking technique is employed in all cases.

When EI-CZO's recorded speed over the threshold of 124 kt is used, and with the lift spoiler and anti-skid systems operational, the threshold to touchdown distance extends to 198 m, and the touchdown to full stop distance increases to 479 m (3). Under the same conditions, but with the spoilers inoperative, the distance from touchdown to full stop increases to 842 m (4).
