Aircraft Type and Registration:	Grob G115E Tutor, G-BYXJ	
No & Type of Engines:	1 Lycoming AEIO-360-B1F piston engine	
Year of Manufacture:	2001	
Date & Time (UTC):	29 June 2004 at 1650 hrs	
Location:	4.5 nm Southwest of Salisbury, Wiltshire	
Type of Flight:	Training	
Persons on Board:	Crew - 2	Passengers - None
Injuries:	Crew - Nil	Passengers - N/A
Nature of Damage:	One propeller blade, part of propeller hub and canopy detached; substantial damage to engine and airframe	
Commander's Licence:	Royal Air Force Qualified Flying Instructor	
Commander's Age:	28 years	
Commander's Flying Experience:	1,450 hours (of which 215 were on type) Last 90 days - 60 hours Last 28 days - 20 hours	
Information Source:	AAIB Field Investigation

Synopsis

The aircraft was completing an aerobatic manoeuvre when one of the propeller blades separated from the hub. Despite severe vibration, the pilot was able to shut down the engine quickly and perform a successful forced landing in a field. There were no injuries to either crew member.

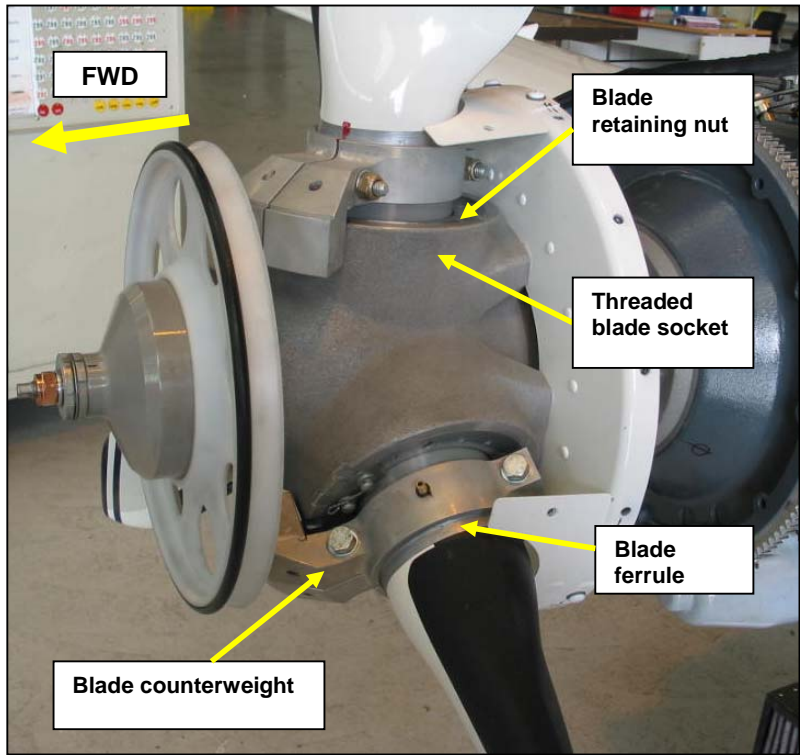
Figure 2

The aircraft had landed in a cornfield and was intact, except for the canopy, the No 1 propeller blade and a section of the propeller hub, which were missing. It was evident that the No 1 propeller blade had detached due to a fracture of the blade socket of the aluminium alloy hub (Figure 1). The fracture, which appeared to originate in the threads inside the blade socket, allowed the outer part of the blade socket and the blade retaining nut to separate from the hub, thus releasing the propeller blade. The departing blade was struck by the following (No 3) blade, causing the detachment of a large portion of the latter (Figure 2).

General view of propeller damage (blade locations numbered)
