**ACCIDENT**

<b>Aircraft Type and Registration:</b>	Agusta A109A II, N2NR	
<b>No &amp; Type of Engines:</b>	2 Allison 250-C20 SER turboshaft engines	
<b>Year of Manufacture:</b>	1986	
<b>Date &amp; Time (UTC):</b>	23 October 2010 at 1448 hrs	
<b>Location:</b>	Shanlieve, Mourne Mountains, Northern Ireland	
<b>Type of Flight:</b>	Private	
<b>Persons on Board:</b>	Crew - 1	Passengers - 2
<b>Injuries:</b>	Crew - 1 (Fatal)	Passengers - 2 (Fatal)
<b>Nature of Damage:</b>	Aircraft destroyed	
<b>Commander's Licence:</b>	Airline Transport Pilot's Licence	
<b>Commander's Age:</b>	63 years	
<b>Commander's Flying Experience:</b>	12,733 hours (of which 1,634 were on type) Last 90 days - 50 hours Last 28 days - 21 hours	
<b>Information Source:</b>	AAIB Field Investigation

**Synopsis**

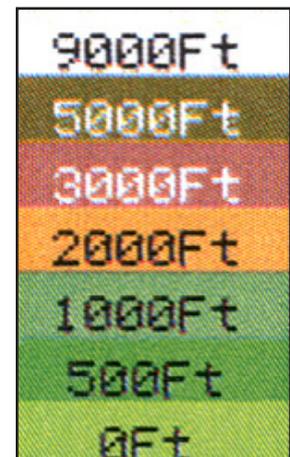
The screen print of the Skymap IIIC on 30 nm range, showing a projected track immediately prior to the left turn onto an easterly heading

The two 'screen prints', Figures 7 and 9, are examples of the information provided. Figure 7 shows the helicopter at the point of the first left turn with a 30 nm scale set and a direct track to Caernarfon selected. Figure 9 shows the position of the helicopter immediately prior to impact with an 8 nm scale selected. It should be noted from both screen prints that the area of the Mourne Mountains is depicted using two shades of green. The shaded areas do not contain any spot heights, or the brown colour representing the terrain between 2,000 ft

It is not known which scale or scales the pilot was using during the flight but Figure 7 shows that, had the helicopter continued on the direct track towards Caernarfon, it would have transited Irish airspace. In order to remain clear of Irish airspace, the pilot would have had to route to Newcastle, County Down, from where a direct track to Caernarfon would have remained in UK airspace.
