ACCIDENT

Aircraft Type and Registration:	Airbus A340-642, G-VSHY	
No & Type of Engines:	4 Rolls-Royce Trent 556-61 turbofan engines	
Year of Manufacture:	2002	
Date & Time (UTC):	25 February 2006 at 1254 hrs	
Location:	Runway 09R, London Heathrow Airport	
Type of Flight:	Public Transport (Passenger)	
Persons on Board:	Crew - 18	Passengers - 268
Injuries:	Crew - None	Passengers - None
Nature of Damage:	Serious damage to two tyres and wheels; minor damage to flaps and right main landing gear	
Commander's Licence:	Airline Transport Pilot's Licence	
Commander's Age:	57 years	
Commander's Flying Experience:	10,000 hours (of which 7,000 were on type) Last 90 days - 240 hours Last 28 days - 80 hours	
Information Source:	AAIB Field Investigation

Synopsis

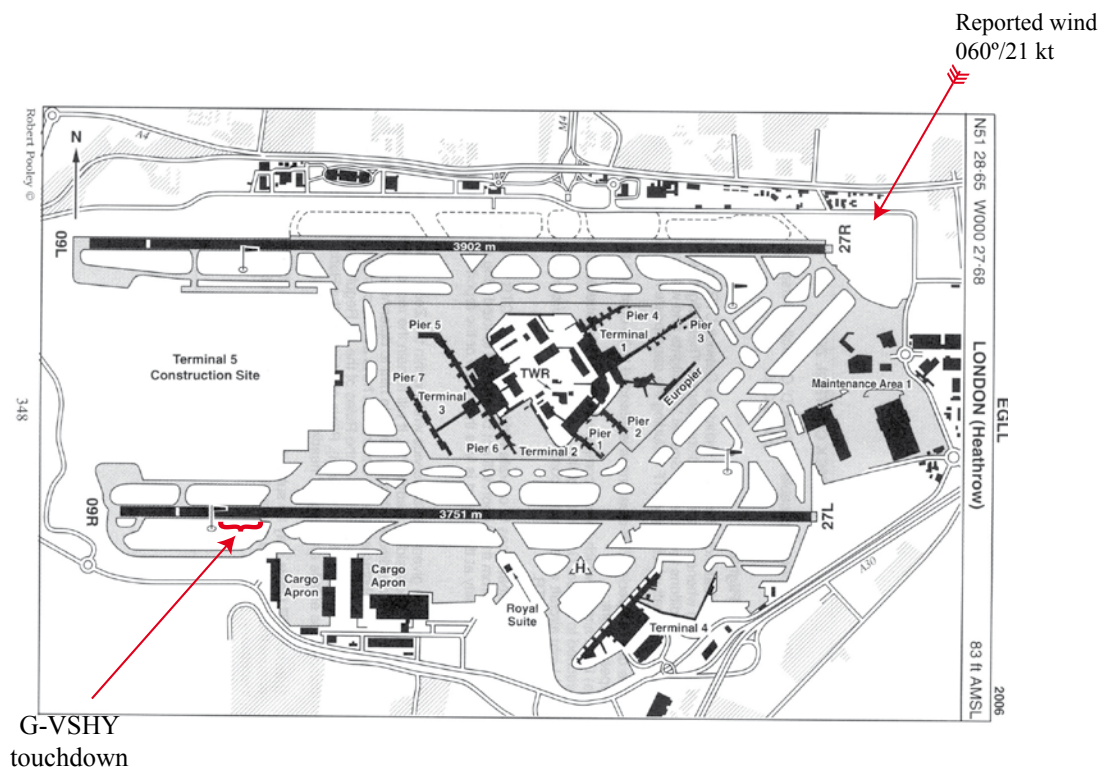
Figure 1

It also advised that there was moderate turbulence on the approach and that windshear had been reported on short final approach to Runway 09L with a loss or gain of 10 kt. The wind direction was such that that the touchdown zone for Runway 09R was generally downwind of the airport's central area, Figure 1. The turbulence downwind of the buildings/structures may have contributed to the overall turbulent conditions

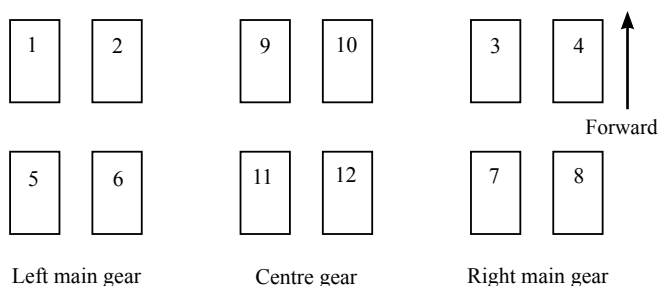
The main and centre landing gear wheels are numbered as follows:

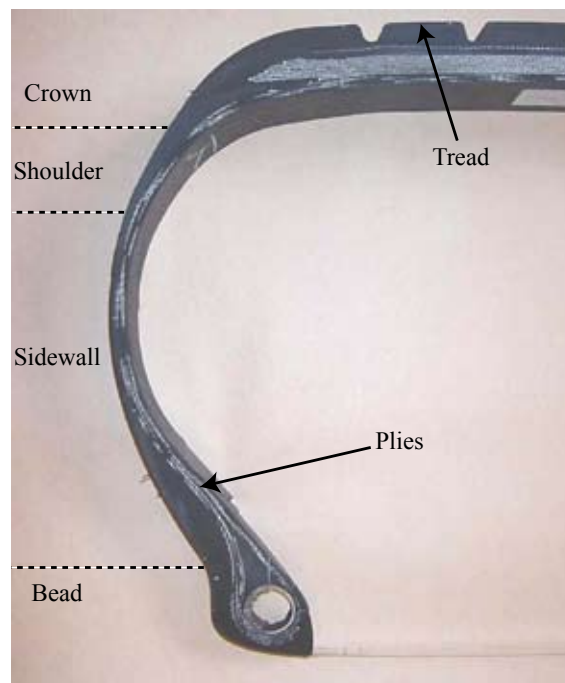
Figure 2

A tyre consists of a bead, sidewall, shoulder, crown and tread, and multiple plies embedded in the rubber, Figure 2. The specific tyre type fitted to G-VSHY was the Michelin Near Zero Growth (NZG) radial tyre, Pt No M16004, size 1400 x 530R23/40/235. Tyre No 4 had undergone 133 landings and 61% of the allowable tread had worn away. Tyre No 8 had also undergone 133 landings, with 58% of the allowable tread worn away.

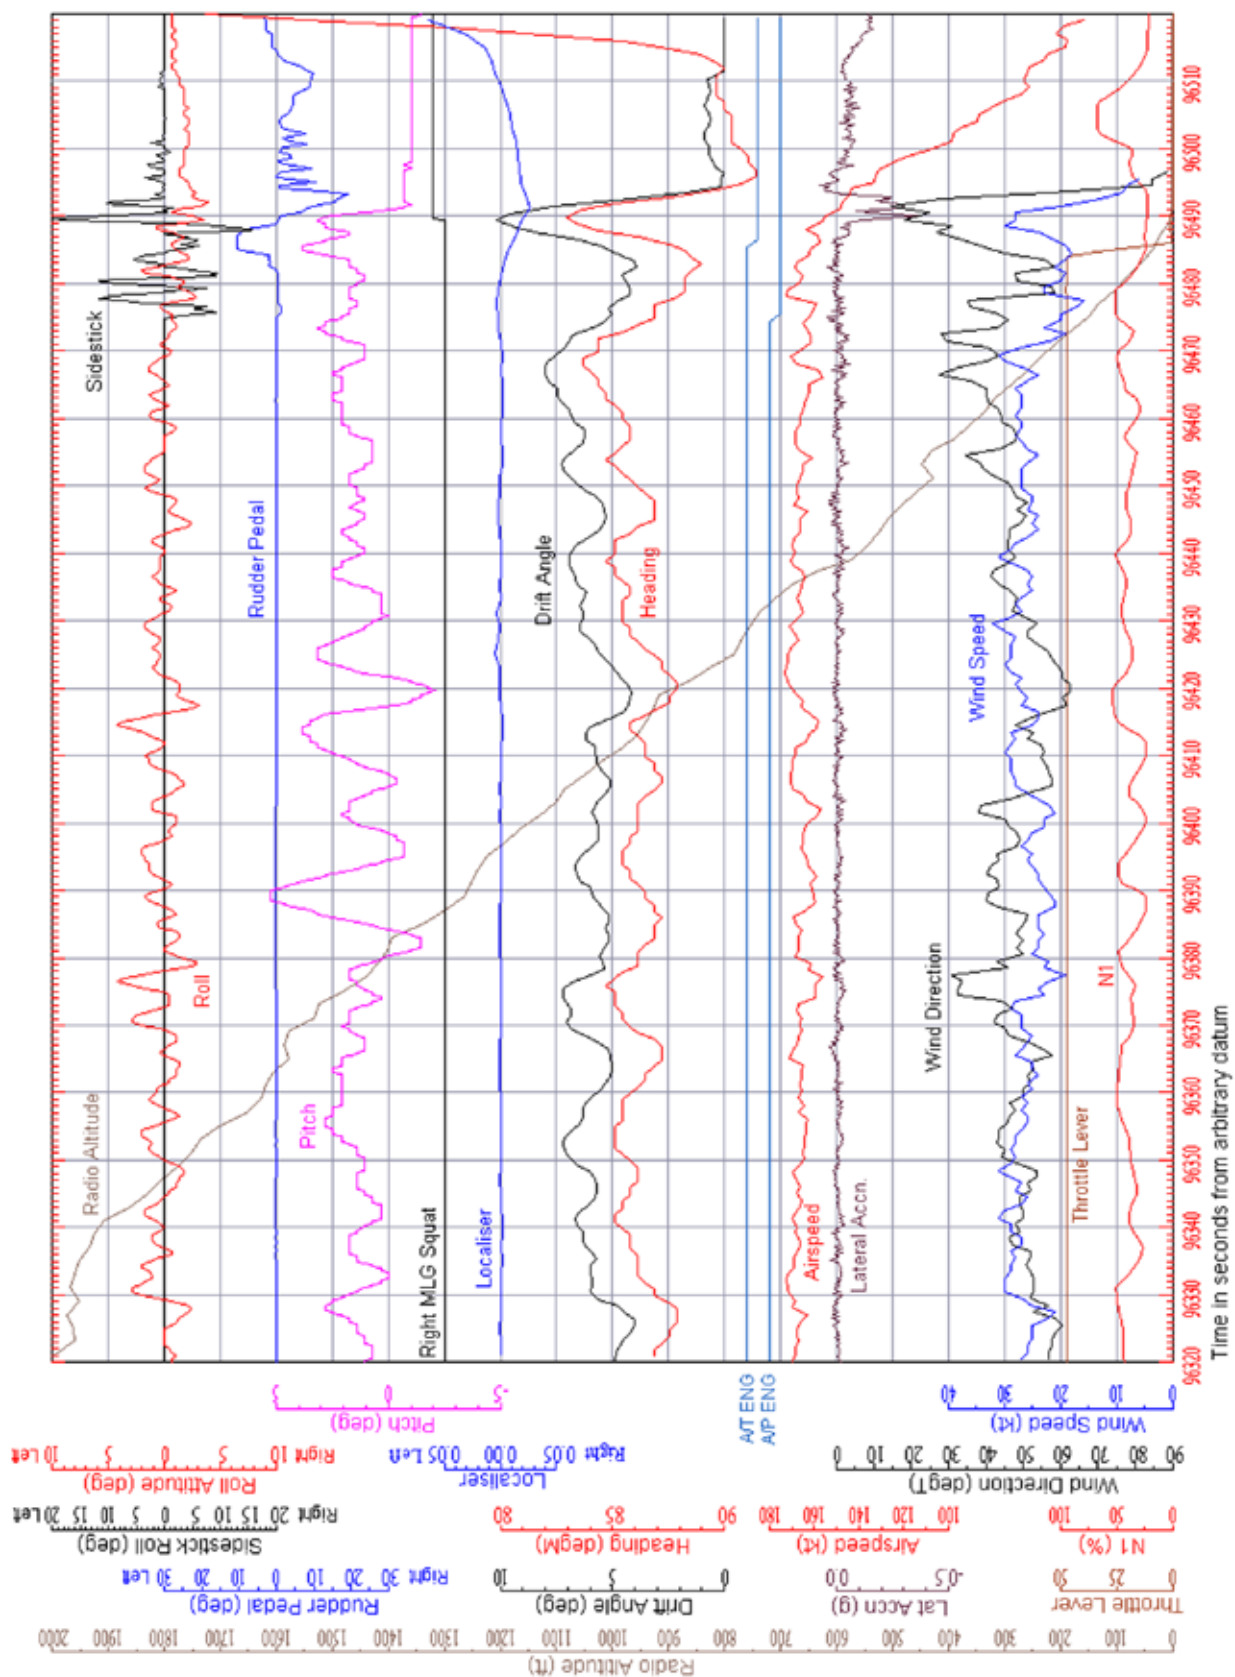
Figure 5

The two solid-state flight recorders (DFDR and QAR) were removed from the aircraft and replayed, and both had retained data covering the events leading up to and during the landing. Pertinent parameters recorded during the approach and landing are shown in Figures 5 and 6.
