AAIB Bulletin No: 9/93

Aircraft Type and Registration: Cessna 310Q G-BBHG

Location: Manston Airport, Kent

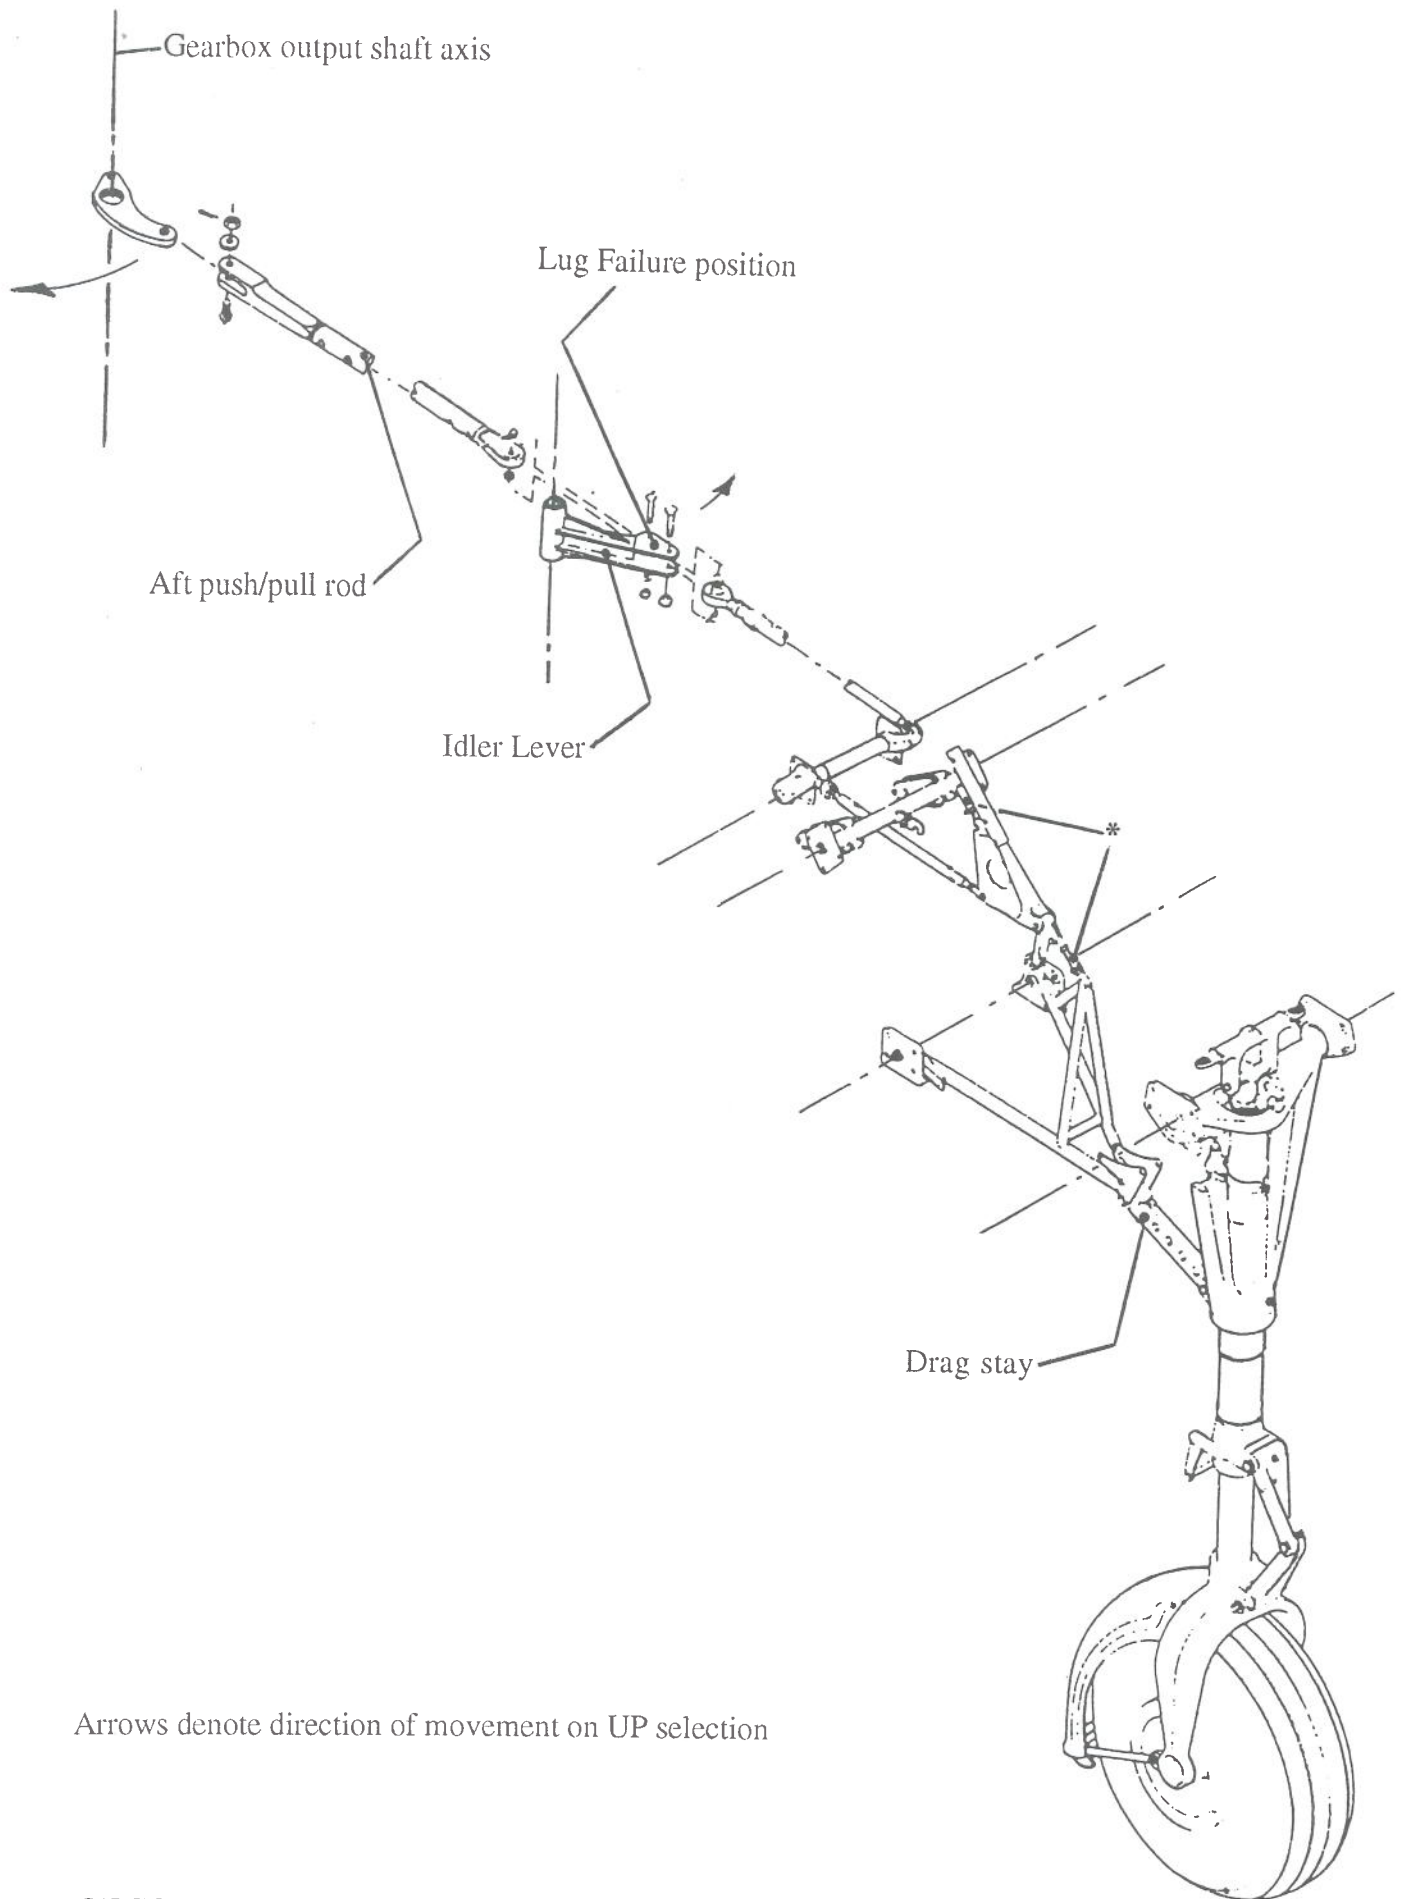
CESSNA 310 NOSE GEAR RETRACTION MECHANISM

Examination of the aircraft quickly revealed that failures had occurred to the upper and lower lugs of an idler lever, Pt No 0842102-497, which supports the junction of the two push/pull rods which transmit the drive from the gearbox forward to the nose gear mechanism. This lever is located between the cabin floor and the fuselage skin and cannot be inspected without removing the front seats, trim and some floor panels. Specifically the lugs had failed through the attachment hole for the aftmost rod end bearing, Figure 2; the lugs associated with the other rod being intact.. Close examination of the failures revealed both to have been as a result of overload. However, deformation and the extent of wear and fretting patterns associated with the upper lug, rod end and particularly the attachment bolt suggested that the failure of the lower lug had occurred some time before the upper lug, probably during a previous flight. A wear /fretting step in the shank of the attachment bolt caused by the inner race being loaded asymmetrically during gear operation after the failure of the lower lug, Figure 3, is shown in Figure 4.

Arrows denote direction of movement on UP selection
