# Piper PA-28R-200-2 Cherokee Arrow II, G-BKCB

| <b>AAIB Bulletin No: 11/2003</b> | <b>Ref: EW/C2000/12/2</b> | <b>Category: 1.3</b> |
| <b>Aircraft Type and Registration:</b> | Piper PA-28R-200-2 Cherokee Arrow II, G-BKCB | |
| <b>Location:</b> | Warren Farm, Lambourne, Berkshire | |

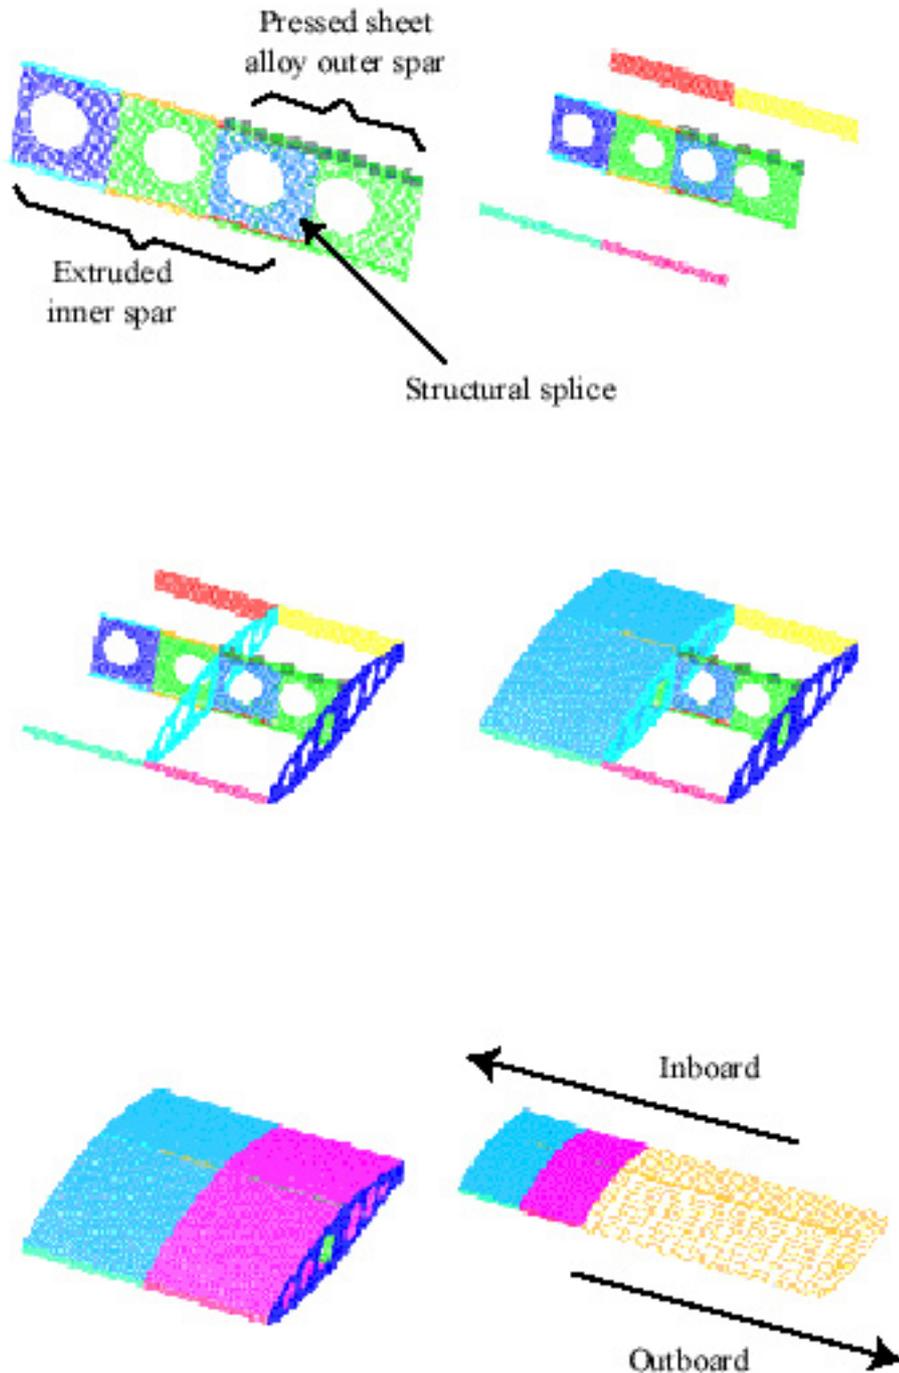
**Figure 5**

In view of this unexpected result, the assumptions used in developing the FE model were reviewed. It was observed that restricting the model to a single bay had the effect of restraining the inboard boundary to remain in one plane and therefore caused the lower skin to provide a greater contribution to the compressive strength of the wing lower surface than would be the case with the actual aircraft structure. The FE model was therefore modified to incorporate a second bay inboard of the area of structure being analysed. This removed the assumed edge restraint of the skin panel in the FE model and allowed a more fully representative behaviour of the lower skin stiffness and compressive strength to be modelled. The geometry of the final FE model is shown pictorially in Figure 5.

Build-up of structural components for Finite Element (FE) model

The loading/time history was then re-applied using twice the -2.7g figures. Once again, the FE model indicated that failure did not occur. Only when the loading was multiplied by 2.5 did the FE analysis show that failure occurred. In view of this second unexpected result of the analysis, doubt remained as to the validity of the FE model.
