**AAIB Bulletin No: 6/98**

**Ref: EW/C97/10/6**

**Aircraft Type and Registration:** Pierre Robin HR200/120B, G-BWPG

**Location:** In the Cromarty Firth off Nigg Yard, Scotland

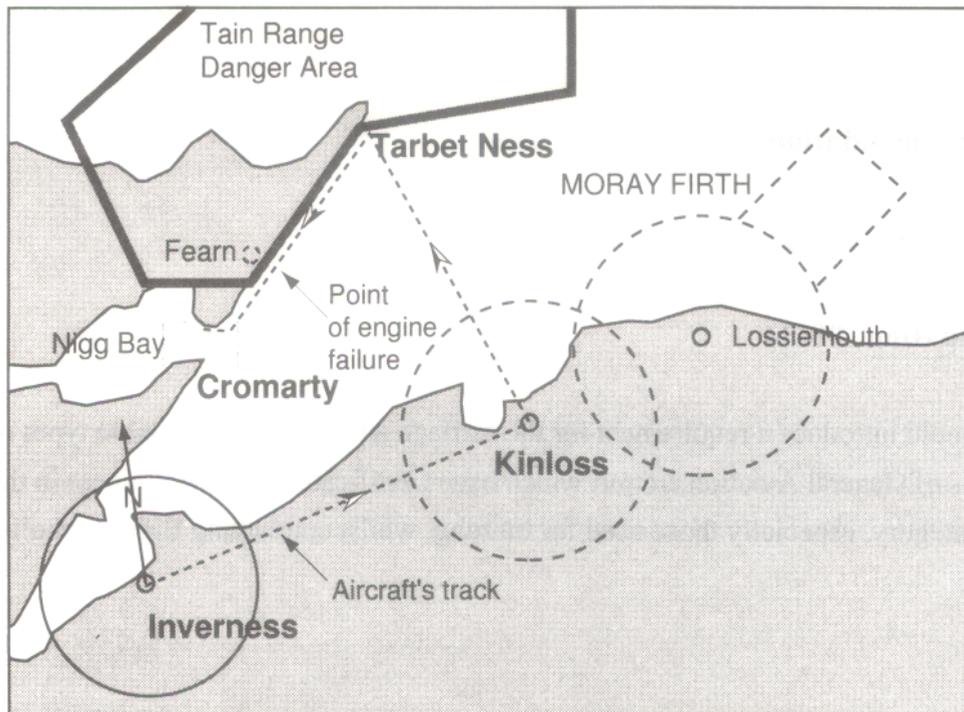
Figure 1 G-BWPG - Navigation exercise track and ditching position

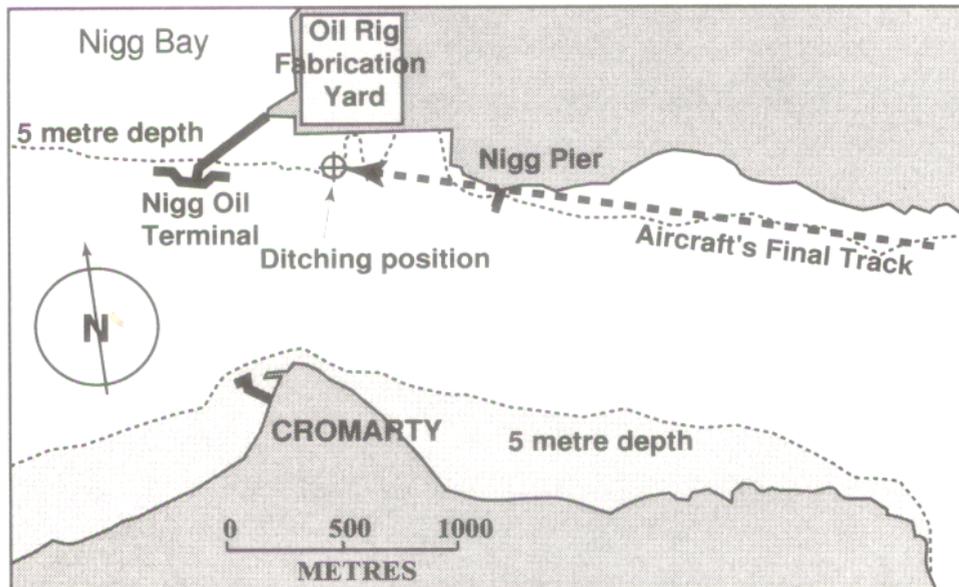
A heading directly for land was considered impractical as the aircraft would have been below the height of the cliffs as it approached the coastline. The aircraft over flew Nigg Pier, (see Figure 2) at a height the instructor believed was about 500 feet although it was clearly much lower than that, and descended into the sea between the pier and two moored oil tankers positioned alongside the Nigg oil terminal jetty. The student had removed both his and the instructor's headsets and unlatched the aircraft's canopy prior to the ditching during which the aircraft pitched inverted. The instructor released his harness and fell onto the unlatched canopy. He escaped from the submerged cockpit and eventually reached the surface, closely followed by his student. Both pilots assumed that the aircraft was in contact with the sea bed as all three wheels were still visible with only the cockpit under water. They both held onto the wings initially but after approximately one minute the aircraft sank leaving them no option but to swim towards the harbour wall some 200 to 300 metres away.

Figure 2 Expanded scale map of ditching position
