**AAIB Bulletin No:** 12/95      **Ref:** EW/G95/09/10      **Category:** 1.3

**Aircraft Type and Registration:** Piper PA-28R-200 Cherokee Arrow II, G-BMJG

**Date & Time (UTC):** 9 September 1995 at 1615 hrs

**Location:** Elstree Aerodrome, Hertfordshire

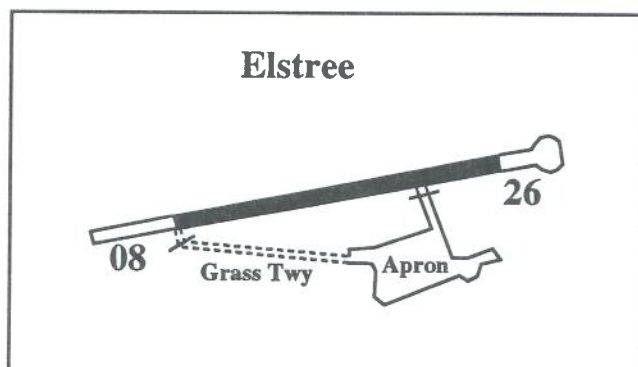
Runway 26 at Elstree has a displaced threshold 128 metres from the end which is dumbbell shaped (see diagram). The taxi route from the paved apron to Runway 26 involves backtracking the runway towards the dumbbell and then turning around. There is no air traffic control at Elstree but there is an air-to-ground radio service.
