INCIDENT

Aircraft Type and Registration:	Lockheed L188C, G-FIZU	
No & Type of Engines:	4 Allison 501-D13 turboprop engines	
Year of Manufacture:	1960	
Date & Time (UTC):	19 March 2007 at 2350 hrs	
Location:	London Stansted Airport	
Type of Flight:	Commercial	
Persons on Board:	Crew - 2	Passengers - 1
Injuries:	Crew - None	Passengers - None
Nature of Damage:	Failure of propeller synchrophase unit	
Commander's Licence:	Airline Transport Pilot's Licence	
Commander's Age:	38 years	
Commander's Flying Experience:	3,625 hours (of which 1,075 were on type) Last 90 days - 60 hours Last 28 days - 15 hours	
Information Source:	AAIB Field Investigation

Synopsis

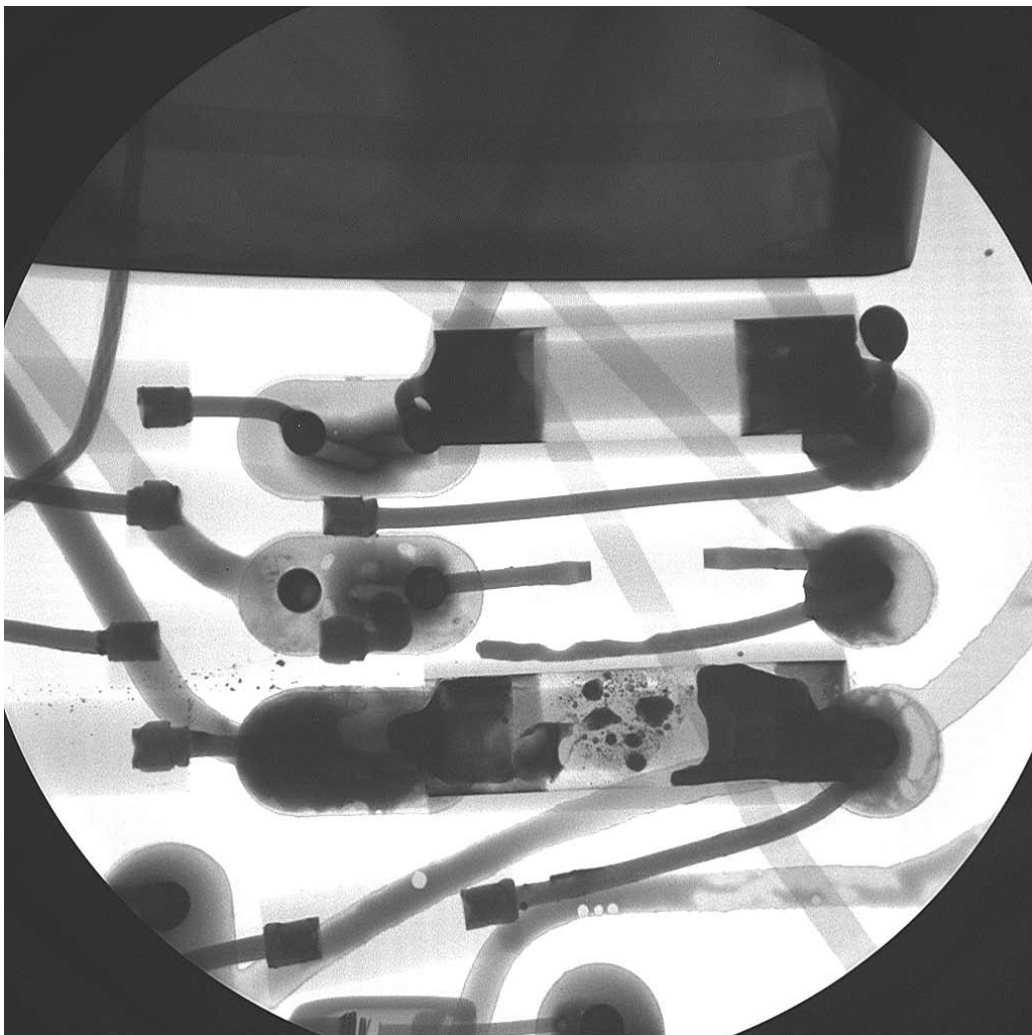
Figure 2

boards, a double synchrophaser board, a saw-tooth synchrophaser board, a speed derivative board and a power supply board. Examination of these circuit boards showed that several components within the power supply board had overheated, with one area showing localised burning of the board (see Figure 1). X-ray examination confirmed that several of the resistors had suffered a breakdown of their internal construction and that a resistor connector had melted and ‘shorted’ across several other connections within the board (see Figure 2). A review of the maintenance records for the component confirmed that the unit had recently been removed from G-FIZU due to the No 4 engine failing to follow the master engine. The unit had been inspected and the defect rectified prior to being returned to the operator in January 2007. The overhaul agency confirmed that the unit passed the post-rectification tests with no abnormalities and that no work was carried out on the power supply circuit board. Discussions with the National Transportation Safety Board of the USA and the engine and airframe manufacturers revealed that this type of unit had also been fitted to the Lockheed P3 Orion and early variants of the Lockheed C130 and L100 (the civil variant of the C130) but had been replaced in the 1980s by a solid state unit. It was confirmed that G-FIZU was the only remaining L188 Electra fitted with this type of synchrophaser unit. Due to the age and low number of these units remaining in operation, only one approved test facility existed worldwide and the damage to the circuits prevented testing of the unit to identify how the failures within the circuit board would have affected the functioning of the unit. The scale of the engine rpm gauges is such that relatively small variations in rpm would produce large movements of the gauge needle, as observed by the crew.

The cause of the incident was a failure within the power supply circuit board in the propeller synchrophaser unit. This caused significant power and rpm fluctuations on all four engines giving the flight crew difficulty in handling the aircraft. The No 2 engine exceeded its maximum governed speed which resulted in the fuel flow to the engine being cut back by its governor; this led the crew to believe that the engine had begun to run down and they shut that engine down. The remaining engines continued to fluctuate and, on final approach, the No 1 and 3 engines also appeared to run down, probably due to fuel being cut back after overspeeding.

that in the event of an identified failure within the synchrophaser unit, the system could be electrically isolated by pulling the circuit breaker on the 'BUS A' panel and the engines would then revert to basic mechanical engine governing.
