**ACCIDENT**

<b>Aircraft Type and Registration:</b>	1) Vans RV-6A, G-RVGC 2) DA 40D Diamond Star, G-CEZR
<b>No &amp; Type of Engines:</b>	1) 1 Lycoming 0-320-D3G (Modified) piston engine 2) 1 Thielert TAE 125-02-99 piston engine
<b>Year of Manufacture:</b>	1) 2004 2) 2008
<b>Date &amp; Time (UTC):</b>	4 July 2011 at 1528 hrs
<b>Location:</b>	Shoreham Airport, West Sussex
<b>Type of Flight:</b>	1) Post-modification test flight 2) Training
<b>Persons on Board:</b>	1) Crew - 1                      Passengers - None 2) Crew - 2                      Passengers - None
<b>Injuries:</b>	1) Crew - 1 (Fatal)          Passengers - N/A 2) Crew - None                Passengers - N/A
<b>Nature of Damage:</b>	1) Destroyed 2) Propeller and gearbox detached, damage to left wing
<b>Commander's Licence:</b>	1) Private Pilot's Licence 2) Airline Transport Pilot's Licence
<b>Commander's Age:</b>	1) 62 years 2) 60 years
<b>Commander's Flying Experience:</b>	1) about 20,600 hours (of which n/k were on type) Last 90 days - n/k hours Last 28 days - n/k hours 2) 3,450 hours (of which 32 were on type) Last 90 days - 35 hours Last 28 days - 13 hours

<b>Information Source:</b>	AAIB Field Investigation

**Syn

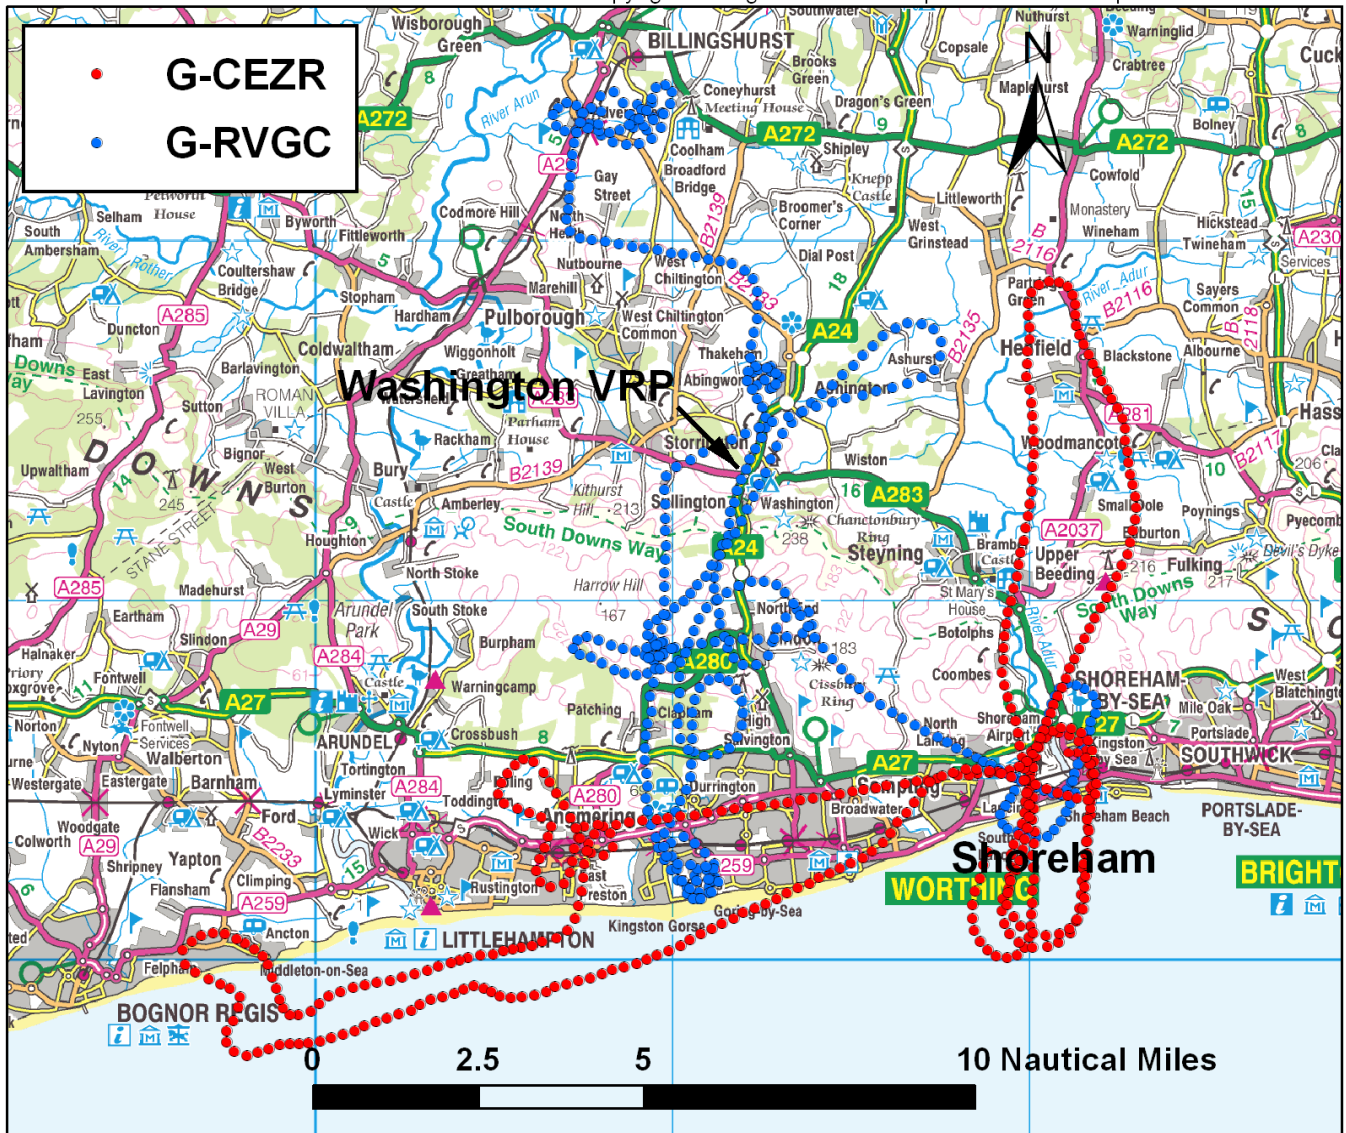
Figure 1

GC departed from Shoreham on its third flight at 1433 hrs and the majority of the flight was recorded by radar (see Figure 1). The pilot called Shoreham ATC for rejoin from the Washington intersection Visual Reporting Point (VRP) at 1519:10 hrs. He was offered a direct arrival, to right base, for Runway 20 but he requested a crosswind join for circuits, saying that he needed to "DO SOME HOURS ON THIS".

ZR departed Shoreham at 1430 hrs and operated, initially, in the instrument pattern overhead the airfield, before departing to the west to conduct general handling exercises. ZR's flight was also recorded on radar (see Figure 1). At 1522:20 hrs the PF reported at the Littlehampton VRP and requested a crosswind join for Runway 20.

Radar tracks of G-CEZR and G-RVGC from 1444 hrs to the collision at 1527:18 hrs

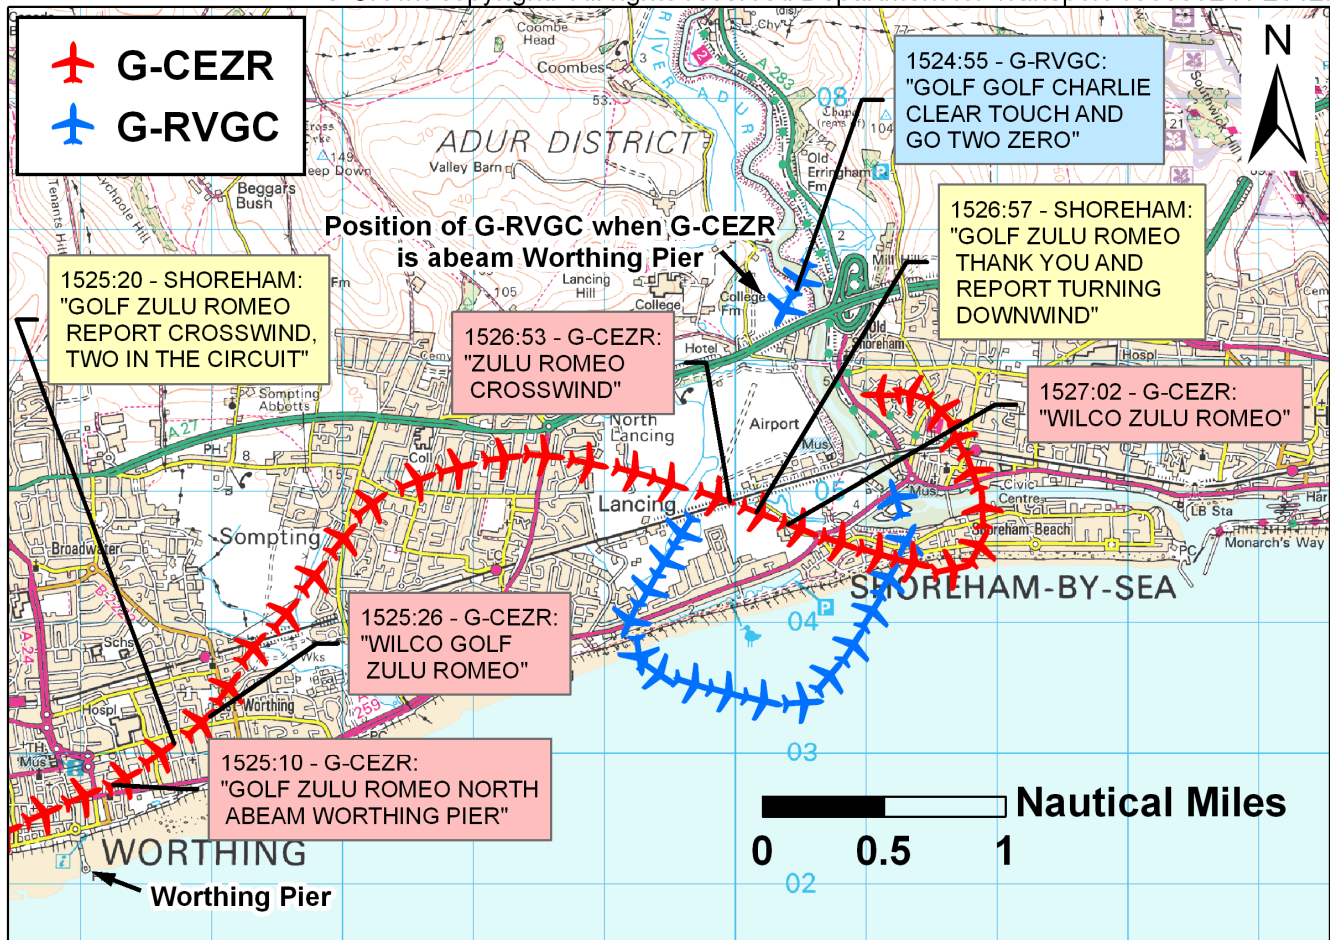
Figure 2 shows the radar tracks, starting at 1524:55 hrs, with ZR approaching Worthing pier and GC on final approach, as it was cleared for a touch-and-go, before it briefly descended below radar coverage. The figure also includes all relevant radio transmissions.

Radar tracks of G-CEZR and G-RVGC from 1524:55 hrs, with relevant radio calls

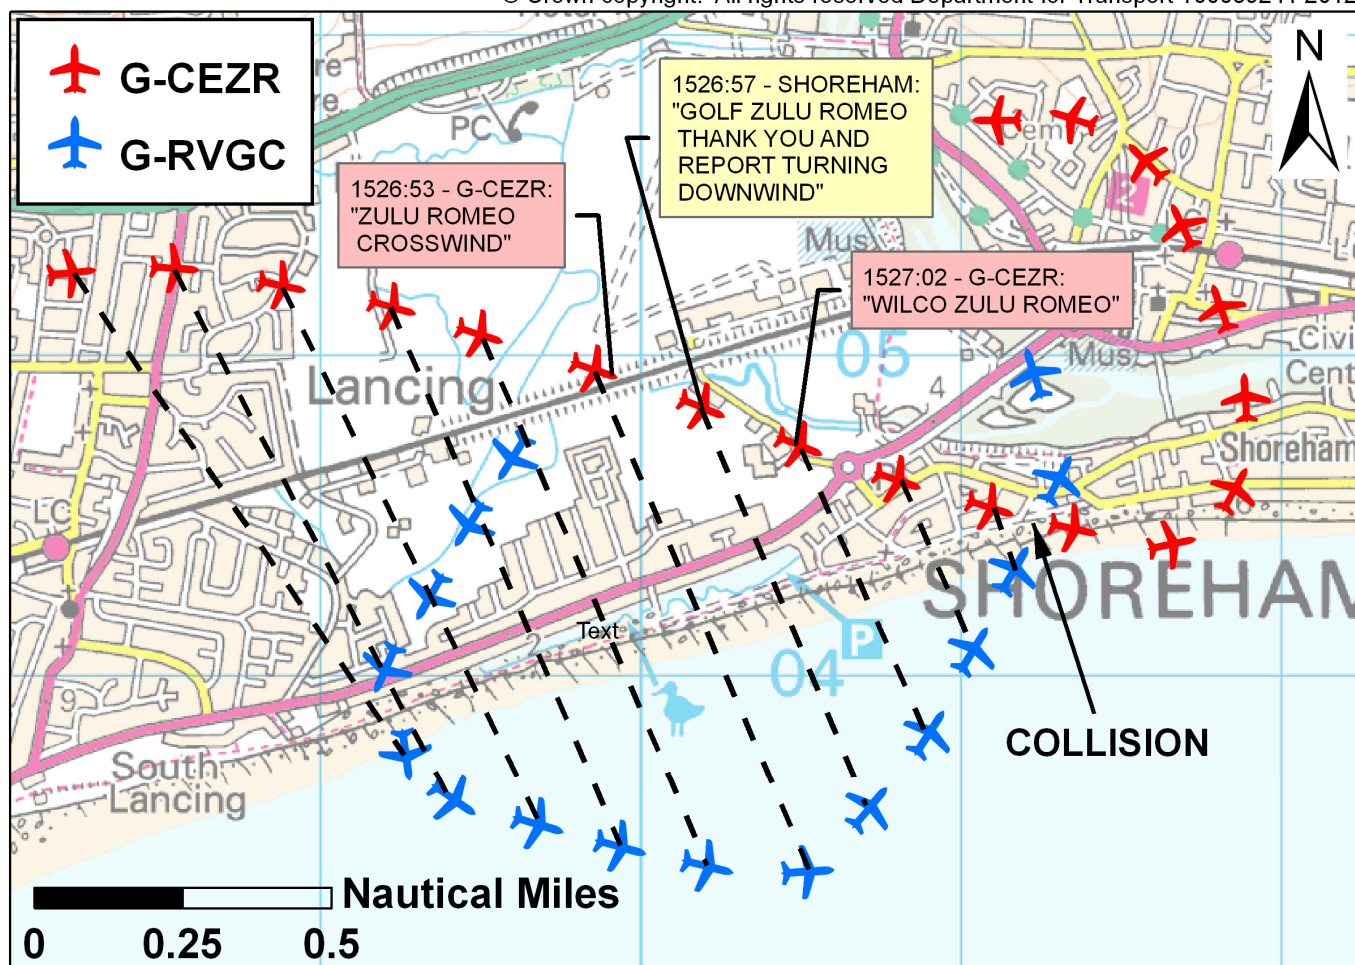
Figure 3 shows a close up of the radar tracks at Shoreham and details the relative positions of the aircraft leading up to the collision.

The figure shows that as ZR was about 1 nm from the airfield, on a track to pass over the upwind end of

Close up of radar tracks with G-CEZR joining, and G-RVGC, in the circuit, through to the collision

Runway 20, GC was turning onto the crosswind leg of the circuit. ZR was descending through 1,225 ft ( $\pm 12.5$  ft) aal and GC was climbing through 800 ft ( $\pm 50$  ft) aal, with a groundspeed of about 90 kt. As ZR crossed over the upwind end of Runway 20 it levelled off at 1,075 ft ( $\pm 12.5$  ft) aal, where it remained until the collision. GC climbed through 1,100 ft ( $\pm 50$  ft) aal as it turned onto the downwind leg, levelling off briefly at 1,200 ft ( $\pm 50$  ft) aal before descending. At 1527:16 hrs, about 3 seconds before the collision, ZR was at 1,075 ft ( $\pm 12.5$  ft) aal and GC was at 1100 ft ( $\pm 50$  ft) aal; the groundspeed for each aircraft was about 96 kt and 94 kt respectively. Figure 3 also
