INCIDENT

Aircraft Type and Registration:	Airbus A320-200, I-BIKE
No & Type of Engines:	2 CFM-56 turbofan engines
Year of Manufacture:	1999
Date & Time (UTC):	25 June 2005 at 0740 hrs
Location:	On approach to Runway 09L at London Heathrow Airport
Type of Flight:	Public Transport (Passenger)
Persons on Board:	Crew - 6 Passengers - 98
Injuries:	Crew - None Passengers - None
Nature of Damage:	Failure of No 1 and 3 ADIRUs
Commander's Licence:	Airline Transport Pilot's Licence
Commander's Age:	41 years
Commander's Flying Experience:	8,300 hours (of which 1,300 were on type) Last 90 days - 130 hours Last 28 days - 50 hours
Information Source:	AAIB Field Investigation

Synopsis

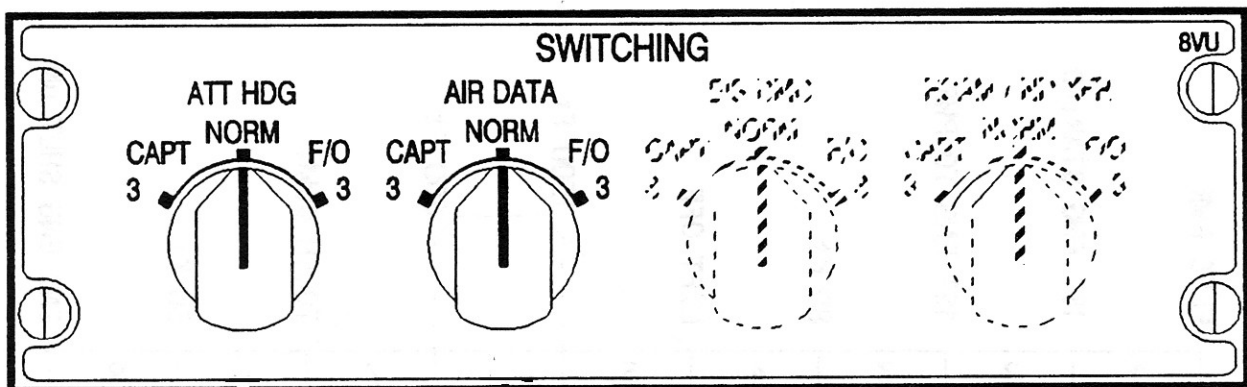
Figure 2

The ADIRS is controlled via the ADIRS control panel on the overhead panel, Figure 2. In normal operation, the rotary selector mode switches are set to the NAV position. In this configuration, the No 1 and 2 ADIRUs supply data to the commander's and co-pilot's EFIS displays respectively, with No 3 ADIRU available as a standby. Following loss of the ADR and/or IR function of either the No 1 or 2 ADIRU, rotary selector switches on the SWITCHING panel on the centre pedestal, Figure 3, enable air data and/or inertial data from the No 3 ADIRU to be selected to replace the data from the failed unit.

An IR fault in ADIRU No 1 or 2 will cause a loss of attitude and navigation information on their associated PFD and ND screens. An ADR fault will cause the loss of airspeed and altitude information on the affected display. In either case the information is restored by selecting the No 3 ADIRU.

According to the Flight Crew Operating Manual, a failure of the IR section of the ADIRU is indicated by a steady amber FAULT light on the corresponding IR push button on the ADIRS control panel, with

ADIRS Control Panel

an associated caution message on one of the ECAM displays. A flashing amber light indicates that the affected system has lost the ability to navigate, but attitude and heading information may be recovered by setting the mode rotary selector switch to the ATT position and performing an alignment procedure. An ADR failure is indicated by a steady amber FAULT light on the corresponding ADR push button and an associated ECAM caution message. In the event of an ADR failure in an ADIRU, the air data output may be switched off by pressing the appropriate ADR push button switch on the ADIRS control panel.
