ACCIDENT

Aircraft Type and Registration:	Piper PA-28R-201T, Turbo Cherokee Arrow III, G-JMTT	
No & Type of Engines:	1 Continental TSIO-360-FB piston engine	
Year of Manufacture:	1978	
Date & Time (UTC):	9 April 2007 at approximately 1050 hrs	
Location:	9 nm south of Oban (North Connel) Airport, Argyll and Butte, Scotland	
Type of Flight:	Private	
Persons on Board:	Crew - 2	Passengers - 1
Injuries:	Crew - 2 (Fatal)	Passengers -1 (Fatal)
Nature of Damage:	Aircraft destroyed	
Commander's Licence:	Private Pilot's Licence	
Commander's Age:	56 years	
Commander's Flying Experience:	324 hours (of which 43 were on type) ¹ Last 90 days - unknown Last 28 days - 2 hours ²	
Information Source:	AAIB Field Investigation

Synopsis

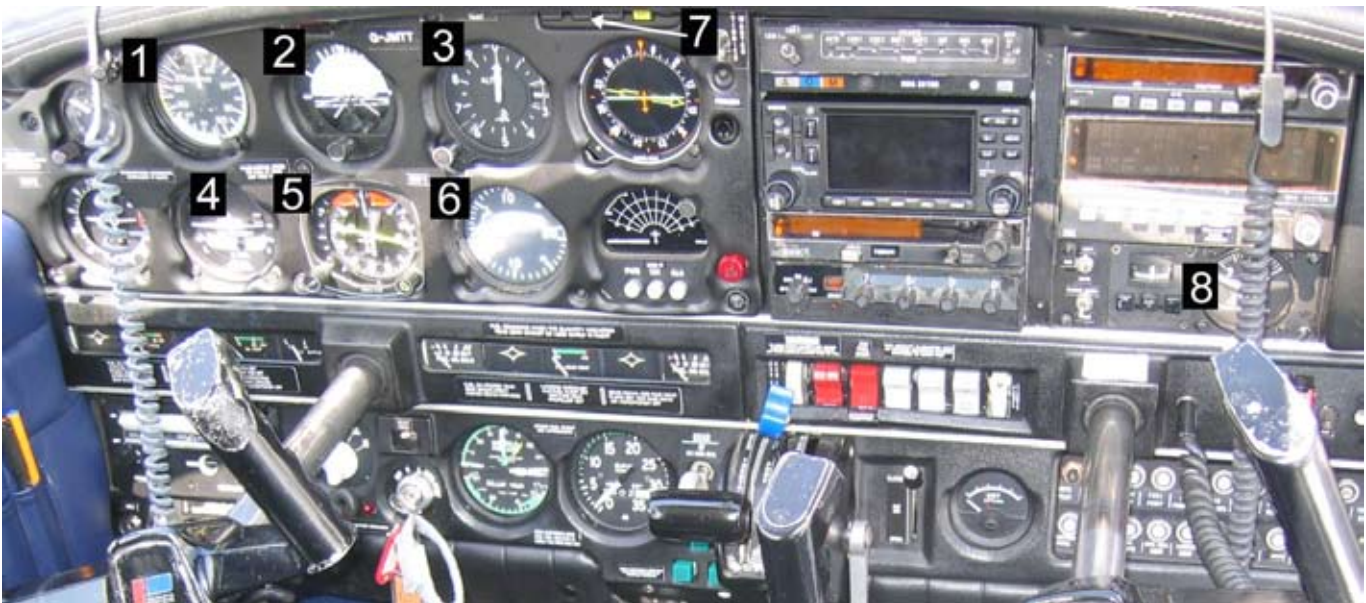
Figure 2

G-JMTT was equipped with three gyroscopic instruments to assist with instrument flight: a vacuum-driven Attitude Indicator (AI), an electric Horizontal Situation Indicator (HSI), and an electric Turn Coordinator (all shown in Figure 2). The vacuum pressure to the AI was supplied by an engine-driven Parker Airborne 211CC vacuum pump. The level of suction supplied by the pump was indicated on a suction gauge located on the right side of the instrument panel (No 8 in Figure 2). A warning light on the upper left side of the instrument panel (No 7 in Figure 2) illuminated if the suction dropped below a level sufficient to operate the AI. An optional backup/auxiliary vacuum pump was not fitted to G-JMTT.

The aircraft was also fitted with a Century III autopilot which used the vacuum-driven AI as its attitude reference source. The autopilot (AP) had four modes: Roll, Heading, Altitude and Pitch. Altitude mode was a pitch mode that used the pressure from the altimeter to command the AP to maintain the pressure altitude at the time the mode was engaged. If the AI instrument failed and supplied erroneous attitude information to the AP, then the AP would not function correctly and would not be able to hold a heading or an altitude.

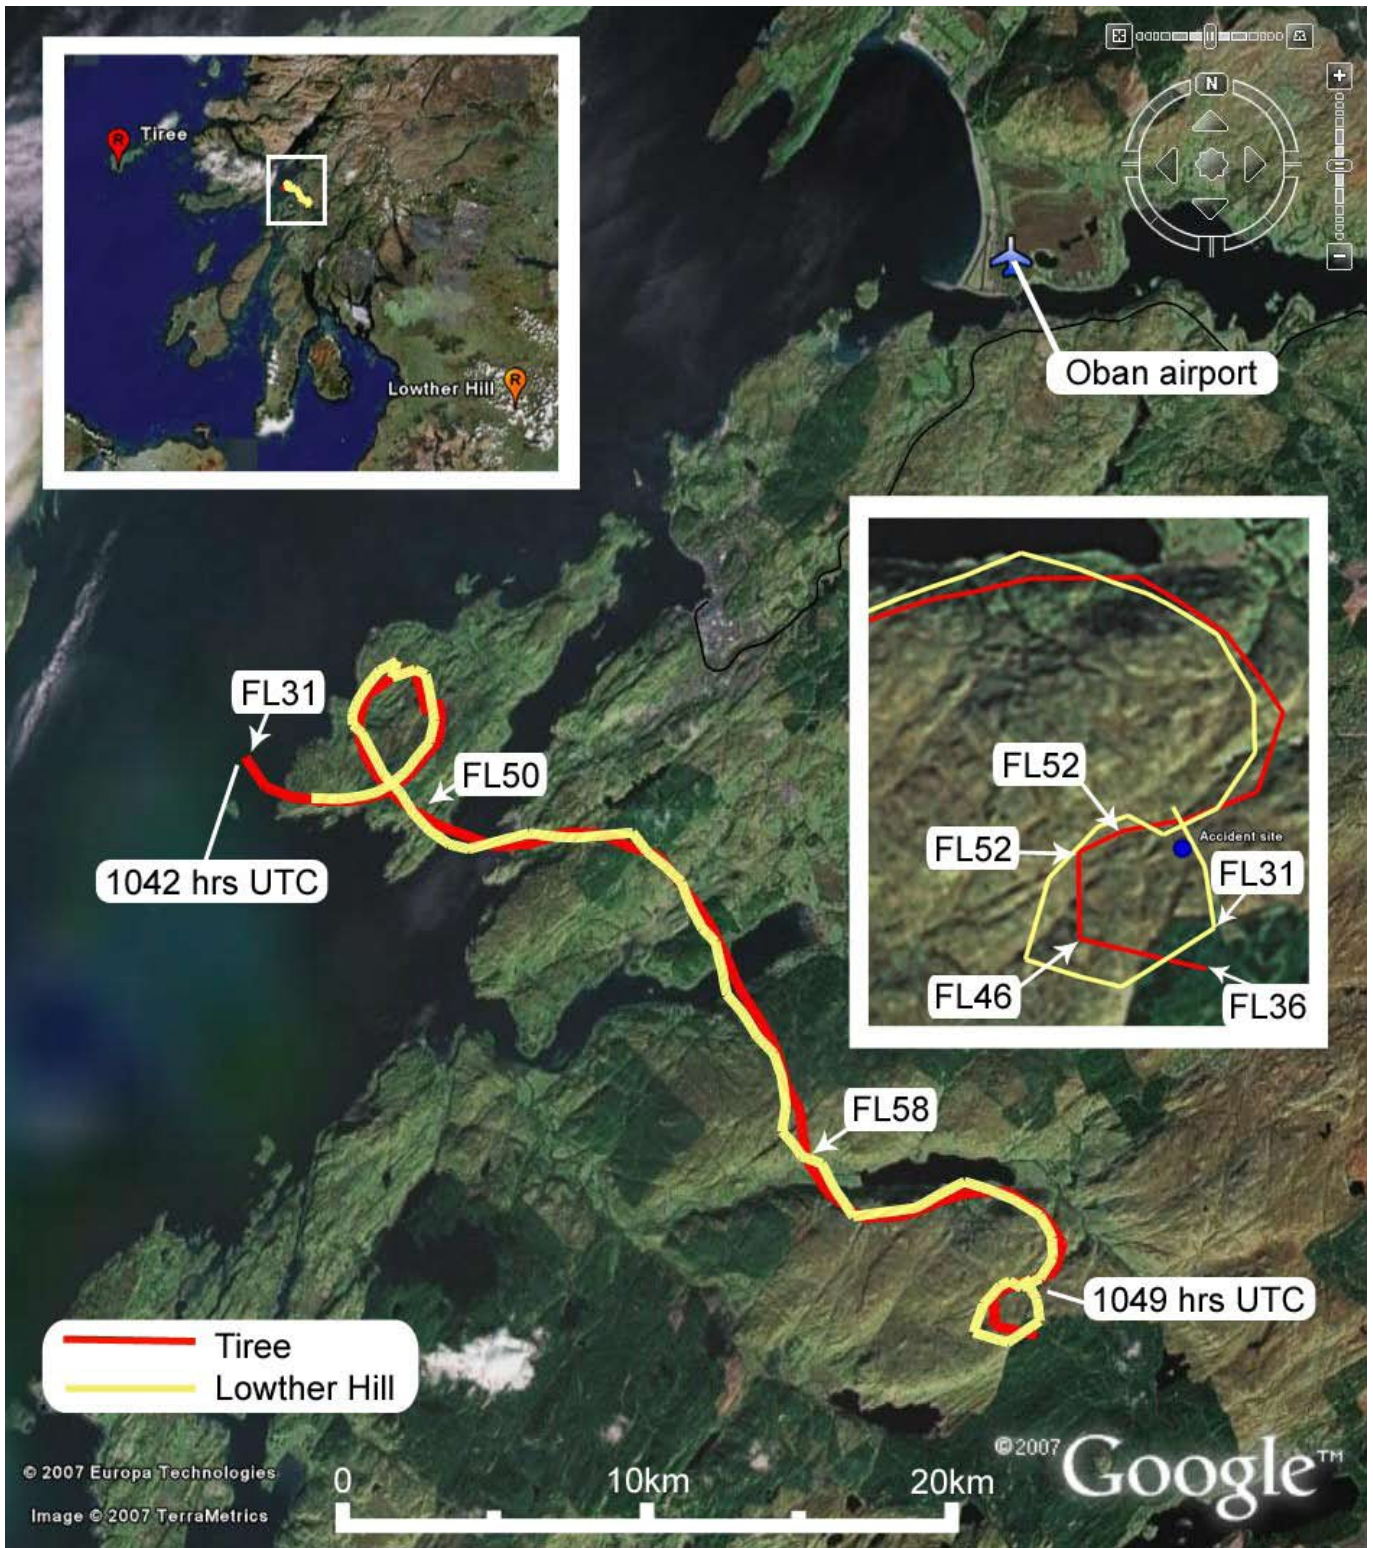
Figure 3
Overview of recorded radar tracks

Both Lowther and Tiree have primary and secondary radar heads. Due to the distance between the aircraft and these radar installations, combined with the terrain in between, the radar tracks do not cover the accident flight from beginning to end. Figure 3 shows the departure airfield, the radar tracks recorded by the Tiree and Lowther radar installations and the location of the accident site. It is worthy of note that the two tracks do not exactly coincide. This is an illustration of the magnitude of the random errors that are involved with radar returns when used at this very small scale, and shows why a detailed description of the manoeuvring of the aircraft from point to point would not be valid. Similarly, speed calculations derived from these points are prone to large errors. The strength of the radar data, when used at this very small scale, is in the motion trends.

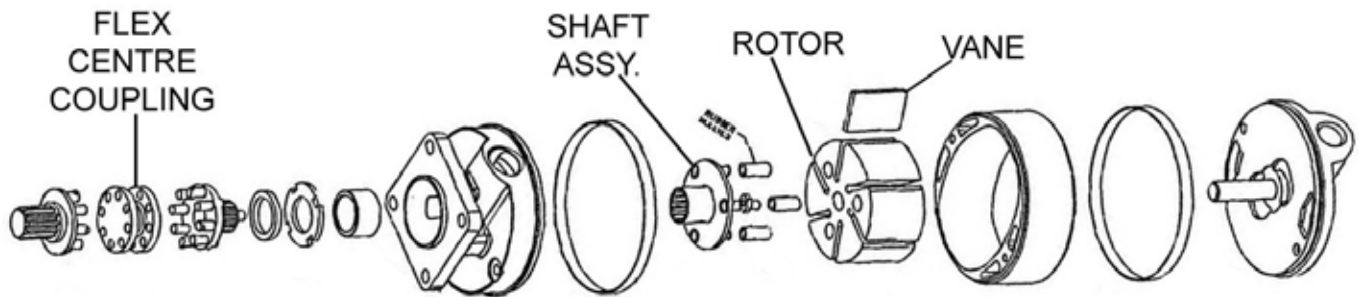
Figure 5

The Parker Airborne 211CC vacuum pump fitted to G-JMTT was examined by the AAIB and then separately

by the component manufacturer. A component diagram of the pump is shown in Figure 5. The pump is driven directly by the engine’s accessory gearbox which, through a drive coupling, turns a carbon rotor with carbon vanes that slide in and out by centrifugal force. A photograph of the rotor and vane assembly is shown in Figure 6. The rotor and vane assembly of the pump from G-JMTT had shattered into multiple pieces (see Figure 6). It was important to determine if the rotor had broken while the aircraft was in the air or as a result of ground impact. The rotor is driven by a metal shaft assembly which connects to a plastic coupling which is connected to a
