ACCIDENT

Aircraft Type and Registration:	Piper PA-38-112 Tomahawk, G-RVRF	
No & Type of Engines:	1 Lycoming O-235-L2C piston engine	
Year of Manufacture:	1978	
Date & Time (UTC):	29 July 2011 at 1123 hrs	
Location:	Newlands Avenue, Eccles, Greater Manchester	
Type of Flight:	Private	
Persons on Board:	Crew - 1	Passengers - 1
Injuries:	Crew - 1 (Fatal)	Passengers - 1 (Serious)
Nature of Damage:	Aircraft destroyed	
Commander's Licence:	Private Pilot's Licence	
Commander's Age:	59 years	
Commander's Flying Experience:	426 hours (of which 302 were on type) Last 90 days - 3 hours Last 28 days - 1 hour	
Information Source:	AAIB Field Investigation

Synopsis

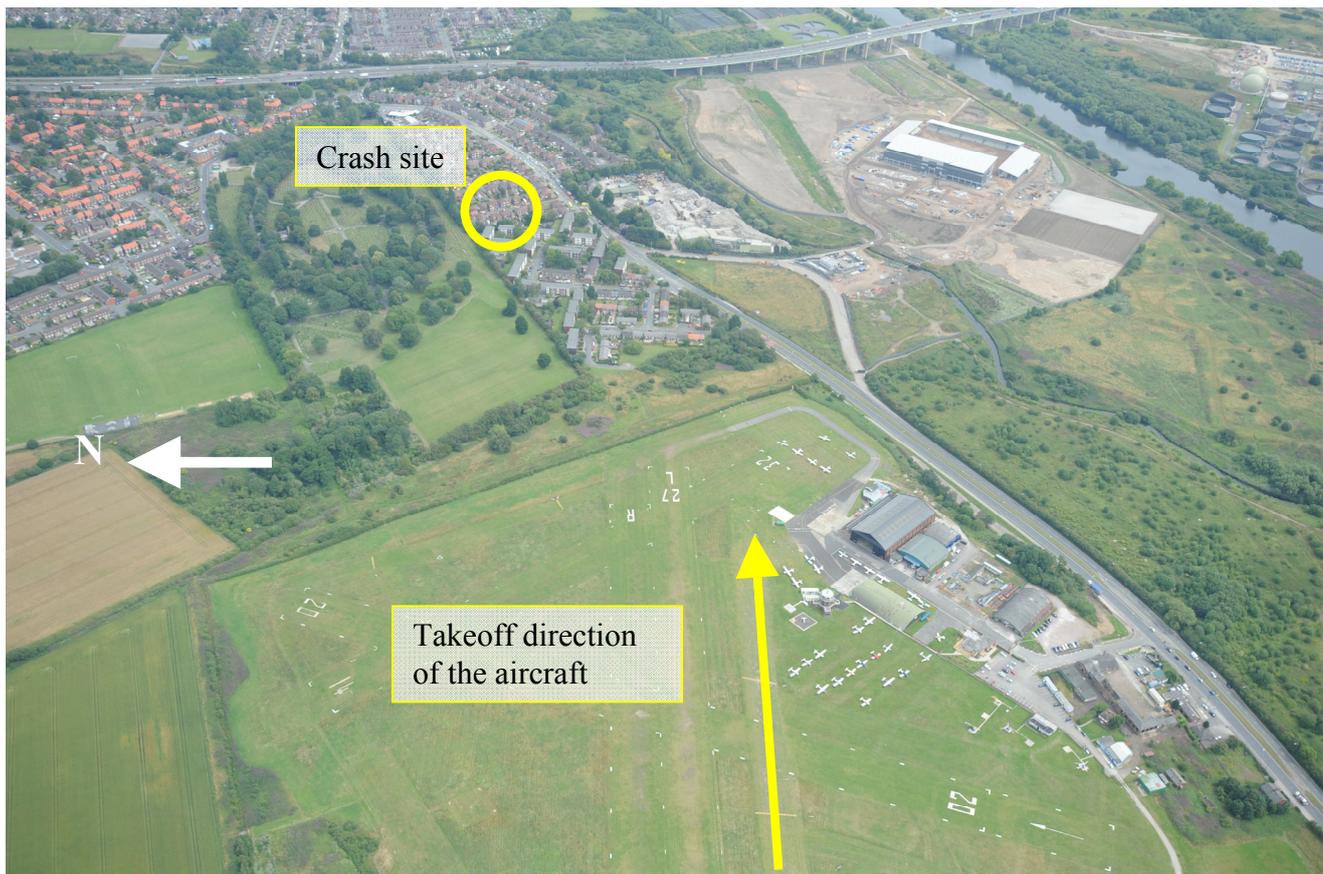
Figure 3

that practice EFATOs are not permitted on climbout from Runways 09L, 09R and 14. An aerial view of the airfield, the crash site and surrounding area is shown in Figure 3. The open grass area to the southeast of the crash site and to the west of the motorway was, at the time of the accident, a building site with a large stadium in the advanced stages of construction. The area to the north of the housing estate on which the aircraft crashed is a cemetery.

Manchester/Barton Airport
