Piper PA-34-200T Seneca II, G-ROLA

AAIB Bulletin No: 5/2004	Ref: EW/C2003/05/09	Category: 1.3
Aircraft Type and Registration:	Piper PA-34-200T Seneca II, G-ROLA	
No & Type of Engines:	2 Continental TSIO-360-EB piston engines	
Year of Manufacture:	1976	
Date & Time (UTC):	8 May 2003 at 1220 hrs	
Location:	Sherburn-in-Elmet Aerodrome, Yorkshire	
Type of Flight:	Private	
Persons on Board:	Crew - 2	Passengers - None
Injuries:	Crew - None	Passengers - N/A
Nature of Damage:	Both propellers bent, engines shock loaded, nose cone split, nose landing gear doors damaged	
Commander's Licence:	Airline Transport Pilot's Licence	
Commander's Age:	51 years	
Commander's Flying Experience:	6,355 hours (of which 750 were on type)	
	Last 90 days - 67 hours	
	Last 28 days - 14 hours	
Information Source:	Aircraft Accident Report Form submitted by the commander and further enquiries by the AAIB

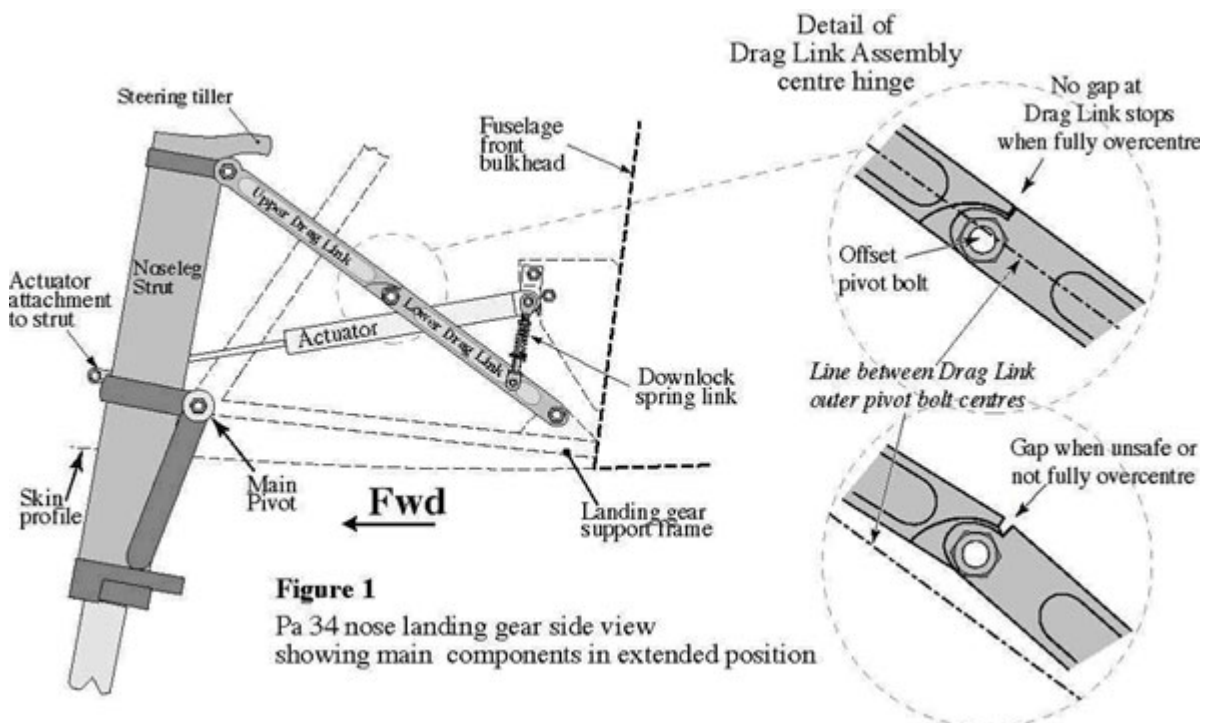
Figure 1: PA-34 nose landing gear side view showing main components in extended position

The overall geometry of the landing gear is such that aircraft weight on the nose-wheel applies a compressive load to the drag link assembly which tends to drive it more firmly into the safe over-centre condition when the gear is properly extended. Conversely, it will tend to cause the drag link to fold, and the gear to retract, if the load is applied when the drag link assembly is in an under-centre condition.

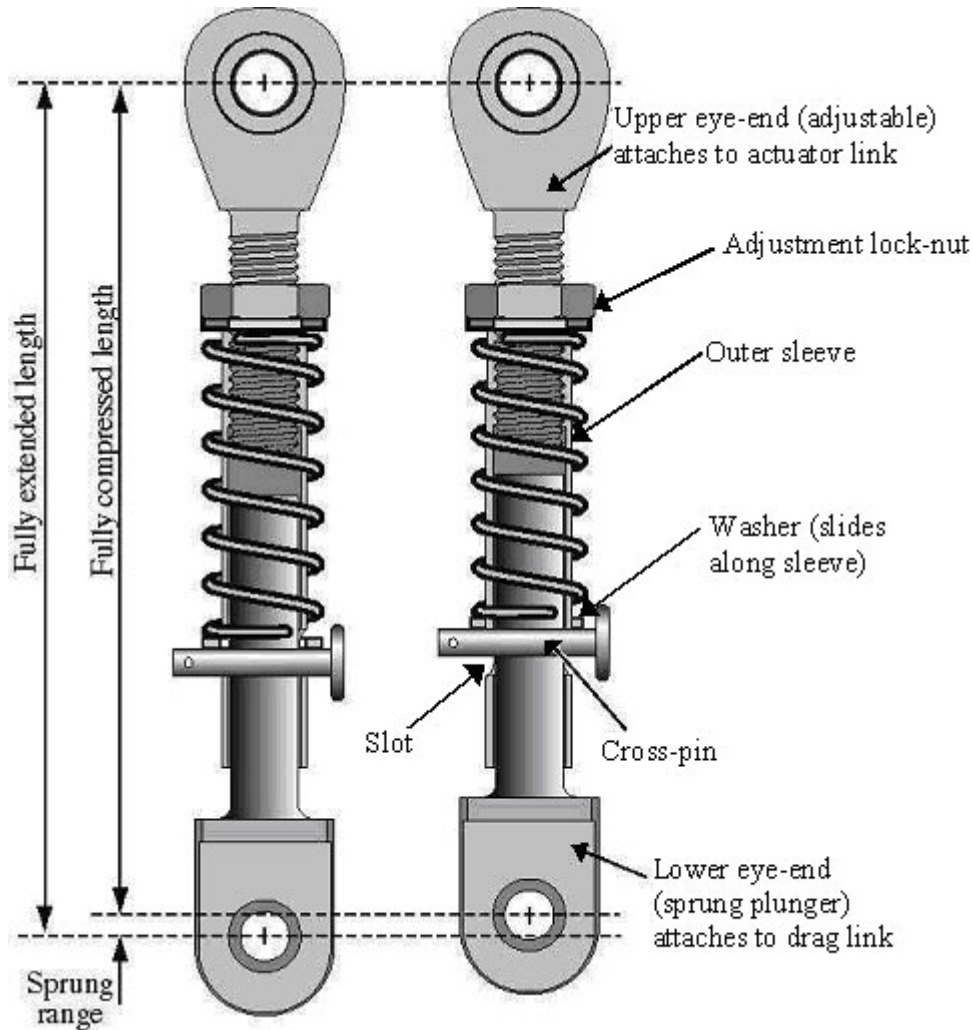
Figure 2: Downlock spring link in compressed and extended position

The downlock spring link helps to maintain the over-centre downlock position by applying a force on the lower drag link. It has a spring and a plunger to permit a small change in its length as it is moved in and out of lock (see Figure 2).

The difference between the compressed and uncompressed length should be approximately 0.08 inch. The travel of the plunger is limited by a cross-pin which abuts against a washer that presses against the spring when the link is compressed. The length of the downlock spring link is adjustable and should be rigged such that it is fully compressed when the drag link assembly is driven to the fully over-centre position. If the downlock link is adjusted too short, the drag link will not be driven to the over-centre position which could result in the nose gear collapsing.
