No: 6/92

Aircraft Type and Registration: Boeing 757-236, G-BMRE

Location: London (Heathrow) Airport

Nature of Damage: Gouge and hole in the fuselage beneath the left hand pilot's seat

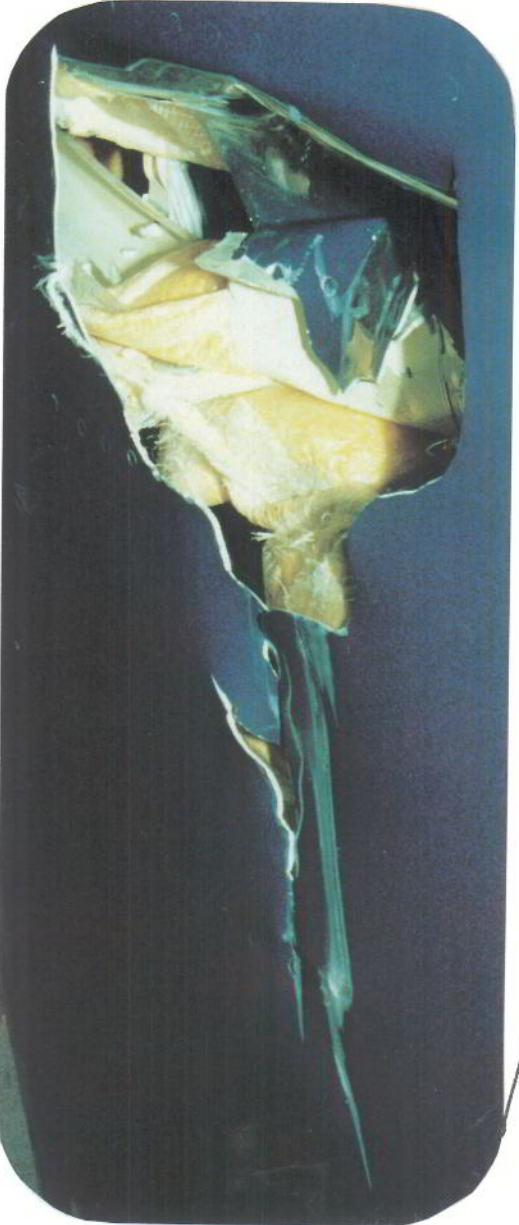
Examination of the damage revealed a rupture to the pressure hull which measured 11 inches by 13 inches and was located in the lower side fuselage three feet below the first pilot's side window (photograph No.1). A more detailed examination of the damage indicated that it had occurred on the ground prior to take-off and that either the aircraft had been reversed into an object, or an object had been driven forward into the aircraft. The section of the object that had caused the damage had been 9 feet 11 inches from the ground, was painted grey and had struck the aircraft from the rear, approximately seven degrees from the aircraft's fore/aft axis, parallel with the ground and travelling at about 12 mph. No damage had been reported to any ground equipment or vehicle except the passenger jetway at the stand from which the aircraft had departed. Examination of the passenger jetway and interviews with the jetway operator and independent observers established positively that the jetway had not caused the damage to this aircraft. An extensive search and examination of the ground equipment and vehicles in the areas of Terminal 1, Terminal 2 the central and northern motor transport and ground equipment servicing and repair workshops and the cargo vehicle parking area revealed a Luton cargo vehicle that had recently received damage to the upper forward right corner of its box body which was painted grey (photograph No.2). Examination of this damaged area showed excellent evidence of the aircraft's paintwork embossed upon it and that it was 9 feet 11 inches from the ground. When the the damaged area of the aircraft, which had been cut away from the aircraft was offered up to the damaged area of the Luton cargo vehicle, the markings on the piece of the aircraft matched perfectly with the structure of the vehicle. The task sheet for this vehicle on the morning of the accident was for it to deliver fast freight to this aircraft on stand C30.

PHOTOGRAPH No. 1 DAMAGE TO THE AIRCRAFT
