INCIDENT TO G-BFVV

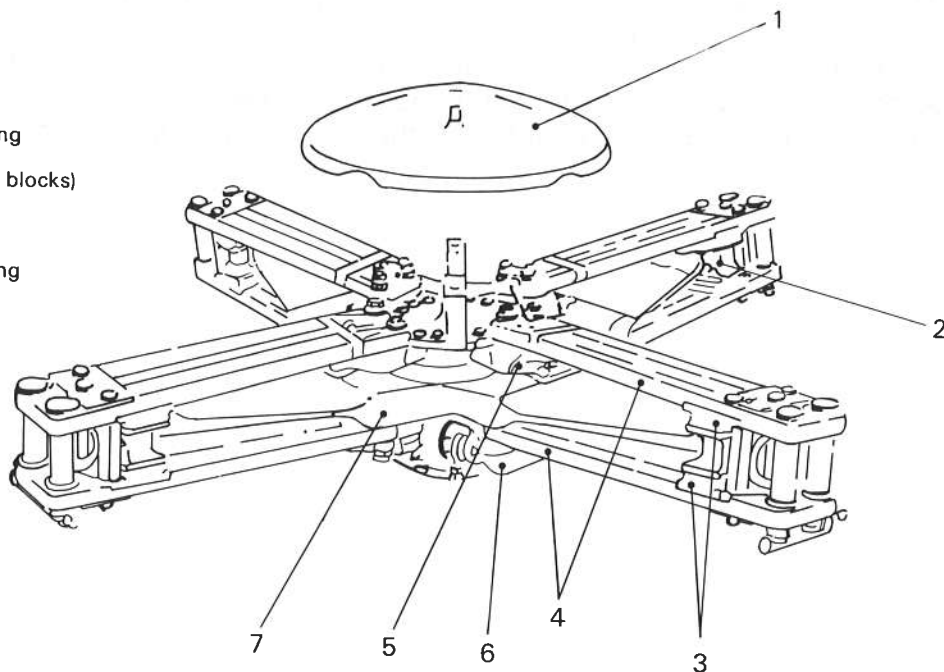
MRH Components

1. Rotor head fairing
2. Self-lubricating oscillating bearing
3. Frequency adapters (elastomeric blocks)
4. Blade attach beams
5. Laminated spherical thrust bearing
6. Pitch-change lever
7. Star

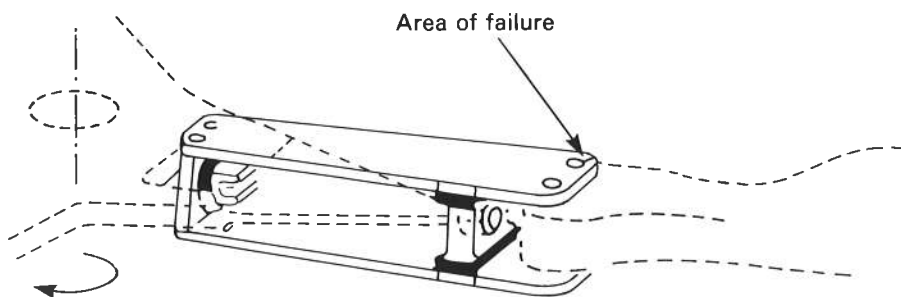
Main rotor blade attachment beam construction details

The subject helicopter had achieved more than 7200 hours and been operated on very short sectors, leading to a high number of cycles. Following the discovery of fretting damage on a number of other helicopters, the manufacturers, together with the French Airworthiness Authorities, have imposed a 3000 hour life on the component by means of an Airworthiness Directive. This has been adopted by the United Kingdom Civil Aviation Authority.
