Ref: EW/G89/08/13

Aircraft Type and Registration: Socata ST.10 Diplomate, G-AZIB

Location: Nottingham Airport

Nature of Damage: Damage to left main landing gear and to left flap.

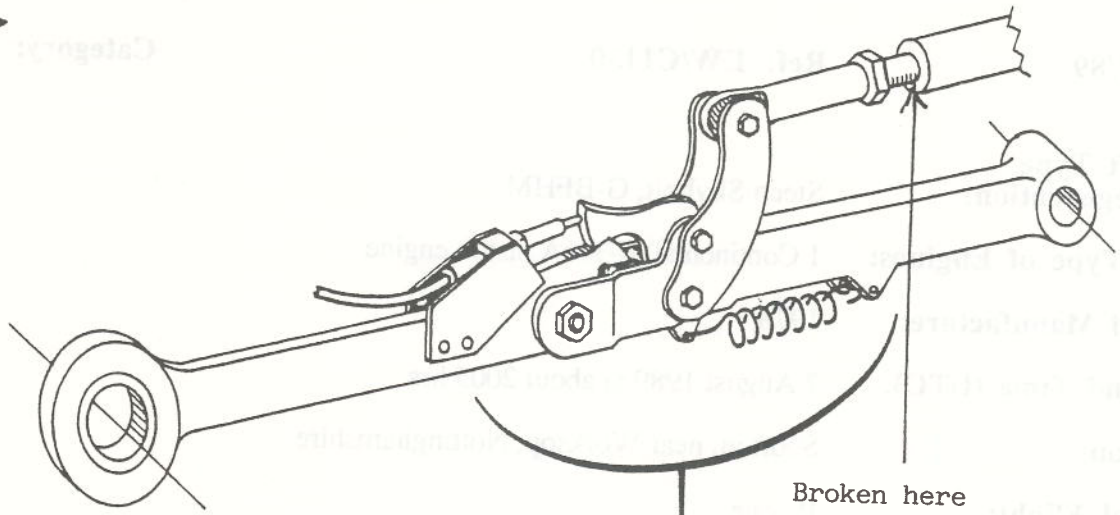
Subsequent inspection of the aircraft showed that the threaded end fitting of the actuating rod assembly had broken (see diagram). This had allowed the mechanism to unlock and retract. Socata Service Bulletin No. 11 called for an inspection of this general area, including the threaded end fitting, at 25 hour intervals. At the time of the accident the aircraft had completed over 1700 hours. It is likely that this fitting had been installed at original build.

Broken here
