# **Air Accidents Investigation Branch**

Report on the serious incident to Airbus A319-131, G-EUOB during the climb after departure from London Heathrow Airport on 22 October 2005

This investigation was carried out in accordance with The Civil Aviation (Investigation of Air Accidents and Incidents) Regulations 1996

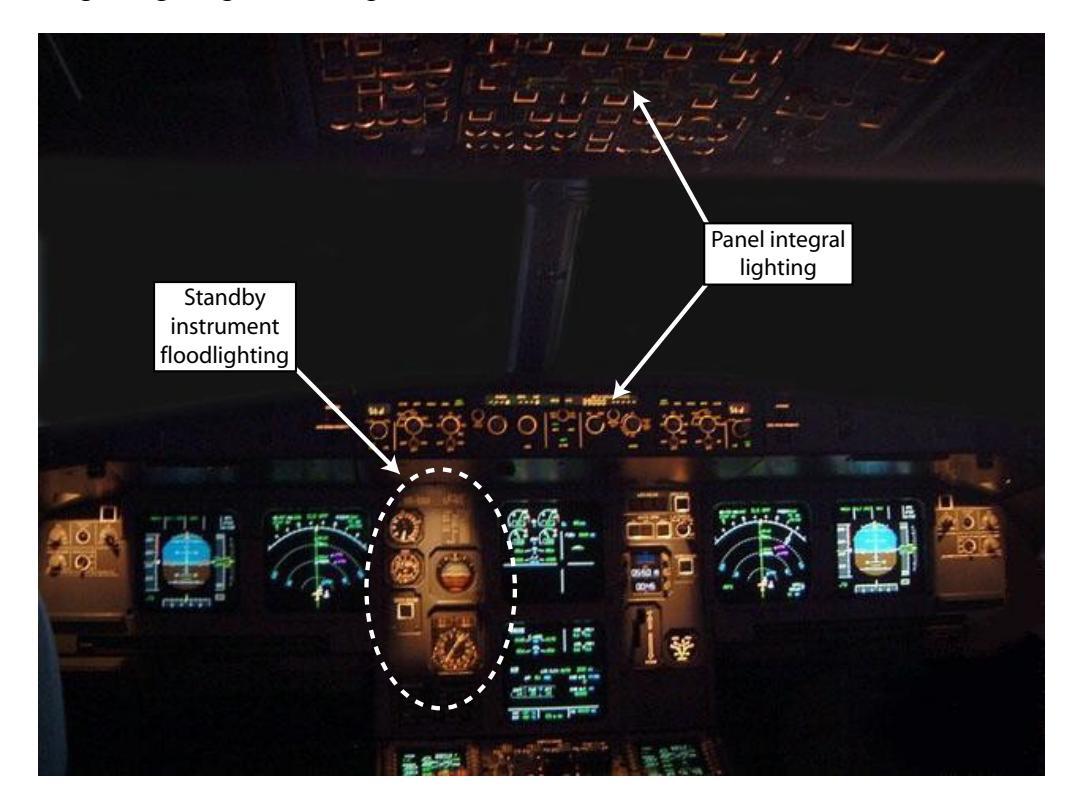
Figure 8

the dome light was switched off, the standby instruments became unreadable due to lack of light. The centre instrument panel floodlight, which can be used to illuminate the standby instruments (Figure 8, page 26), was no longer available.
