**ACCIDENT**

<b>Aircraft Type and Registration:</b>	Extra EA 300/L, G-IIEX	
<b>No &amp; Type of Engines:</b>	1 Lycoming AEIO-540-L1B5 piston engine	
<b>Year of Manufacture:</b>	1995	
<b>Date &amp; Time (UTC):</b>	26 May 2008 at 1351 hrs	
<b>Location:</b>	Hastingleigh, near Ashford, Kent	
<b>Type of Flight:</b>	Private	
<b>Persons on Board:</b>	Crew - 1	Passengers - 1
<b>Injuries:</b>	Crew - 1 (Minor)	Passengers - 1 (Serious)
<b>Nature of Damage:</b>	Extensive - aircraft damaged beyond economic repair	
<b>Commander's Licence:</b>	Commercial Pilot's Licence	
<b>Commander's Age:</b>	41 years	
<b>Commander's Flying Experience:</b>	1,716 hours (of which 204 hours were on type) Last 90 days - 119 hours Last 28 days - 47 hours	
<b>Information Source:</b>	AAIB Field Investigation

**Synopsis**

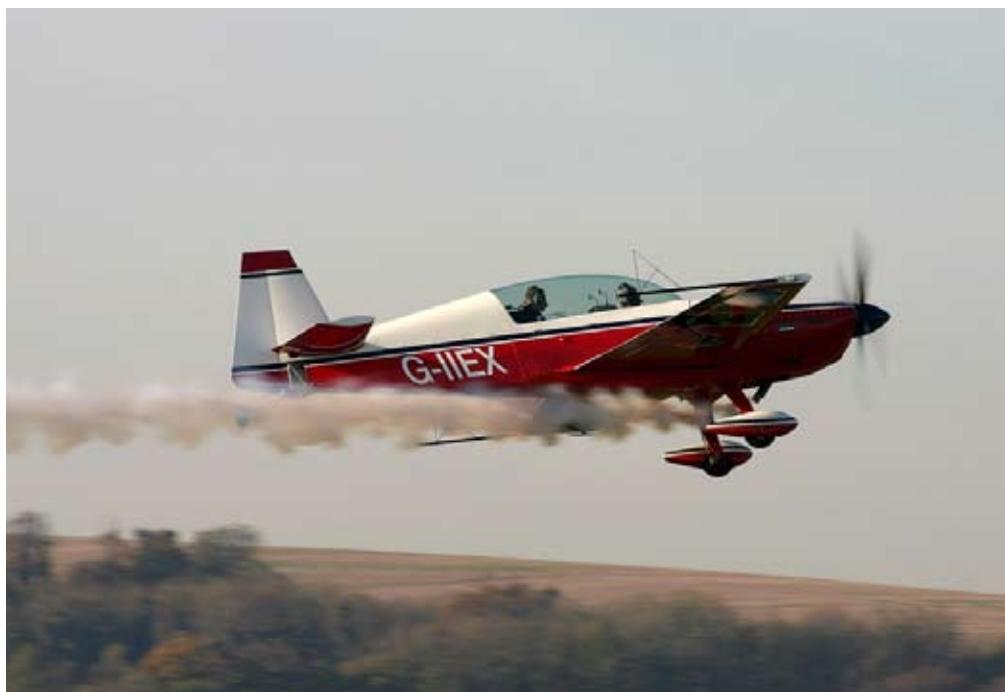
**Figure 4**  
Configuration of G-IIEX

The Extra 300/L is a single-engine low-winged monoplane, designed to be fully aerobatic, Figure 4. It is qualified for manoeuvre load factors of  $\pm 10g$ . The aircraft is powered by a 300 shp piston engine driving a four-bladed constant-speed wooden propeller. The fuselage is constructed of a tubular steel frame covered with aluminium and fabric fairings; the wings are of

carbon-fibre reinforced plastic (CRP). The ailerons are almost full span and there are no flaps. The aircraft is of tailwheel configuration with fixed landing gear. The wing section creates a 'conventional' turbulent flow. At maximum all-up weight, at 1g, the aircraft stalls at 55 kt.
