AIRCRAFT ACCIDENT REPORT 2/2005

**Report on the accident to
Pegasus Quik, G-STYX
at Eastchurch, Isle of Sheppey, Kent
21 August 2004**

Air Accidents Investigation Branch

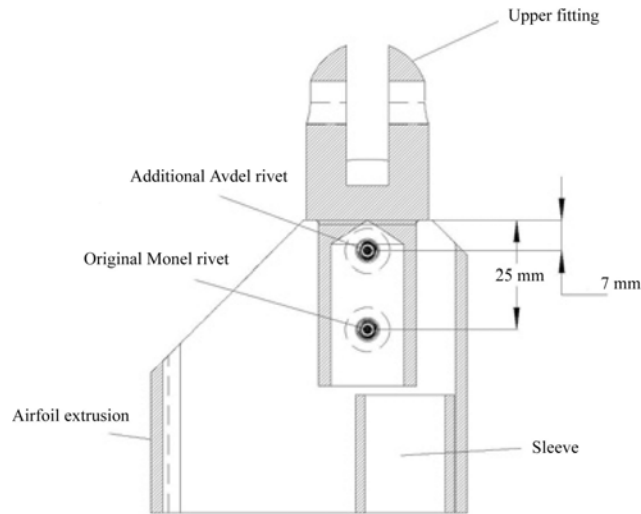
Figure 2 Drawing of upright upper fitting

- (i) Failure of the right upright upper fitting caused the microlight to enter a tumble manoeuvre from which it was not possible to recover.
- (ii) Service Bulletin 116, which introduced additional rivets in the upper fitting, was not correctly embodied.

The uprights, which are under compressive load during normal flight, each consist of an aerofoil extrusion and an inner tubular sleeve with fittings at each end to connect to the basebar and hang bracket (Figure 2). The compressive load in the upright is taken by the aerofoil extrusion with the inner sleeve, which carries no compressive load, stabilising the upright against buckling. The sleeve on the right upright is secured to the extrusion to ensure that it does not foul on the trim cable that runs inside the extrusion. The left sleeve rests on the lower fitting. The upper fittings slide into the extrusion and are secured by two Monel rivets and two Avdel rivets. The Avdel rivets were introduced by Mandatory Permit Directive (MPD) 2004-009 Mainair Sports Service Bulletin 116 following the failure of an upright fitting in April 2004 (see Annex A and B).

Similar rivets to the wrong ones fitted to the uprights were later found in the inspector's tool box and were used by him to reattach aircraft and engine data plates. It would appear that the mix up of the rivets occurred when the supplied items were placed in the top of his tool kit for safekeeping.

The instructions in Service Bulletin 116 (at Annex B) state that the wing is to be removed from the trike and the top knuckles, and PVC boots are to be removed prior to drilling the holes 7 mm below the upright top edge. If these instructions had been followed then the owner and inspector would have been able to look inside the aerofoil extrusion and gain an understanding of the construction of the joint. They would also have been able to check that the rivets went through both the extrusion and shank of the upper fitting and would have been able to check the joint for looseness.
