INCIDENT

Aircraft Type and Registration:	DHC-8-402 Dash 8, G-JEDI
No & Type of Engines:	2 Pratt & Whitney Canada PW150A turboprop engines
Year of Manufacture:	2001
Date & Time (UTC):	21 December 2009 at 1052 hrs
Location:	London Gatwick Airport
Type of Flight:	Commercial Air Transport (Passenger)
Persons on Board:	Crew - 4 Passengers - 72
Injuries:	Crew - None Passengers - None
Nature of Damage:	Damage to a wiring loom, and structure, in the left centre-wing section
Commander's Licence:	Air Transport Pilot's Licence
Commander's Age:	33 years
Commander's Flying Experience:	4,241 hours (of which 2,677 were on type) Last 90 days - 108 hours Last 28 days - 35 hours
Information Source:	AAIB Field Investigation

Synopsis

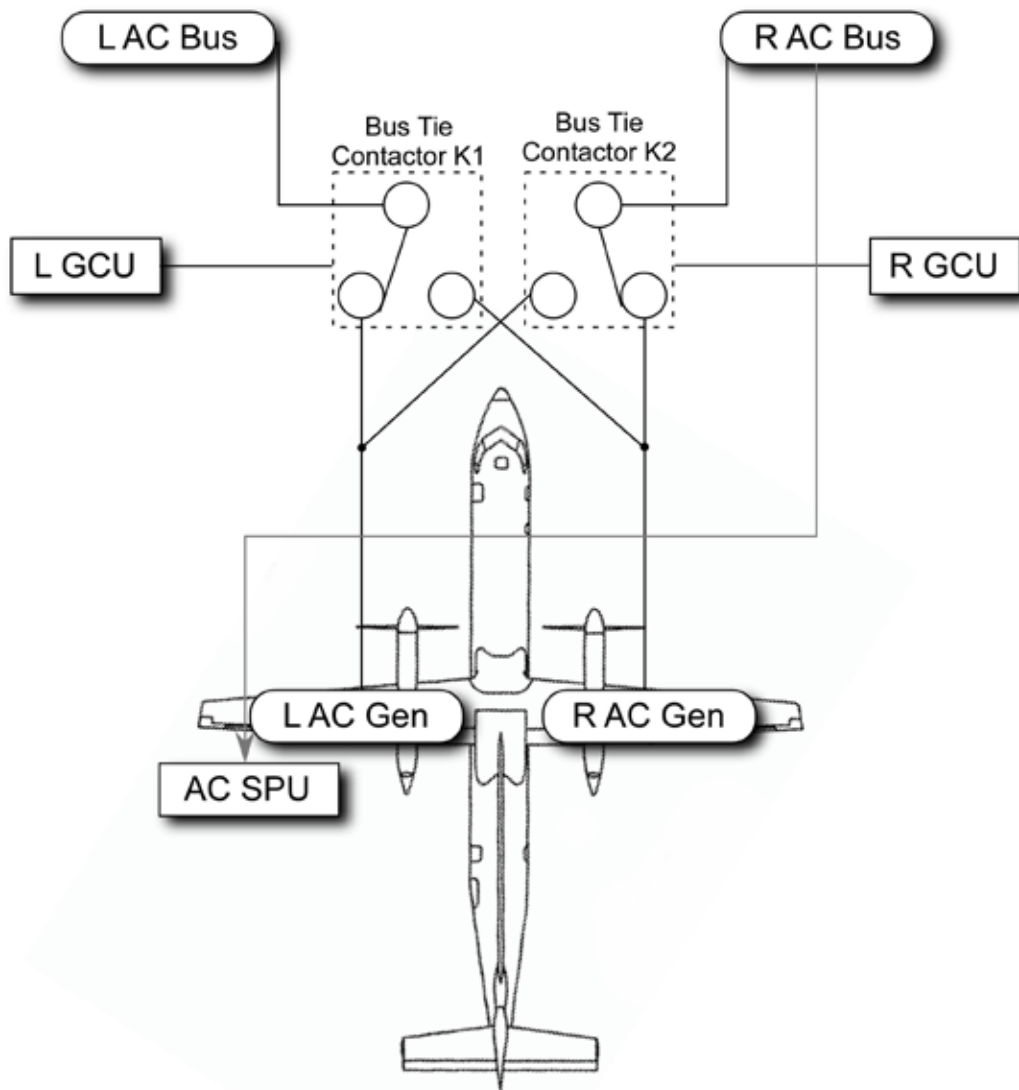
Figure 1
AC Electrical System

The Dash 8 electrical system is predominantly DC, however certain systems such as de-icing heaters, fuel auxiliary pumps and the standby power unit (SPU) hydraulic pump are powered from a frequency-wild 115 V AC electrical system. Each engine drives an AC generator which in turn supplies its respective AC Bus. Each generator is controlled by its own Generator

Control Unit (GCU). The Electrical Power Control Unit (EPCU) receives voltage and current information and uses this for output to the cockpit display; it also stores the last fault condition in its memory.

In the event of a fault with a generator, the related GCU will isolate the generator and illuminate the related ‘#1 AC GEN’ or ‘#2 AC GEN’ caution light on the cockpit warning panel. Contactors (K1 and K2) provide a means of powering an AC Bus from the opposite engine. In the event of a generator failure, the related contactor automatically connects the affected AC Bus to the serviceable generator. If the AC Bus is not powered, the ‘L AC BUS’ or ‘R AC BUS’ cautions lights are illuminated on the cockpit warning panel. The FDR records the status of the cockpit warning lights as an indication of the status of the AC Gen and the AC Buses.
