ACCIDENT

Aircraft Type and Registration:	Bolkow 208C Junior, D-EGFU	
No & Type of Engines:	1 Roll-Royce/Continental 0-200-A engine	
Year of Manufacture:	1967	
Date & Time (UTC):	2 September 2011 at 1314 hrs	
Location:	Peterborough Sibson Airfield, Cambridgeshire	
Type of Flight:	Private	
Persons on Board:	Crew - 1	Passengers - None
Injuries:	Crew - 1 (Fatal)	Passengers - N/A
Nature of Damage:	Aircraft destroyed	
Commander's Licence:	Private Pilot's Licence	
Commander's Age:	52 years	
Commander's Flying Experience:	675 hours (of which 22 were on type) Last 90 days - 6 hours Last 28 days - 0.3 hours	
Information Source:	AAIB Field Investigation

Synopsis

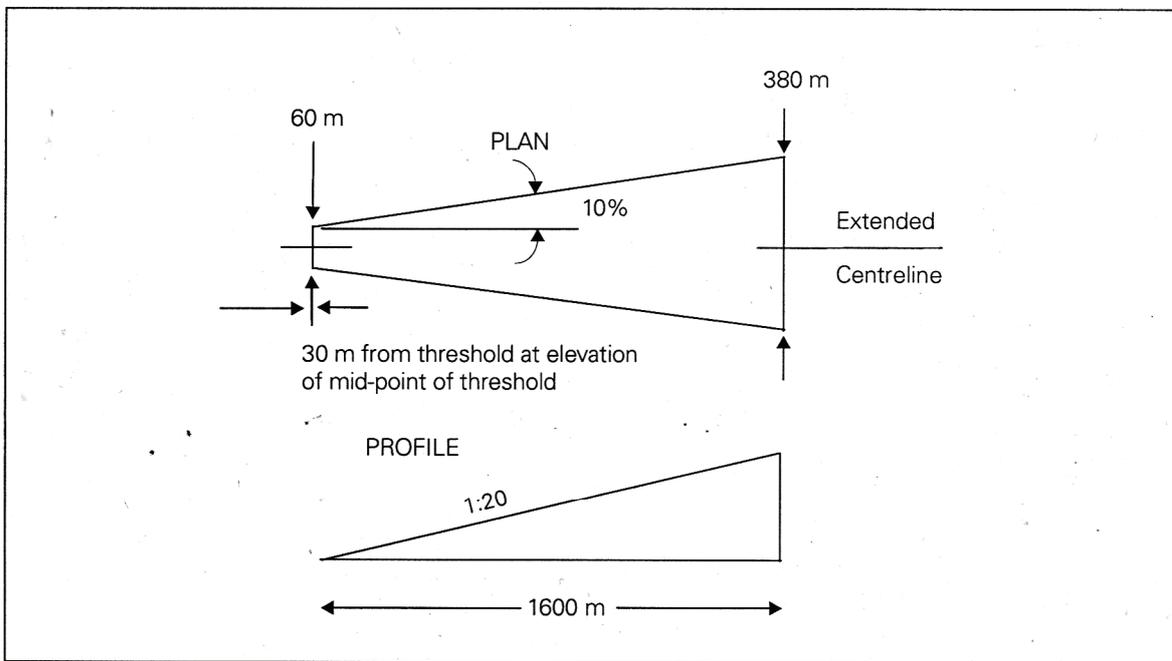
Figure 4 illustrates the obstacle limitation surface as defined in CAP 168 for the category of runway appropriate to Runway 24 at Sibson.

Figure 4
Obstacle limitation surface as defined in CAP 168 for the category of runway appropriate to Runway 24 at Sibson
