INCIDENT

Aircraft Type and Registration:	Airbus A319-131, G-DBCI	
No & Type of Engines:	2 International Aero Engines V2522-A5 turbofan engines	
Year of Manufacture:	2006	
Date & Time (UTC):	18 April 2007 at 0944 hrs	
Location:	Amsterdam Schiphol Airport, The Netherlands	
Type of Flight:	Commercial Air Transport (Passenger)	
Persons on Board:	Crew - 5	Passengers - 112
Injuries:	Crew - None	Passengers - None
Nature of Damage:	None	
Commander's Licence:	Airline Transport Pilot's Licence	
Commander's Age:	53 years	
Commander's Flying Experience:	11,123 hours (of which 3,493 were on type) Last 90 days - 132 hours Last 28 days - 44 hours	
Information Source:	AAIB Field Investigation

Synopsis

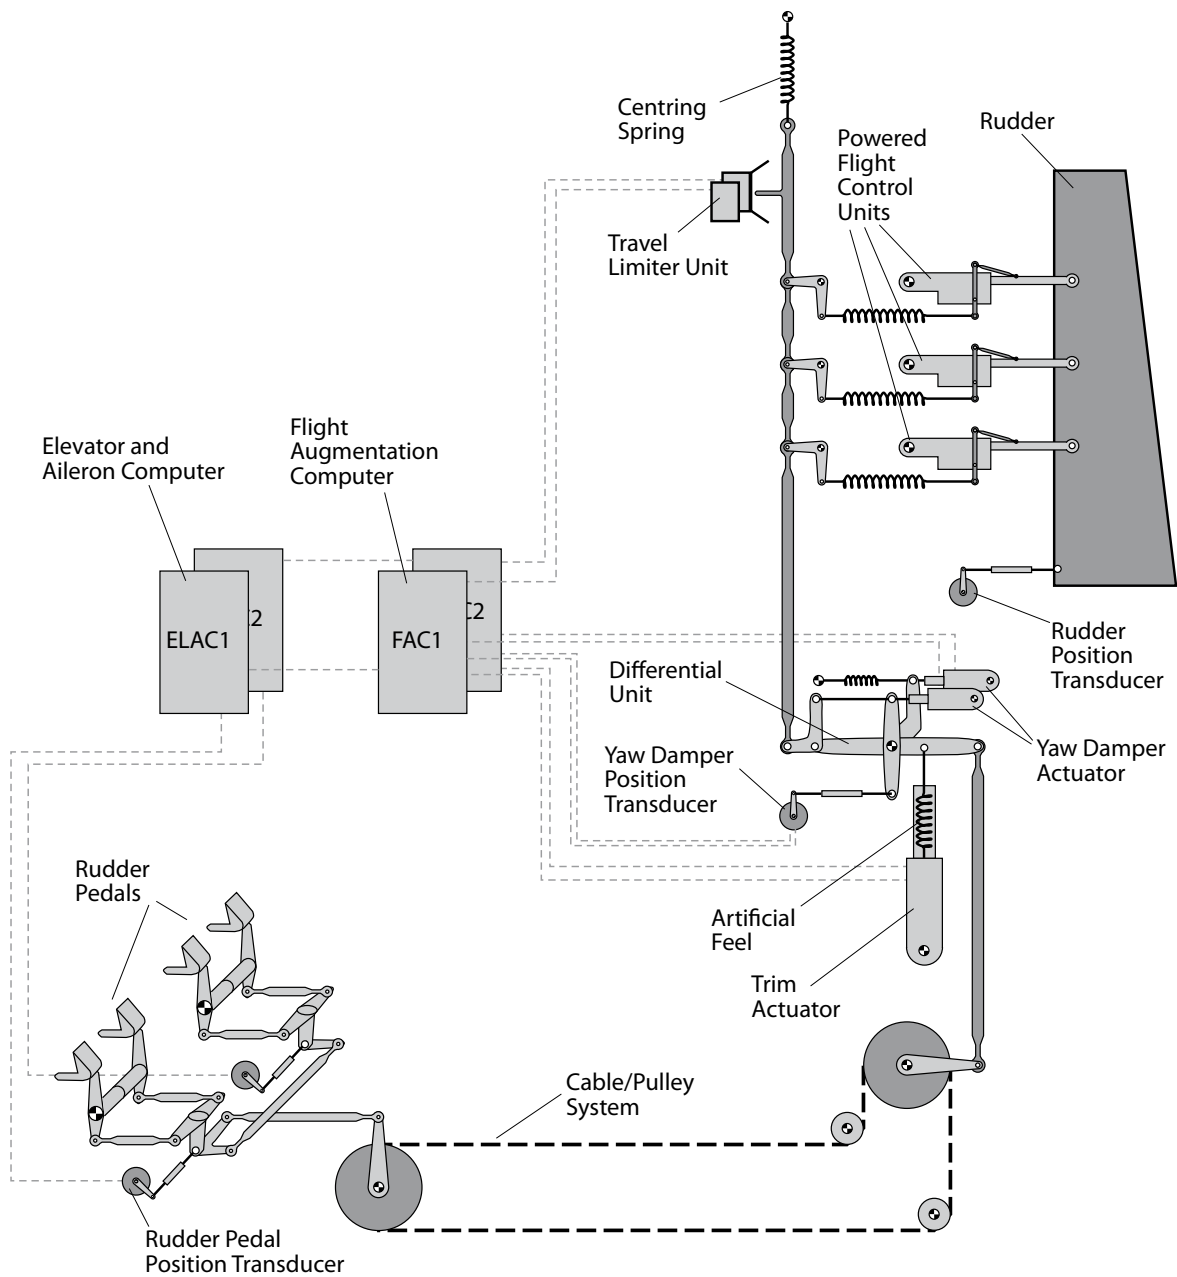
Figure 1
A319 Rudder Control System Schematic

The rudder is controlled by three hydraulic Powered Flight Control Units (PFCUs) in the fin, each fed from a different hydraulic system and signalled mechanically (Figure 1).

A transducer mechanically linked to the rudder surface provides rudder position signals. Commands from the pilots' rudder pedals are transmitted by a cable-pulley system to a mechanical differential unit in the fin and thence to the PFCUs via a rod and bellcrank system. The input to each PFCU is in the form of a spring-centred rod that allows continued rudder operation in the event of one of the PFCUs ceasing to function. The two pairs

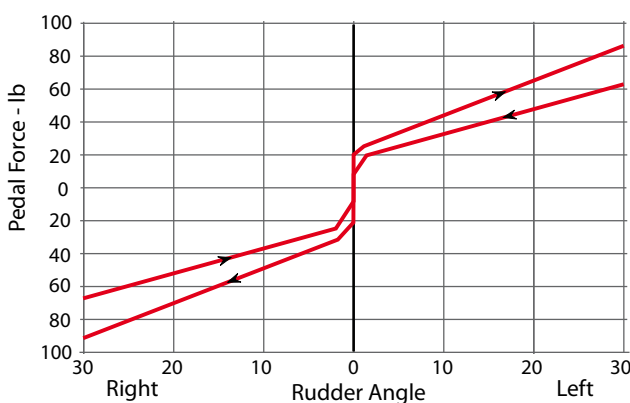
Figure 2

Artificial feel for the pedals is generated by a feel spring acting on the mechanical input system in the fin. A centring spring also acts on the input mechanism for the upper two PFCUs to prevent rudder runaway in the event of disconnection of the input system. The arrangement provides a constant pedal force/displacement characteristic irrespective of the flight conditions. Pedal force/deflection characteristics for the A319 are shown in Figure 2.

A319 Normal Rudder Pedal Force vs Rudder Deflection
