# **Air Accidents Investigation Branch**

Report on the incident to Airbus A321-231, registration G-MEDG During an approach to Khartoum Airport, Sudan on 11 March 2005

Aircraft Incident Report No:	5/2007	(EW/C2005/03/02)
------------------------------	--------	------------------

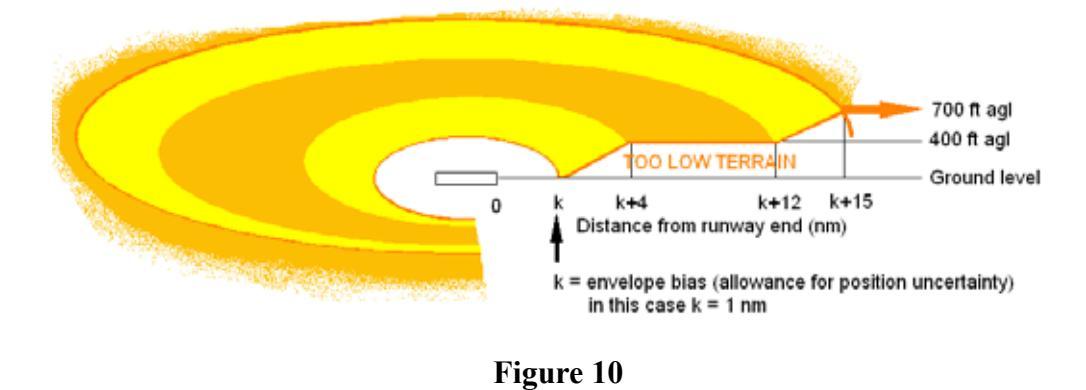
The EGPWS alert envelope that covers the PDA requirement is called the Terrain Clearance Floor (TCF). This alerts against insufficient terrain clearance for any given distance from the runway. The TCF alert envelope for the installed system is illustrated Figure 10. Penetration of this stationary envelope by the aircraft results in a "TOO LOW TERRAIN" caution.

The TCF alert envelope for the standard of EGPWS fitted.

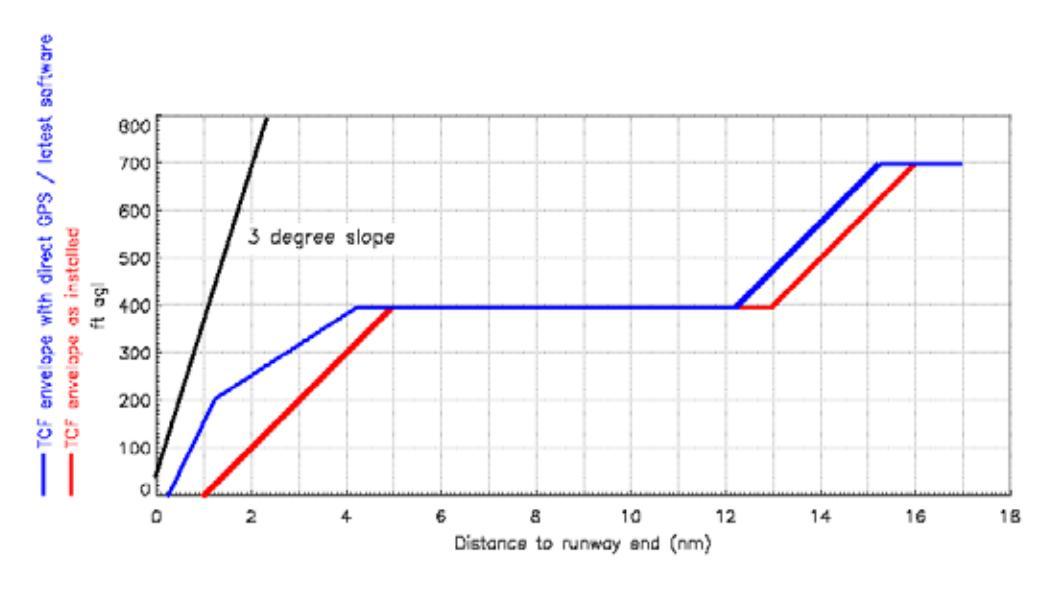
The actual boundary is shown in more detail in Figure 11 together with the alert envelope that would have been active had the latest software and a GPS direct link been installed in G-MEDG. These were not current requirements and were not available at the time of initial installation. Penetrating below these alert envelopes would result in a "TOO LOW TERRAIN" alert.

The TCF alert envelope.

A direct data link from the GPS would allow alert/warning boundaries to operate up to <sup>1</sup>/<sub>4</sub> nm from the runway instead of the 1 nm in use on non-GPS aircraft. Using an FMS as the EGPWS positional sensor, even if the FMS is using a GPS feed, does not provide uniform results across the large spread of FMS products being flown and is subject to the vagaries of the many different radio aid environments at airfields. Other solutions that feed GPS data to the EGPWS via other systems also increase the chances of data being corrupted and a common mode sensor failure proliferating errors across the aircraft systems. Non-GPS installations are more prone to nuisance alerts due to lateral and vertical positional errors. This provides a higher rate of nuisance warnings to flight crews, potentially resulting in a lack of appropriate reactions to alerts and/or routine inhibiting of the look-ahead functions. Both issues negate the benefits that TAWS has to offer.

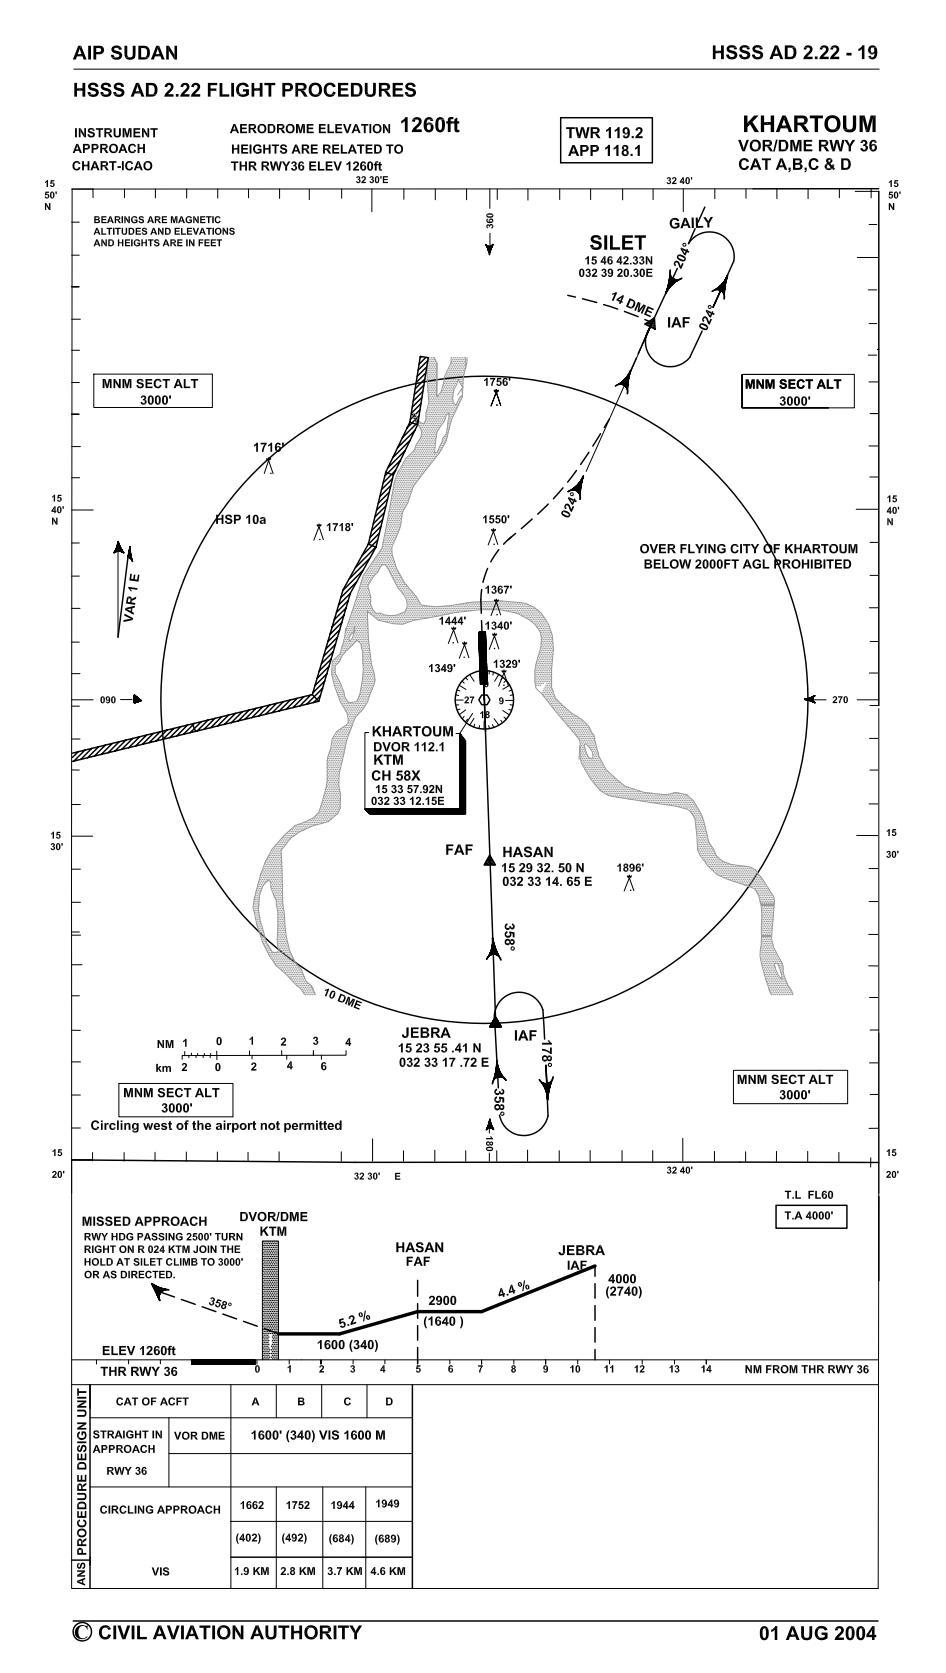
Extract from Sudan AIP 01 August 2004 for the KTM VOR/DME 36 approach

The operator was collecting feedback on the MNPA approaches flown by its pilots, but at the time of the incident, the management had neither implemented a system to check the information received nor had they acted upon any of it. The lack of such a system was not due to an oversight by the operator; the management's intention was to introduce a system at a later date as part of the approval process for conducting MNPA in IMC. It was considered that as the approaches were initially being flown only under VFR conditions, the implementation of a review system was not a priority. This decision represented another missed opportunity to identify the differences between the chart and the database.

Note that HASAN is shown 5 nm from the runway but also labelled as 5 nm from the DME, positions 0.6 nm apart
