## AIRCRAFT ACCIDENT REPORT NO 2/90

### REPORT ON THE ACCIDENT TO BOEING 747-121, N739PA AT LOCKERBIE, DUMFRIESSHIRE, SCOTLAND ON 21 DECEMBER 1988

**No:** 10/90      **Ref:** EW/G90/08/21      **Category:** 1a

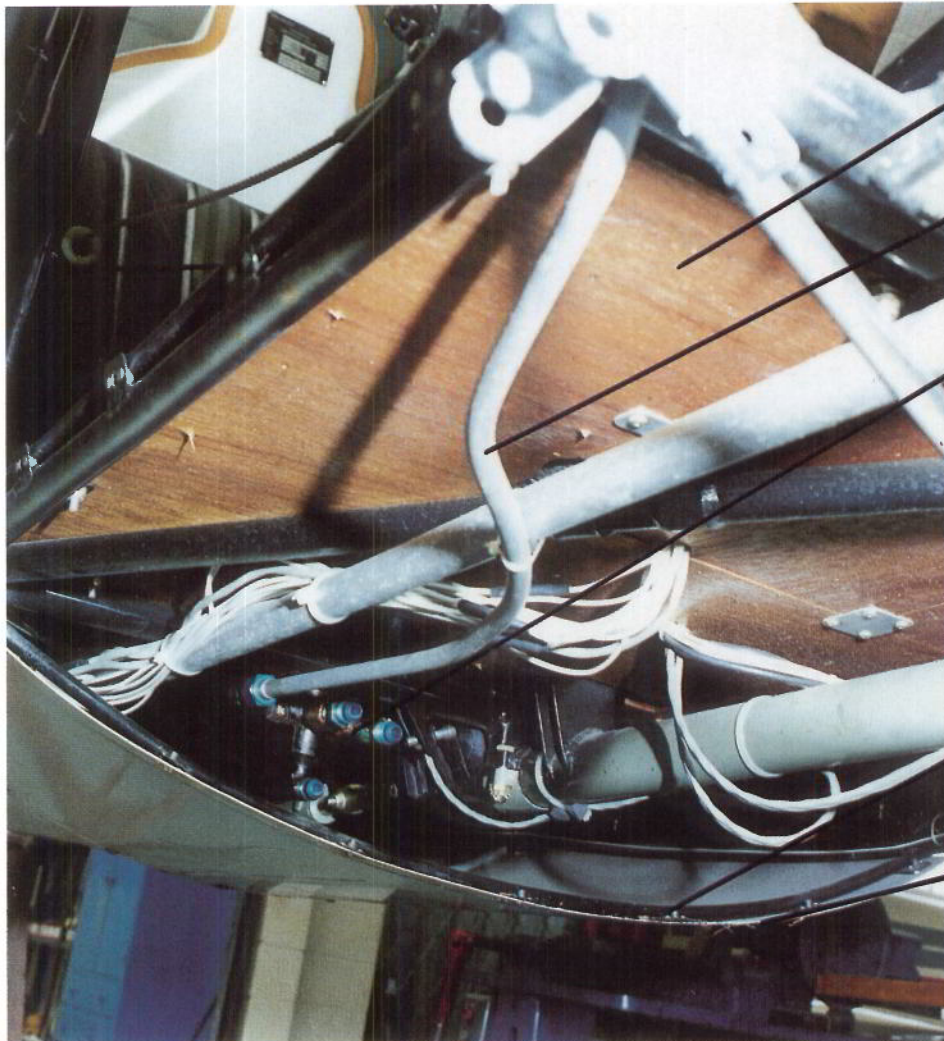
FIG 3

Seat Pan

Pipeline (three others absent)

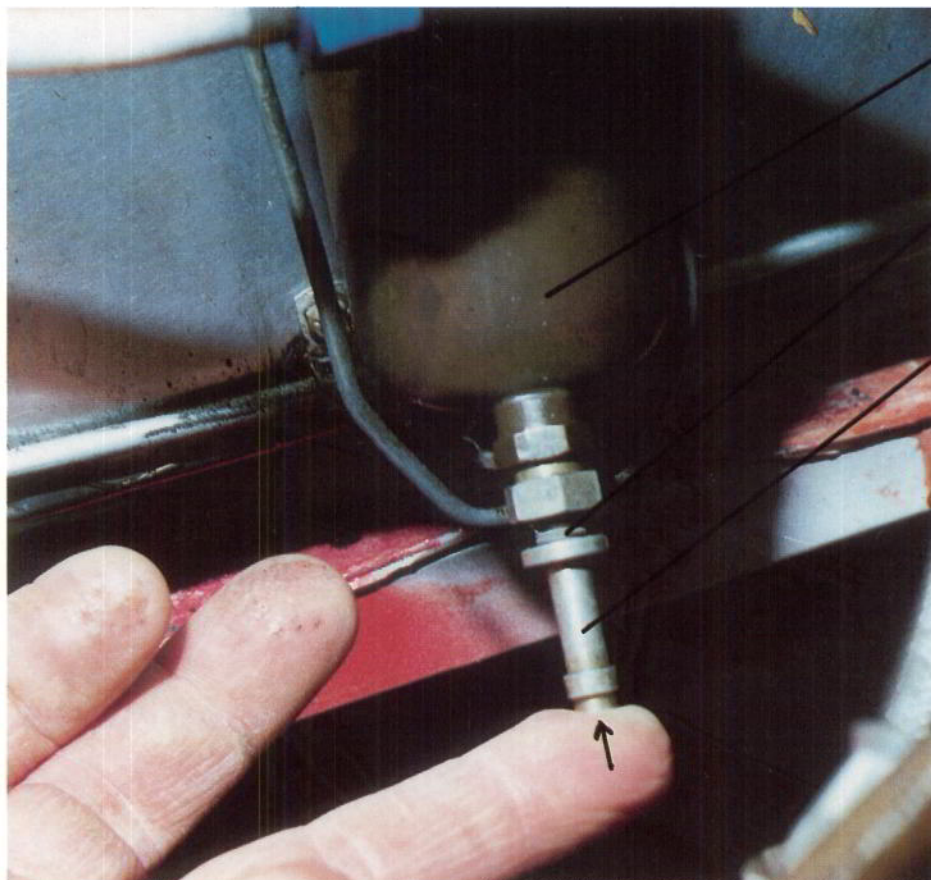
FIG 5

It was also noted that a fuel filter located in the engine bay was situated low down on the engine bay bulkhead and incorporated a water drain that protruded below the bowl and hence below the fuselage main structural framework (Fig 5). The drain was of the spring loaded plunger type, opened by a light upward push with no twisting action required. In a case where the aircraft belly contacted the ground and the fuselage undersurface fairing distorted, the drain appeared vulnerable to being opened (Fig 6) or wiped off as a result of ground contact. In the case of G-BOBT the drain remained intact and it was probable that the fuel release noted after the accident had resulted from the drain valve being opened and held open by ground contact. It could not be established whether the fuel cock had indeed been selected off before evacuation, but no additional fuel system damage was reported.

Fuel Filter  
Bowl

Spring
