SERIOUS INCIDENT

Aircraft Type and Registration: Airbus A330-343, G-VKSS

Location: On departure from Orlando International Airport, USA

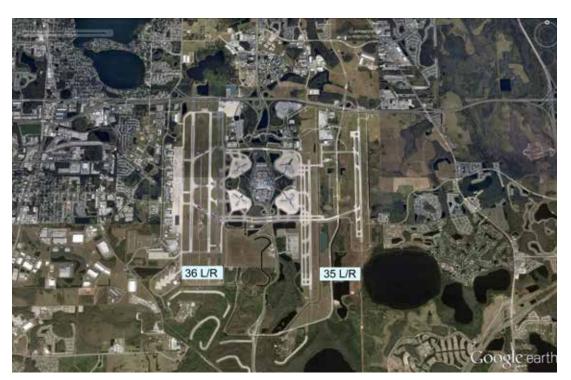
Figure 1Orlando International Airport

During 2011 there were 317,020 aircraft movements. 115 aircraft were struck by birds of which arriving aircraft accounted for 72% of the strikes. The majority of strikes (44%) occurred on Runway 17L/35R, 22% on Runway 17R/35L, 22% on Runway 18L/36R and 12% on 18R/36L. Approximately 66% occurred on the eastern airport complex which is considerably less developed than the western complex (Figure 1).
