INCIDENT

Aircraft Type and Registration:	Airbus A340-311, 4R-ADB	
No & Type of Engines:	4 CFM56-5C2 turbofan engines	
Category:	1.1	
Year of Manufacture:	1994	
Date & Time (UTC):	26 June 2005 at 0913 hrs	
Location:	School Hill Lane, Wargrave, Berkshire	
Type of Flight:	Public Transport (Passenger)	
Persons on Board:	Crew - 14	Passengers - 304
Injuries:	Crew - None	Passengers - None
Nature of Damage:	Damage to right inboard flap, No 3 flap fairing and No 3 engine exhaust nozzle	
Commander's Licence:	Air Transport Pilot's Licence	
Commander's Age:	54 years	
Commander's Flying Experience:	17,000 hours (of which 5,760 were on type) Last 90 days - 223 hours Last 28 days - 48 hours	
Information Source:	AAIB Field Investigation

Synopsis

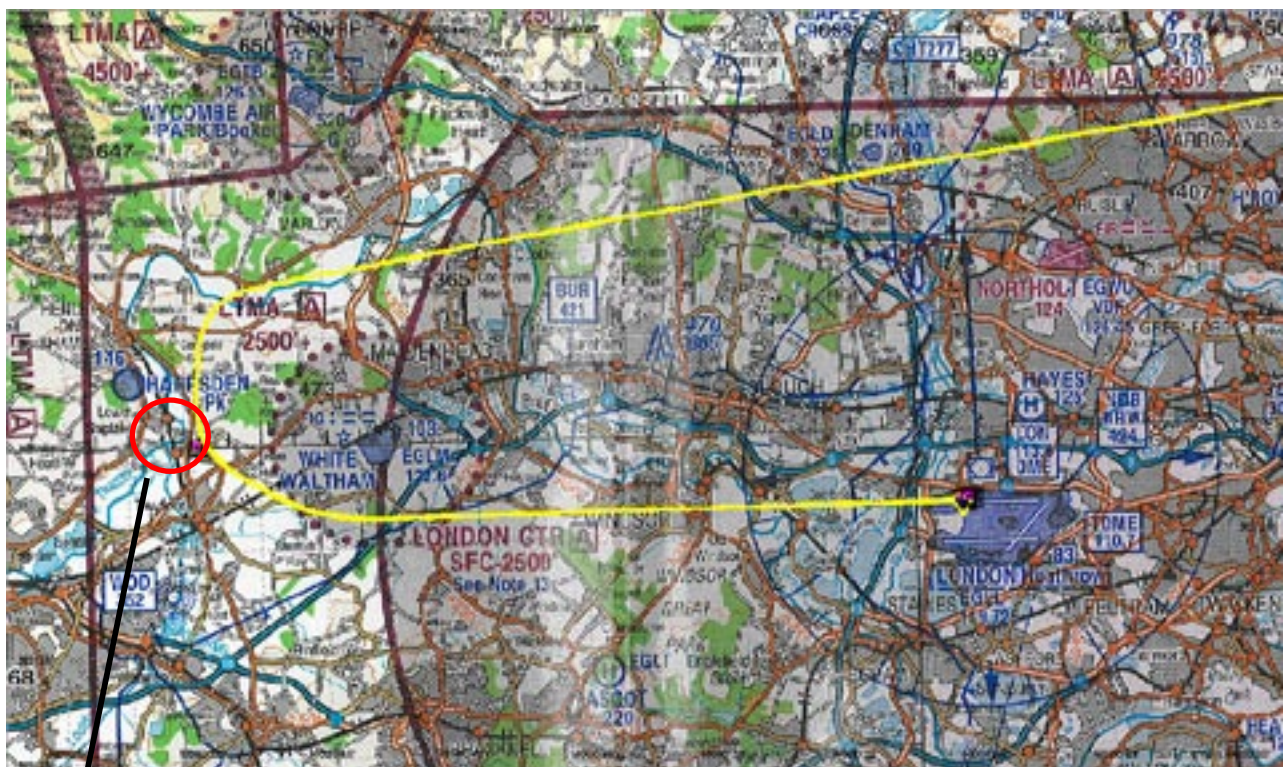
Figure 2

With this knowledge, an organisation based at LHR which maintain Airbus A340 aircraft was contacted. This revealed that a Sri Lankan Airbus A340-311, registration 4R-ADB, had been in their facility on 27 June 2005 for 'ad hoc' maintenance as one of its lower flap fairing attachment fittings was missing and required replacement. Repair of damage to the right wing inboard flap, the No 3 flap track fairing and No 3 engine was also required.

Wargrave

From the nature of the damage it was evident that the No 3 flap track fairing attachment fitting had departed the aircraft via the rear of the fairing and, in the process, made contact with the trailing edge of the inboard flap. Fortunately, it landed in an unoccupied wooden outbuilding albeit in a relatively highly populated area.
