AAIB Bulletin No: 3/94

Ref: EW/C94/1/5

Aircraft Type and Registration: Challenger, N585UC

Location: Block 94B, London Heathrow Airport

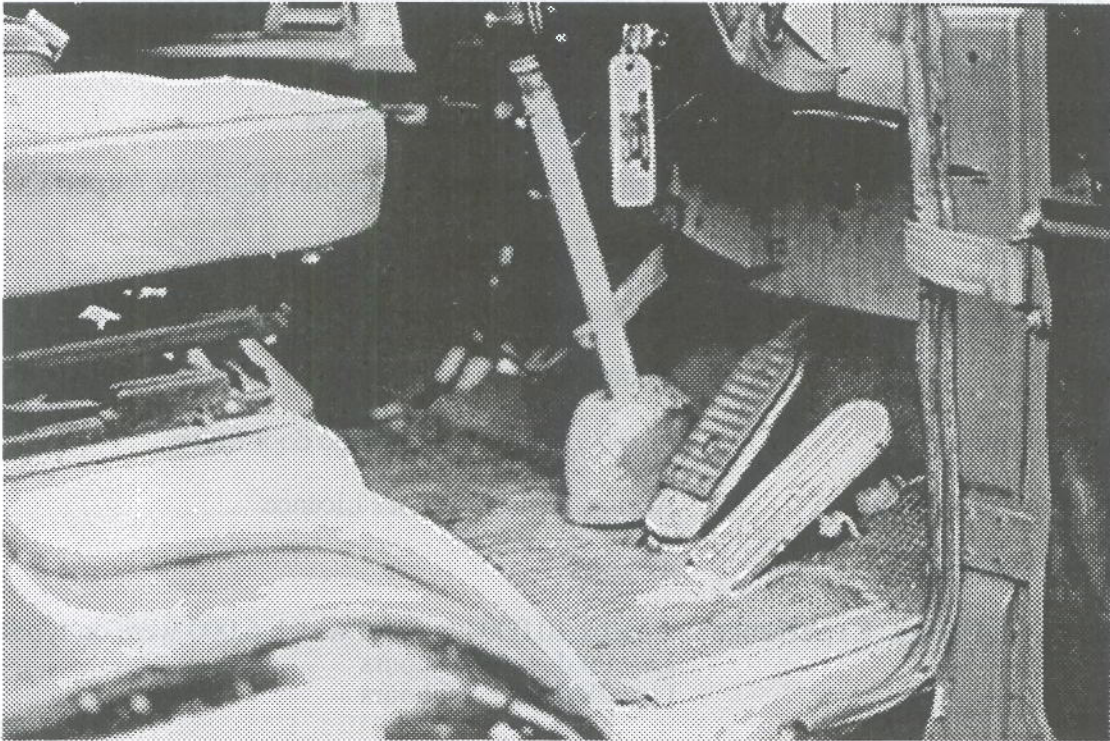
The driver's assistant guided the vehicle back to a halt adjacent to the aircraft, and then found that the hose was about an inch too short to connect with the aircraft. He restowed the hose on the vehicle and asked the driver to back up just a bit more; the vehicle then shot back, hitting the aircraft and trapping the assistant against the side. The driver attempted to drive forwards, but the vehicle did not disengage from the aircraft. When questioned later the driver stated that his foot had slipped off the brake.

The driver had received adequate training for his job, and the vehicle was serviceable for the task, however, the brake and accelerator pedals were close together, and the use of industrial safety boots reduced the amount of 'feel' available to the driver.
