BOARD OF TRADE

## CIVIL AIRCRAFT ACCIDENT

Report of the German Federal Office of Aviation  
relating to the re-opened Inquiry into the Accident  
to BEA Ambassador (Elizabethan) Aircraft G - ALZU  
on 6th February 1958 at Munich Riem Airport  
and

Royal Aircraft Establishment, Farnborough,  
memorandum on "Application of the Results of  
Slush Drag Tests on the Ambassador to the Accident  
at Munich" submitted as evidence to the Inquiry

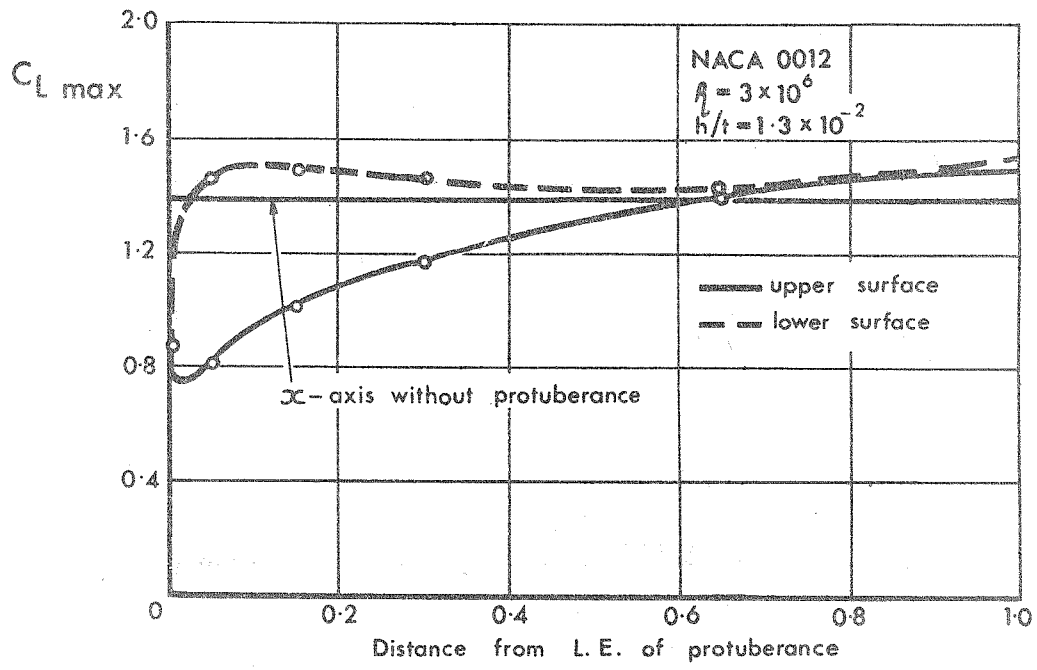
FIG. 8

References [7] and [8] show that protuberances on the upper surface of a section have a much greater effect on lift and drag than do protuberances on the lower surface. This is understandable since the effect of protuberances on the aerodynamic characteristics of a wing is undoubtedly dependent on the local velocity (of the airflow) on the upper surface of the section. Figure 8 shows that according to measurements

Abb. 12 Sensitivity of various wing sections to protuberances

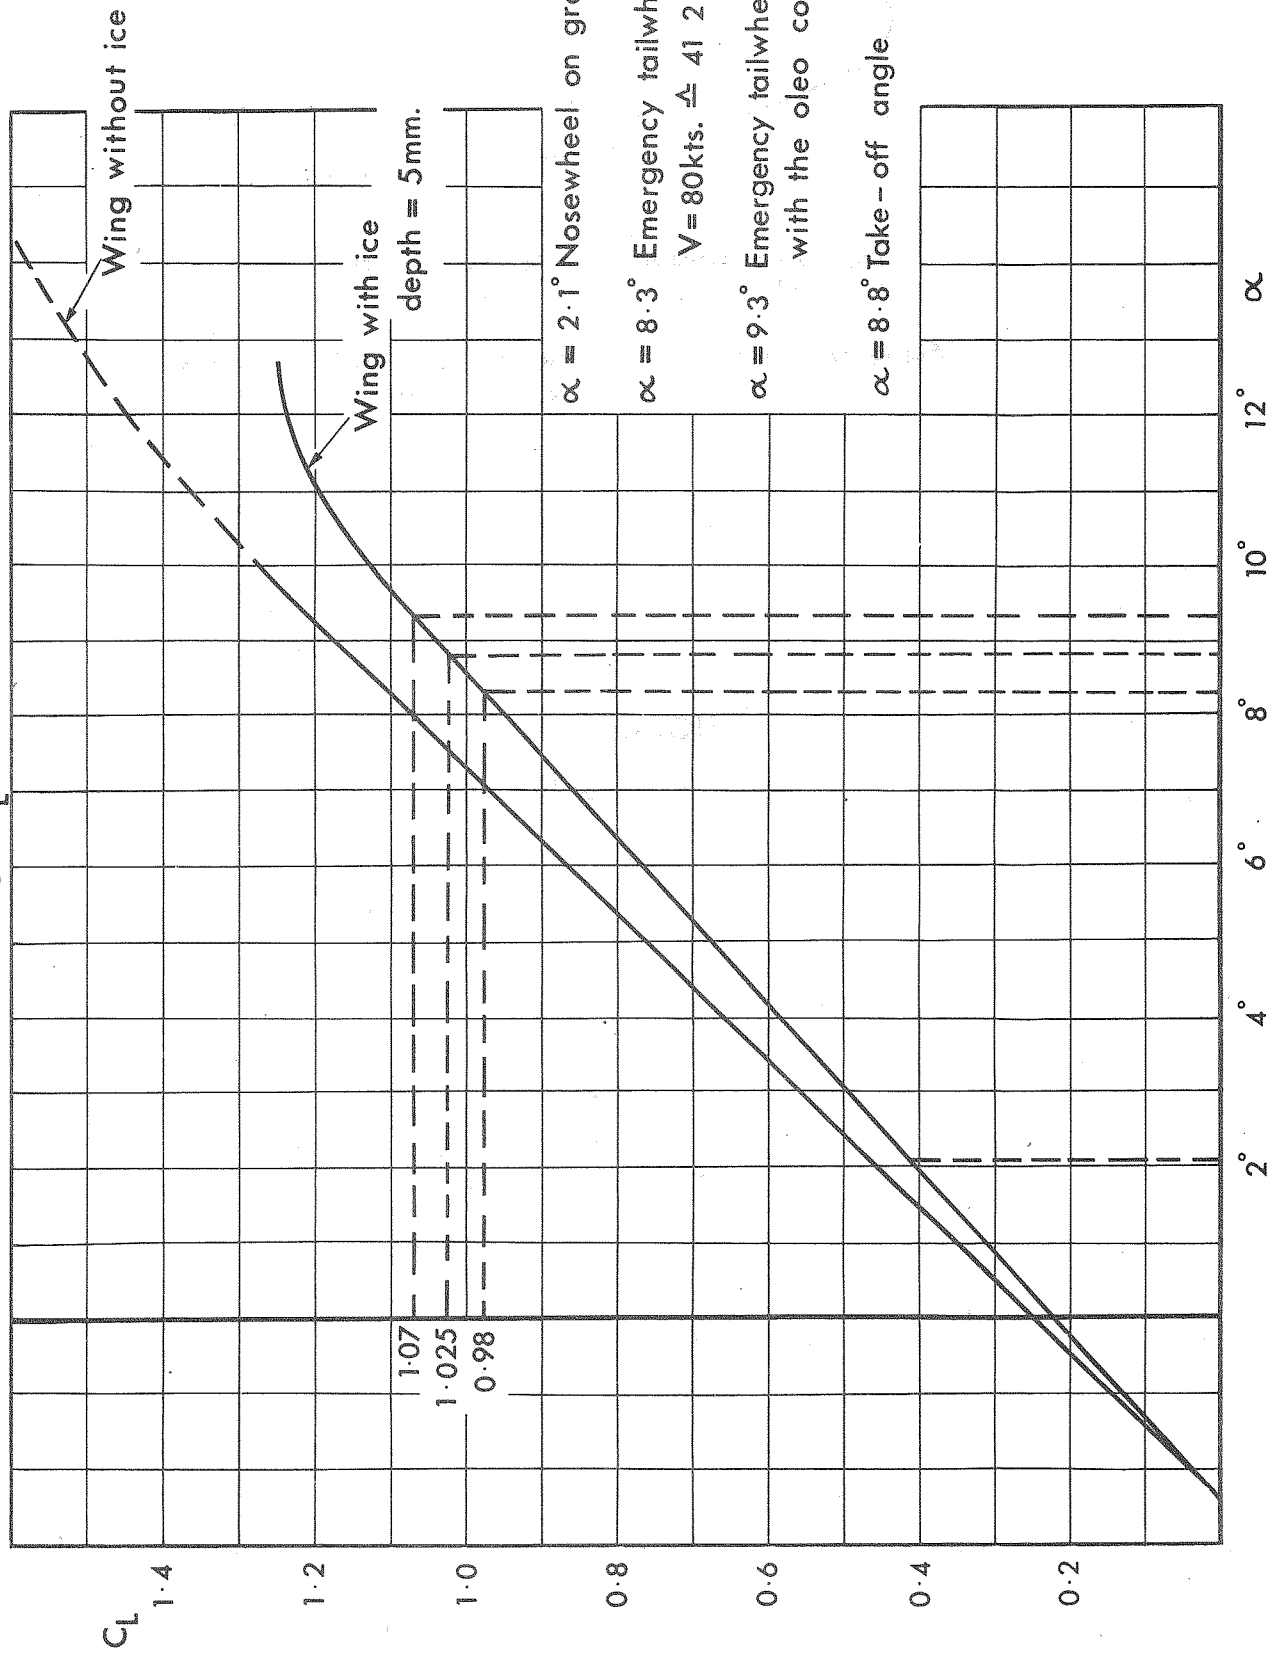
FIG. 9

As already explained, it is to be assumed that at least 45% of the wing upper surface was iced (Figure 1). On the basis of all the material, it appears justifiable to assume that the effect of wing icing on lift during the fatal take-off by G-ALZU was not as great as it would have been in the case of totally iced-up wings but was as shown in Figure 9.

VARIATION OF  $C_L$  WITH  $\alpha$

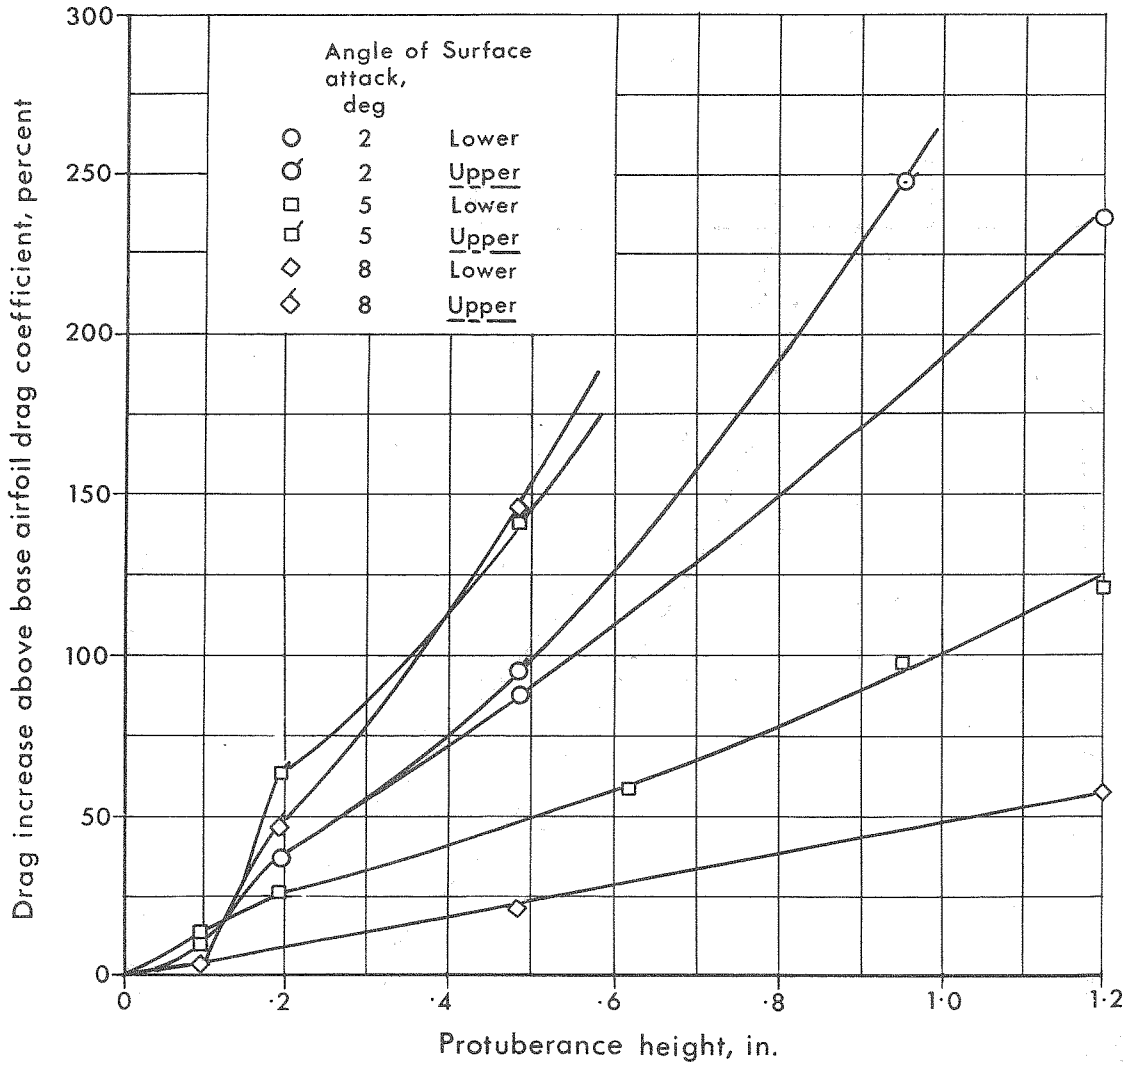
FIG.11

It was therefore possible to use the results of the aforementioned report, in the absence of any more precise data, as an indication of the drag to be assumed for G-ALZU in an iced-up state. It can be assumed that, given ice on 45% of the wing upper surface, the drag increase is at least equal to half the drag increase occurring with an upper-surface roughness (height 5 mm.) corresponding to that in Figure 10 at approximately 15% of wing chord (Figure 11).

(c) Protuberance location, 15-percent-chord station.

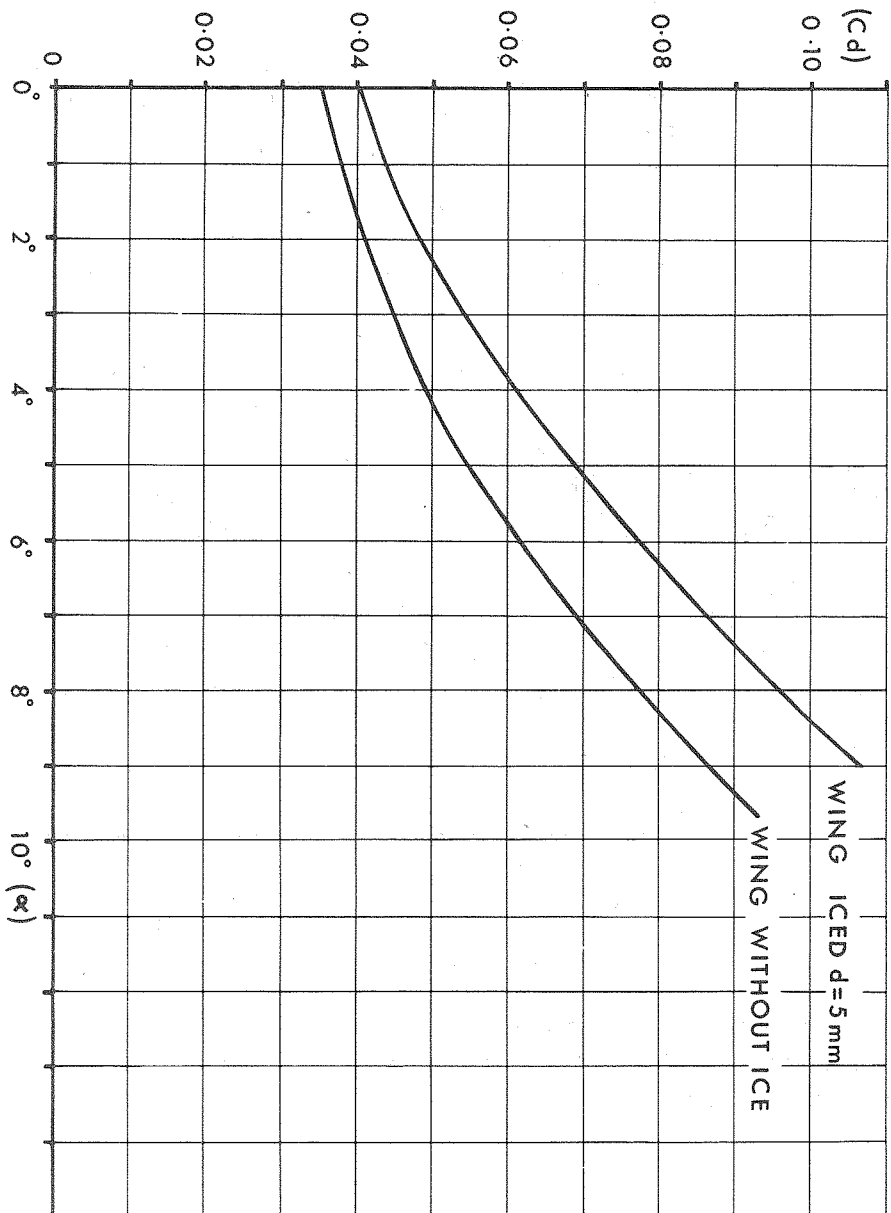
FIG 12

For an angle of incidence of 2.1 degrees there is an increase in the drag coefficient from  $C_D = 0.0415$  to  $C_D = 0.049$ . This means a  $\Delta C_D$  of 18%. With an angle of incidence of 8.8 degrees  $\Delta C_D$  amounts to approximately 23.5%. The drag coefficient increases from  $C_D = 0.085$  for the clean wing to  $C_D = 0.105$  for an iced-up wing (Figure 12).

VARIATION OF  $C_D$  WITH  $\alpha$

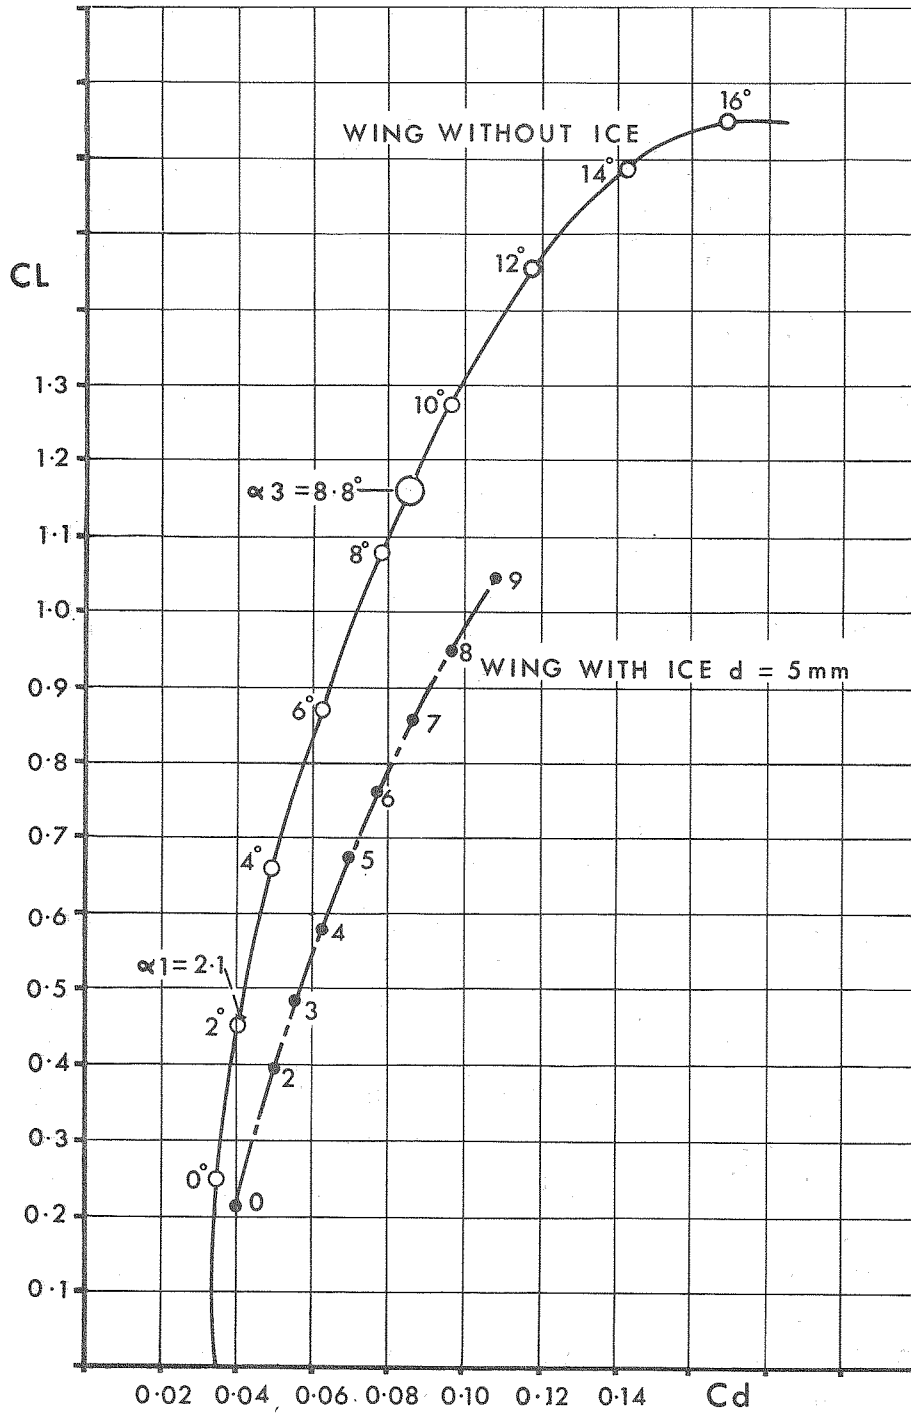
FIG 13

On the basis of the investigations set out in the report and assuming a degree of icing corresponding to that in Figure 1 and an ice thickness of 5 mm., variation of lift and drag with angle of incidence can be taken to be as shown in Figure 13; i.e. at the maximum unstick angle with icing, as

LIFT/DRAG POLARS FOR GALZU

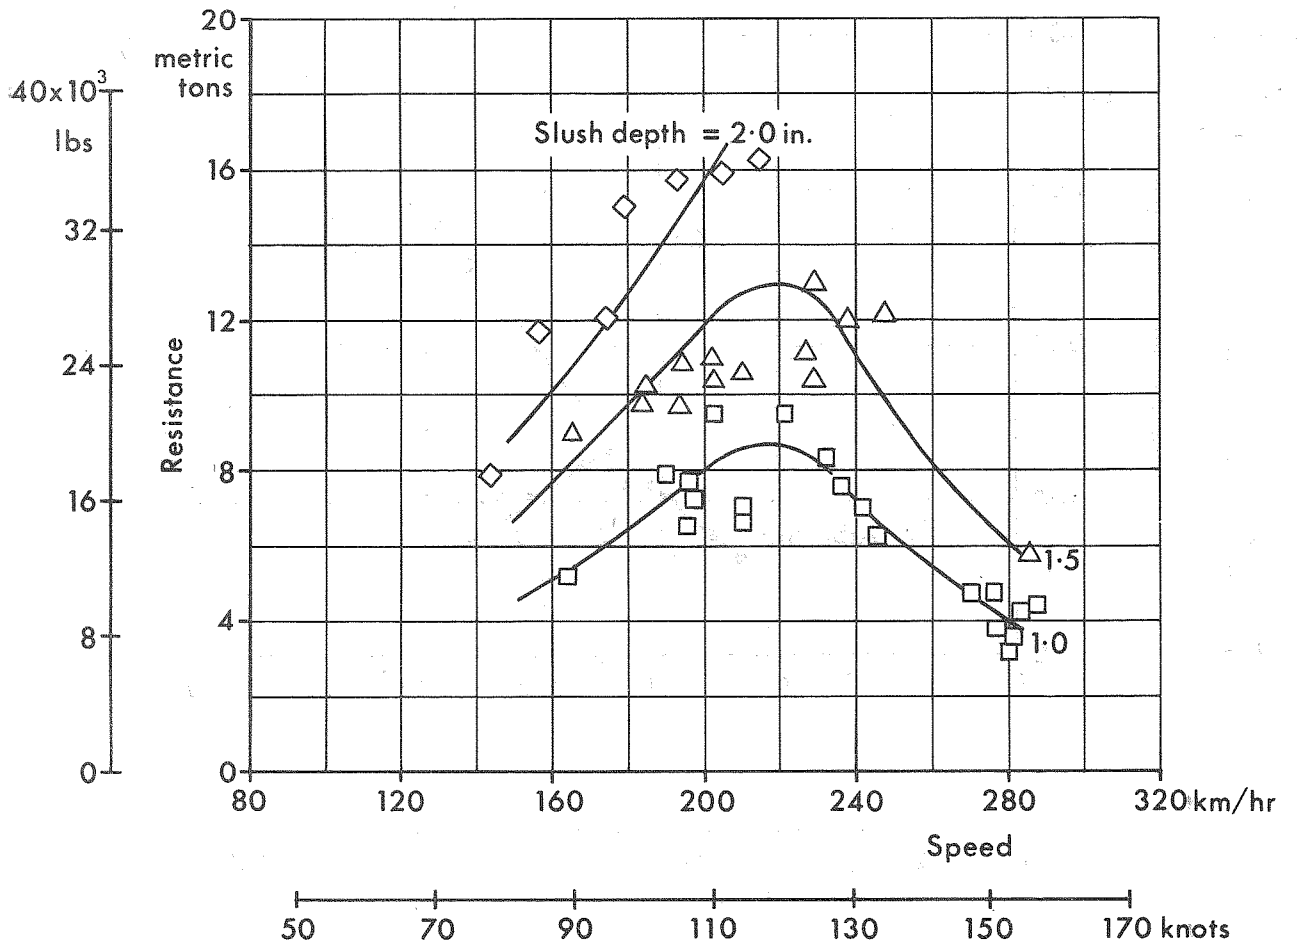
FIG.15

The results appear also to be in general agreement with tests and comments by the FAA in the U.S.A. [11]. Of most value for purposes of comparison are the tests on a Convair 880M. These were, it is true, carried out within a higher speed range, but they did confirm the basic effect on drag of the various parameters in particular that of the rolling speed and slush depth (Figures 15 and 16).

Variation with speed of the drag of the Convair 880M at different slush depths.

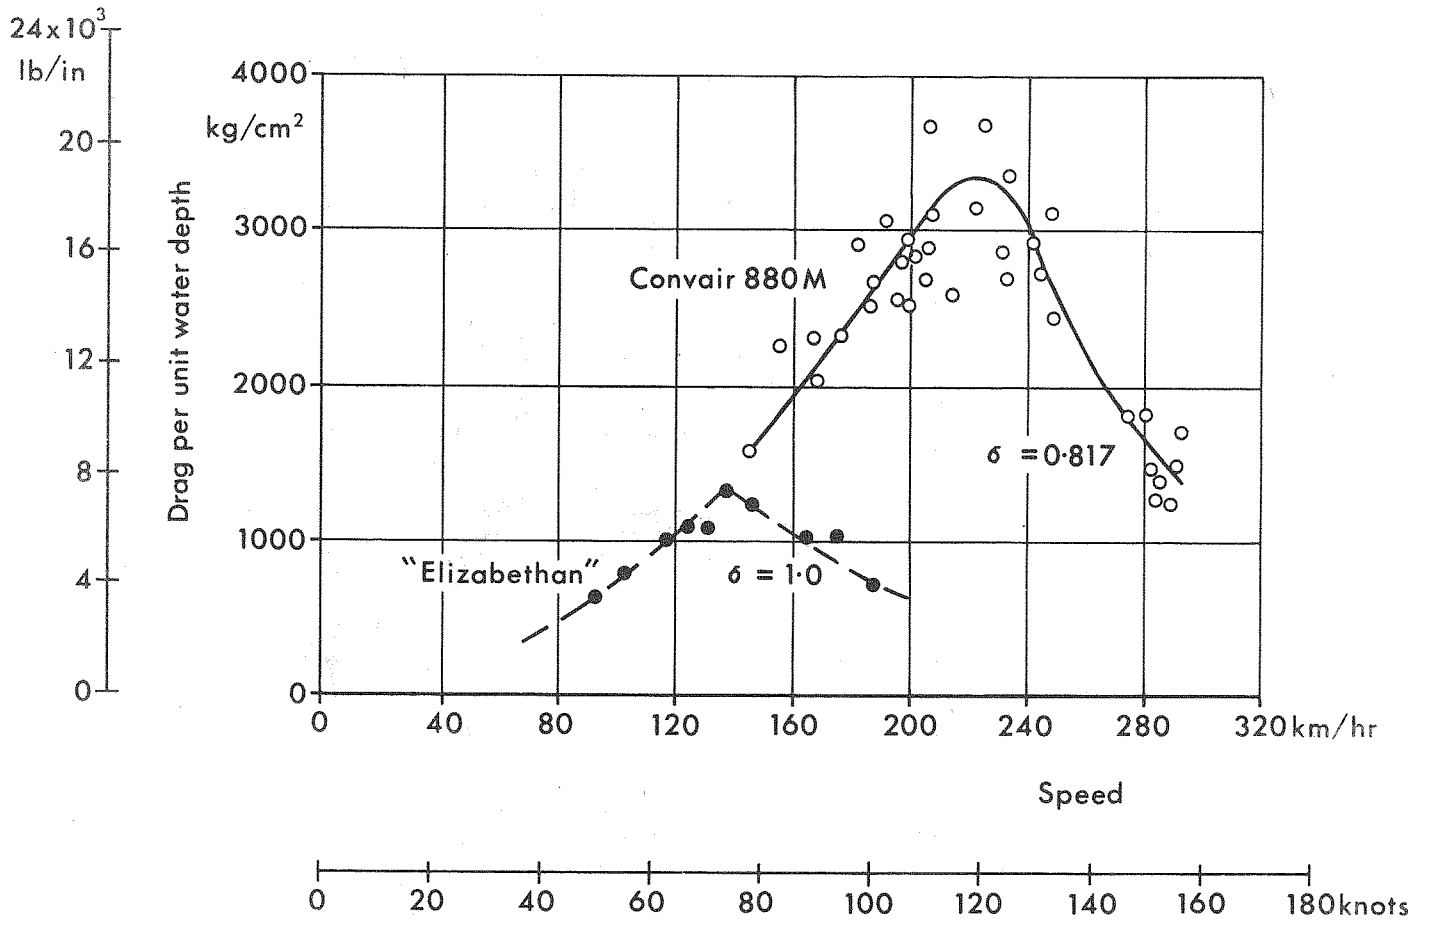
FIG.16

Drag per unit water depth as a function of speed.

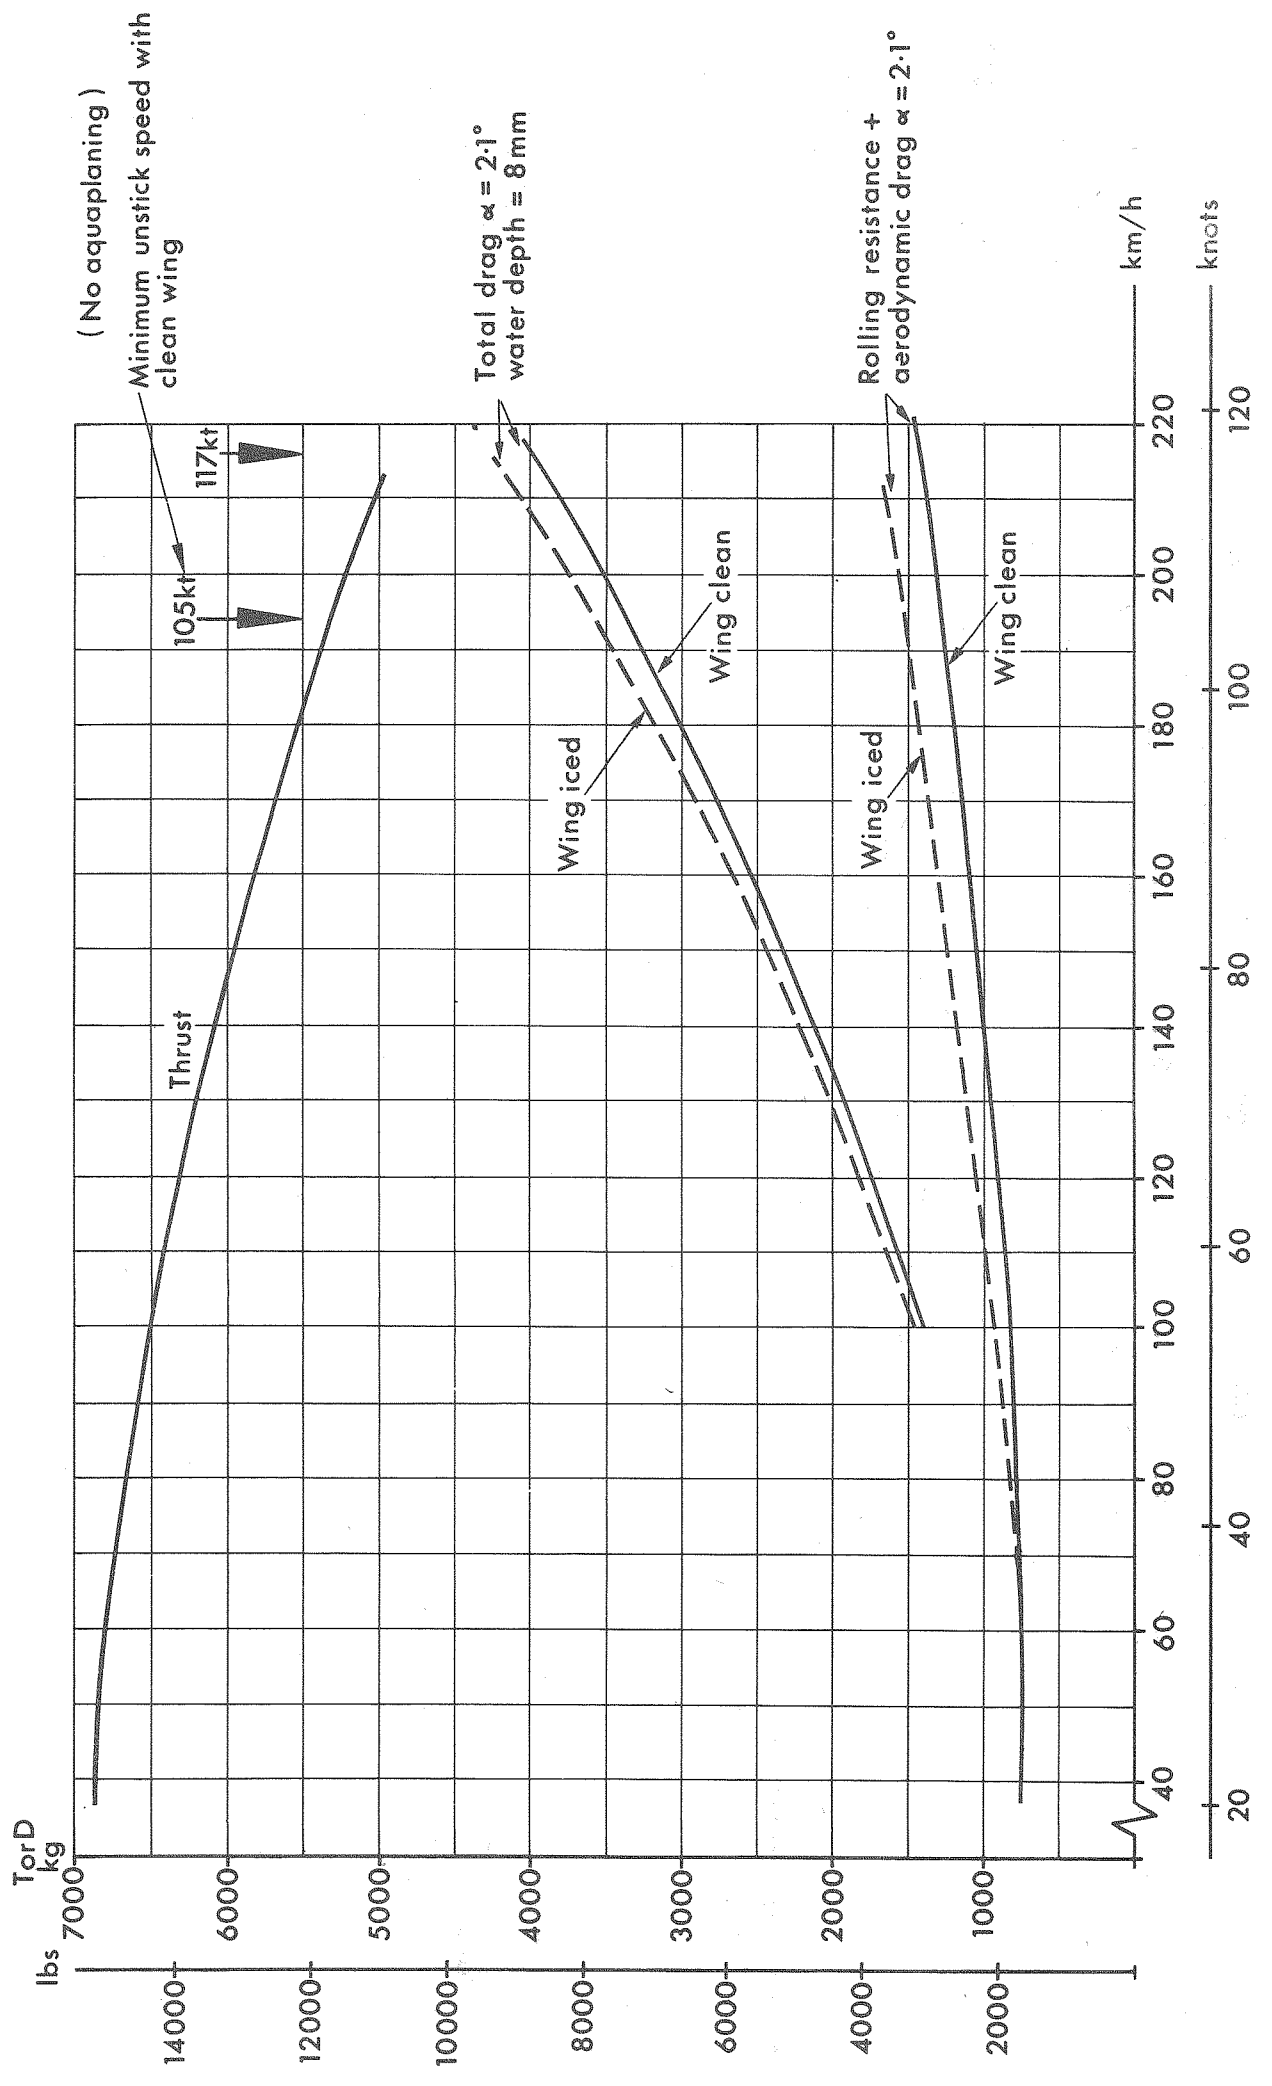
**FIG. 19**

Extrapolating slush drag in accordance with Figure 14 beyond 140 km/h. (75 kt), the margin of performance in the speed range above about 185 km/h. (100 kt), as shown in Figures 19 and 20 diminishes considerably.

VARIATION OF THRUST AND DRAG AT  $\alpha = 2.1^\circ$

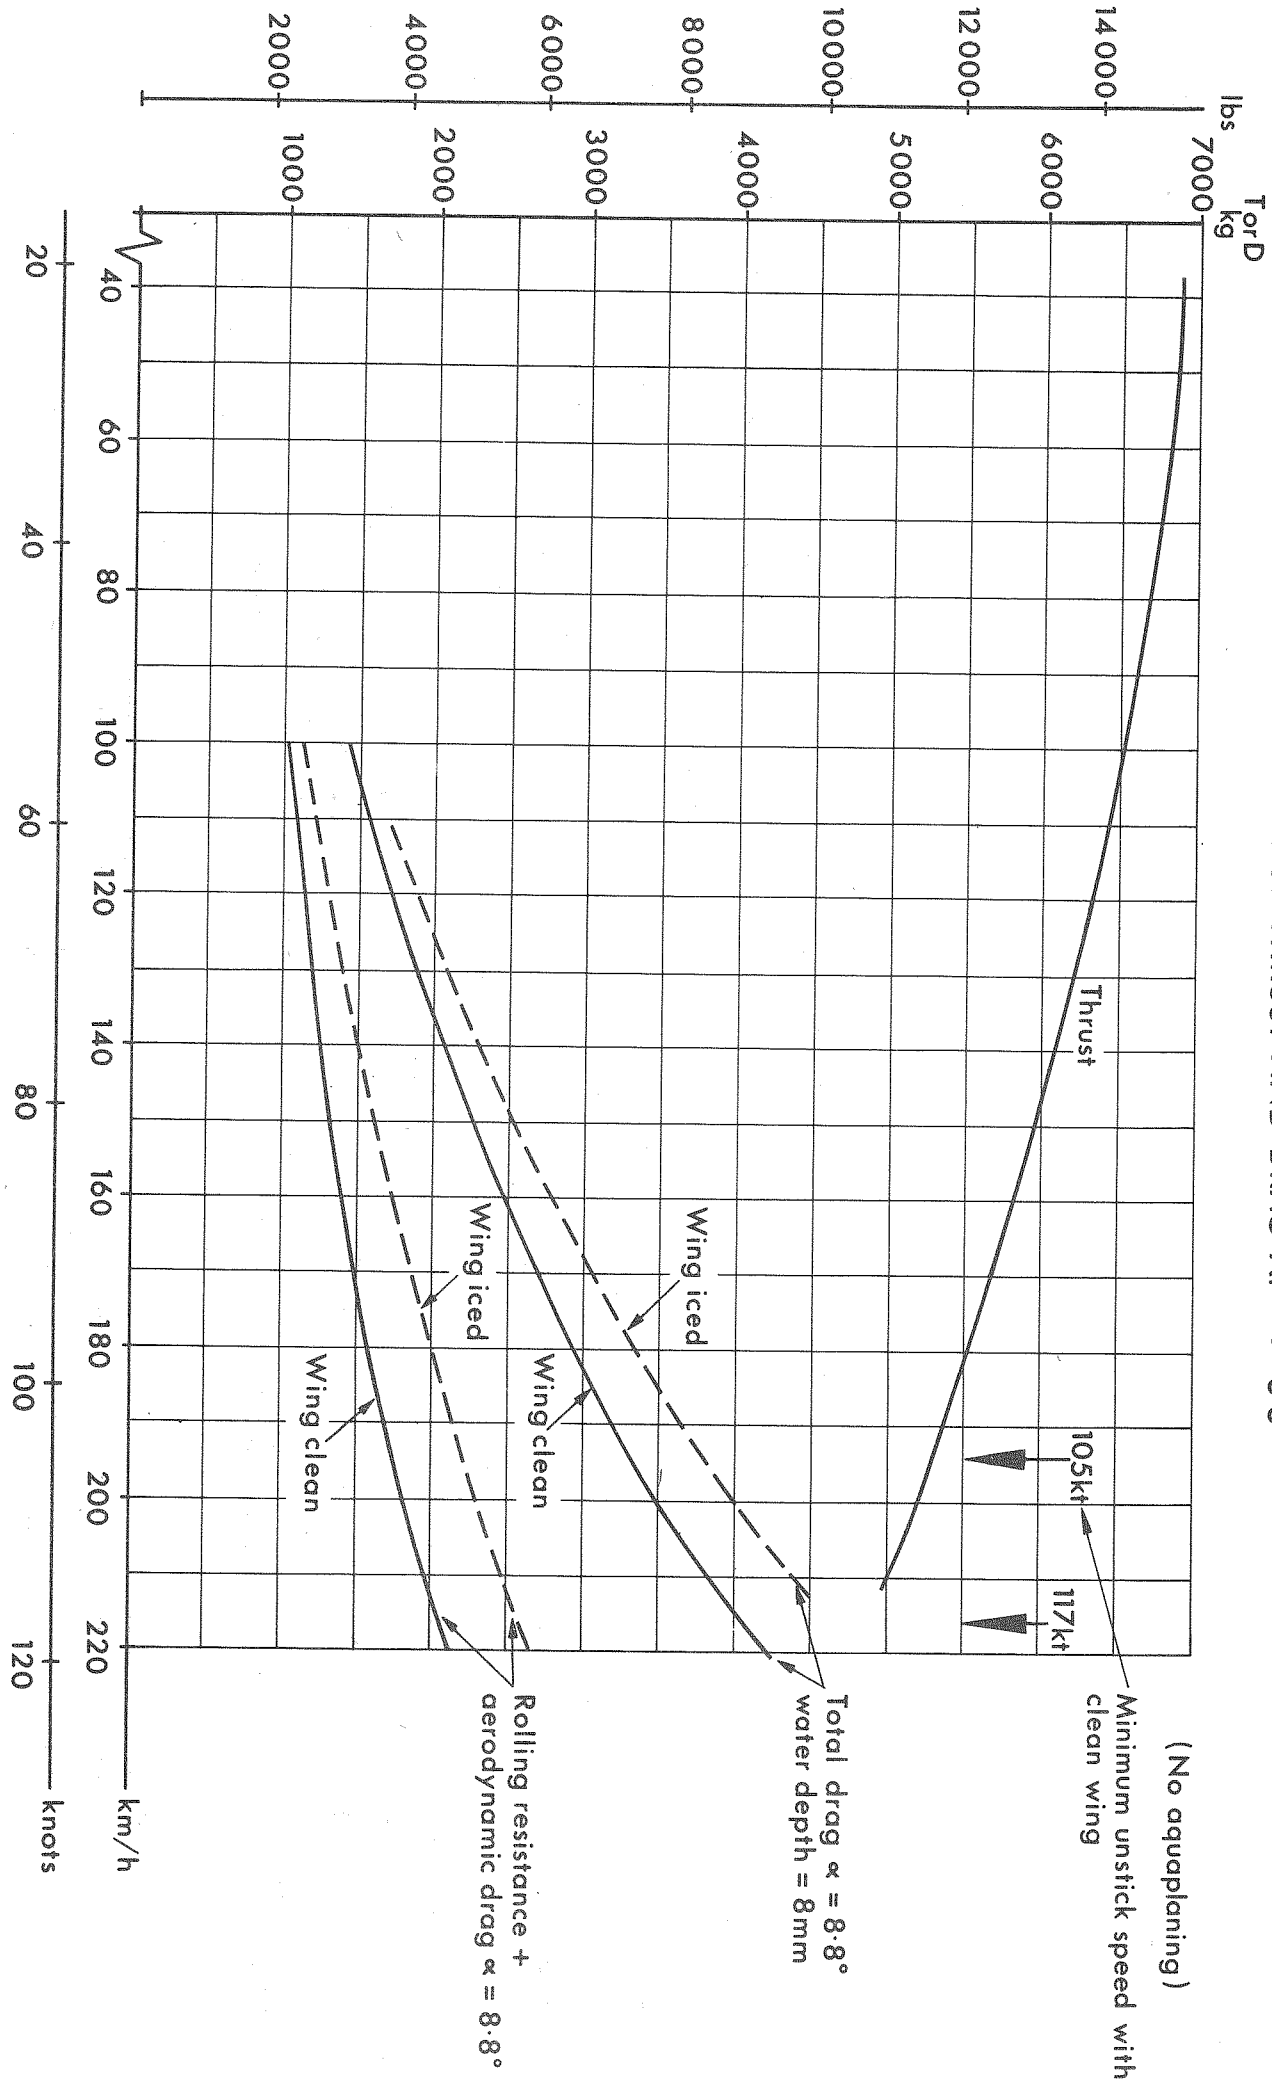
VARIATION OF THRUST AND DRAG AT  $\alpha = 8.8^\circ$
