Pegasus XL-Q Microlight, G-MWOX

AAIB Bulletin No: 3/2004	Ref: EW/C2003/05/01	Category: 1.4
Aircraft Type and Registration:	Pegasus XL-Q Microlight, G-MWOX	
No & Type of Engines:	1 Rotax 462 piston engine	
Year of Manufacture:	1991	
Date & Time (UTC):	7 May 2003 at 1710 hrs	
Location:	Fristling Hall Farm, Stock, Essex	
Type of Flight:	Private	
Persons on Board:	Crew - 1	Passengers - None
Injuries:	Crew - 1 (Fatal)	Passengers - N/A
Nature of Damage:	Aircraft destroyed	
Commander's Licence:	Private Pilot's Licence	
Commander's Age:	67 years	
Commander's Flying Experience:	168 hours (of which 22 were on type)	
	Last 90 days - 0 hours	
	Last 28 days - 0 hours	
Information Source:	AAIB Field Investigation

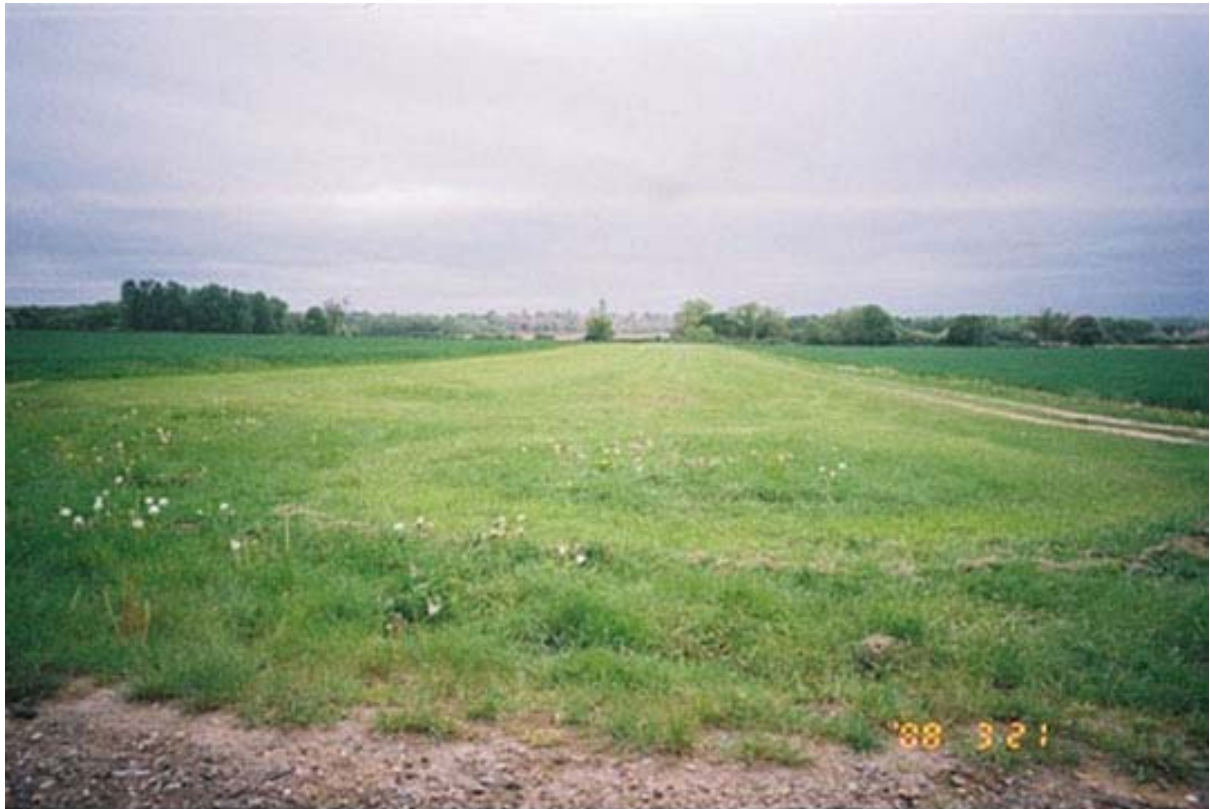
Figure 1

The pilot started microlight flying in 1988 and in 1992 became the owner of a Pegasus XL-R microlight. By 2001 he had accrued 97 hours on the type. The majority of this flying had been from the airstrip at London Colney (see Figure 1) located in a large field with good clearance from hedges and trees.

London Colney Airstrip
