REPORT ON: Re-evaluation of hub failure - Reference: A-Lab report #93-090805.

SAMPLE IDENTIFICATION: Fracture surfaces of Aluminum Hub
from PA 31-325 G-BMGH.

STRESS ANALYSIS OF PROPELLER HUB FOR FAILED PIPER ENGINE

During a flight on 7th June 1993, a Piper Navajo G-BMGH plane suffered the loss of one of the three propeller blades from the starboard engine. The blade loss was caused by a fracture through the hub at the root of the blade. The crack emanated by fatigue from the inner end of a grease nipple hole. A stress analysis of the hub containing this hole has been made assuming the predominant loading to be the centrifugal loading of the propeller blade. A high stress concentration is seen to exist at the crack propagation site. Another analysis is made when the grease nipple hole lies in the thicker flange region of the hub. There, a reduction in the stress concentration is observed. The results are obtained by three dimensional finite element analysis, from which stresses may be obtained at all locations in the hub. Thus, stresses away from stress raisers like the hole may be compared.

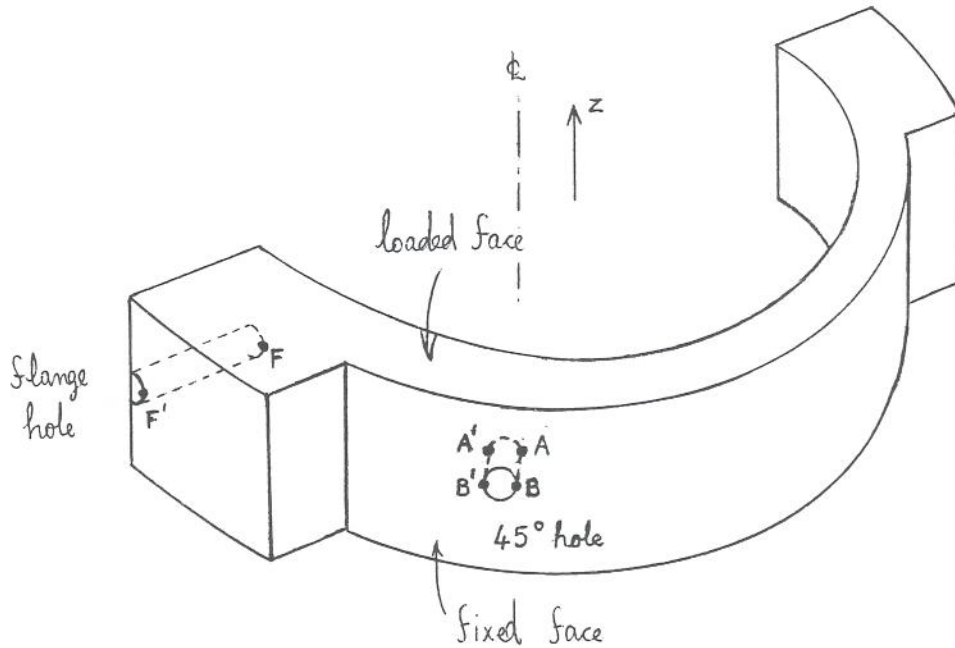
Figure 2 Three dimensional Hub Structure Used

Both three dimensional analyses modelled the hub and the thicker flange attachments in the regions where the two parts of the hub assembly were connected together. Only one half of the complete ring was modelled, assuming mirror-image symmetry. The first model included the grease nipple hole at 45° , and the second with the grease nipple hole in the flange on the axis of symmetry. Both placings of the holes are shown in the structure as analysed in figure 2. Although the actual flange holes are a few degrees above the symmetry plane, their analysis would have required a complete ring mesh which would have been unnecessarily expensive on model generation and computer time, and the key results would have been little different.
