Appendices

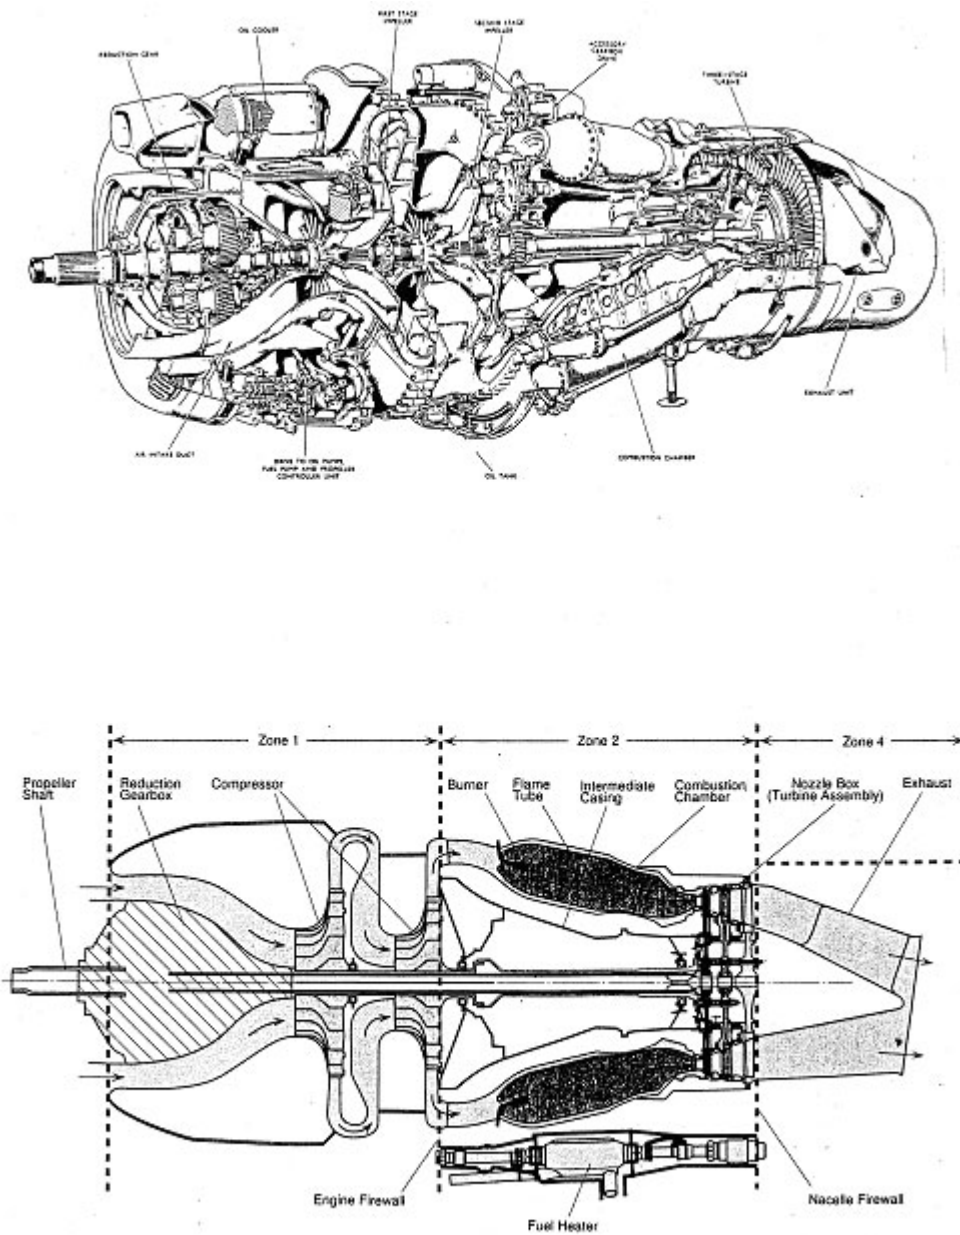
Figure 3 RR Dart Engine - Cutaway and schematic views

**RR DART ENGINE
CUTAWAY AND SCHEMATIC VIEWS**

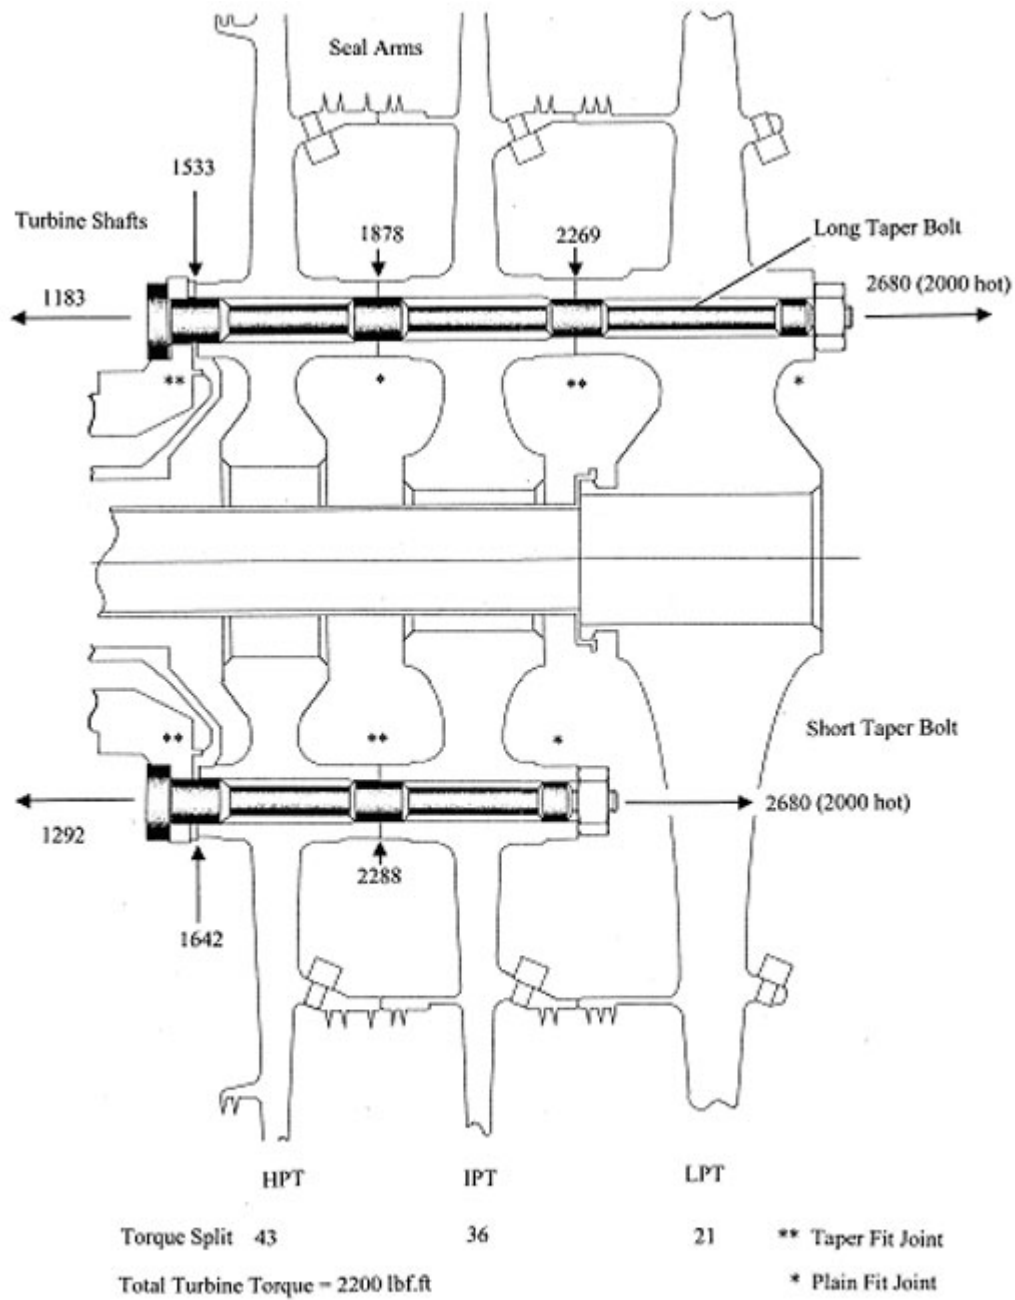
Figure 11 Taper locations in turbine assembly and loads analysis

TAPER LOCATIONS IN TURBINE ASSEMBLY AND LOADS ANALYSIS
