AAIB Bulletin No: 2/93

Ref: EW/C92/9/5

**Aircraft Type and Registration:** (1) McDonnell Douglas DC9 - 32, G-PKBE  
(2) Boeing 747-400, PP-VPG

**Location:** Runway 09R holding area at London Heathrow Airport

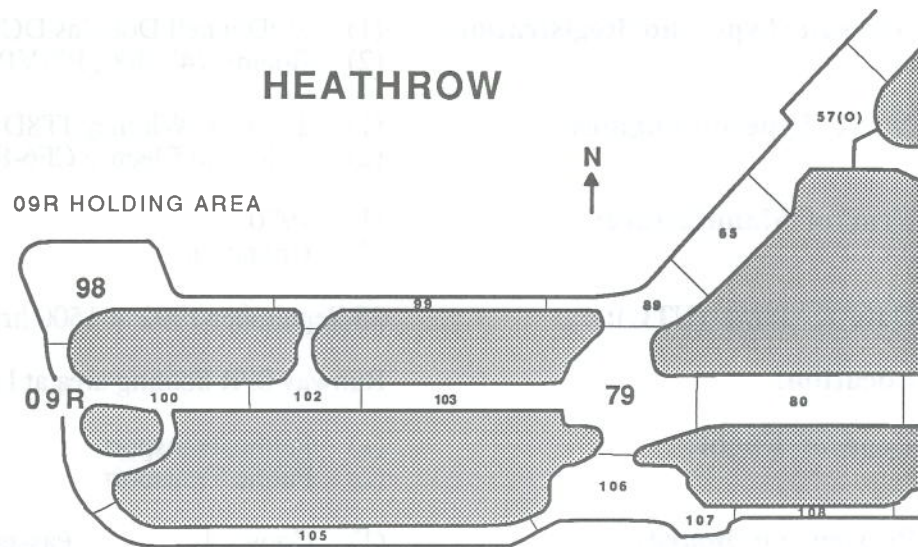
do not arrive at the threshold in the correct order for expeditious departure. A diagram of the relevant section of the airport with the block numbers is shown below.
