**ACCIDENT**

<b>Aircraft Type and Registration:</b>	Cessna T303 Crusader, G-PTWB
<b>No &amp; Type of Engines:</b>	2 Continental Motors Corp TSIO-520-AE piston engines
<b>Year of Manufacture:</b>	1984
<b>Date &amp; Time (UTC):</b>	5 August 2006 at 1810 hrs
<b>Location:</b>	Denham Green, Buckinghamshire
<b>Type of Flight:</b>	Private
<b>Persons on Board:</b>	Crew - 1                      Passengers - 5
<b>Injuries:</b>	Crew - 1 (Serious)      Passengers - 5 (Serious)
<b>Nature of Damage:</b>	Aircraft destroyed
<b>Commander's Licence:</b>	Private Pilot's Licence
<b>Commander's Age:</b>	60 years
<b>Commander's Flying Experience:</b>	1,717 hours (of which 662 hours were on type) Last 90 days - 37 hours Last 28 days - 5 hours
<b>Information Source:</b>	AAIB Field Investigation

**Synopsis**

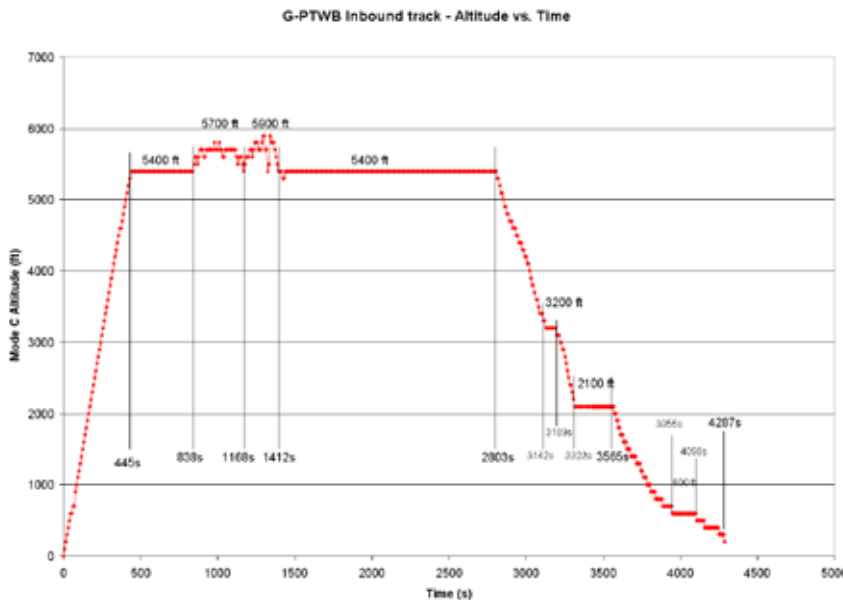
Figure 1

From the recorded radar data, the ground track of the aircraft and the vertical profile of the outbound and return flights were established. The ground track distance for the outbound flight was 196 nm and the return ground distance flown was 184 nm. This was a total increase of 24 nm over the planned distance of 178 nm. The flight profiles were plotted and used to estimate the outbound and return flight fuel consumption.
