<b>Aircraft Type and Registration:</b>	Hughes 369HS, G-CSPJ	
<b>No &amp; Type of Engines:</b>	1 Allison 250-C20 turboshaft engine	
<b>Year of Manufacture:</b>	1976	
<b>Date &amp; Time (UTC):</b>	19 July 2003 at 0849 hrs	
<b>Location:</b>	Cudham Lane South, Knockholt, Sevenoaks, Kent	
<b>Type of Flight:</b>	Private	
<b>Persons on Board:</b>	Crew - 1	Passengers - 2
<b>Injuries:</b>	Crew - 1 (Fatal)	Passengers - 2 (Fatal)
<b>Nature of Damage:</b>	Aircraft destroyed	
<b>Commander's Licence:</b>	Private Pilot's Licence	
<b>Commander's Age:</b>	39 years	
<b>Commander's Flying Experience:</b>	112 hours (of which 8 were on type) Last 90 days - 12 hours Last 28 days - 3 hours	
<b>Information Source:</b>	AAIB Field Investigation

### Synopsis

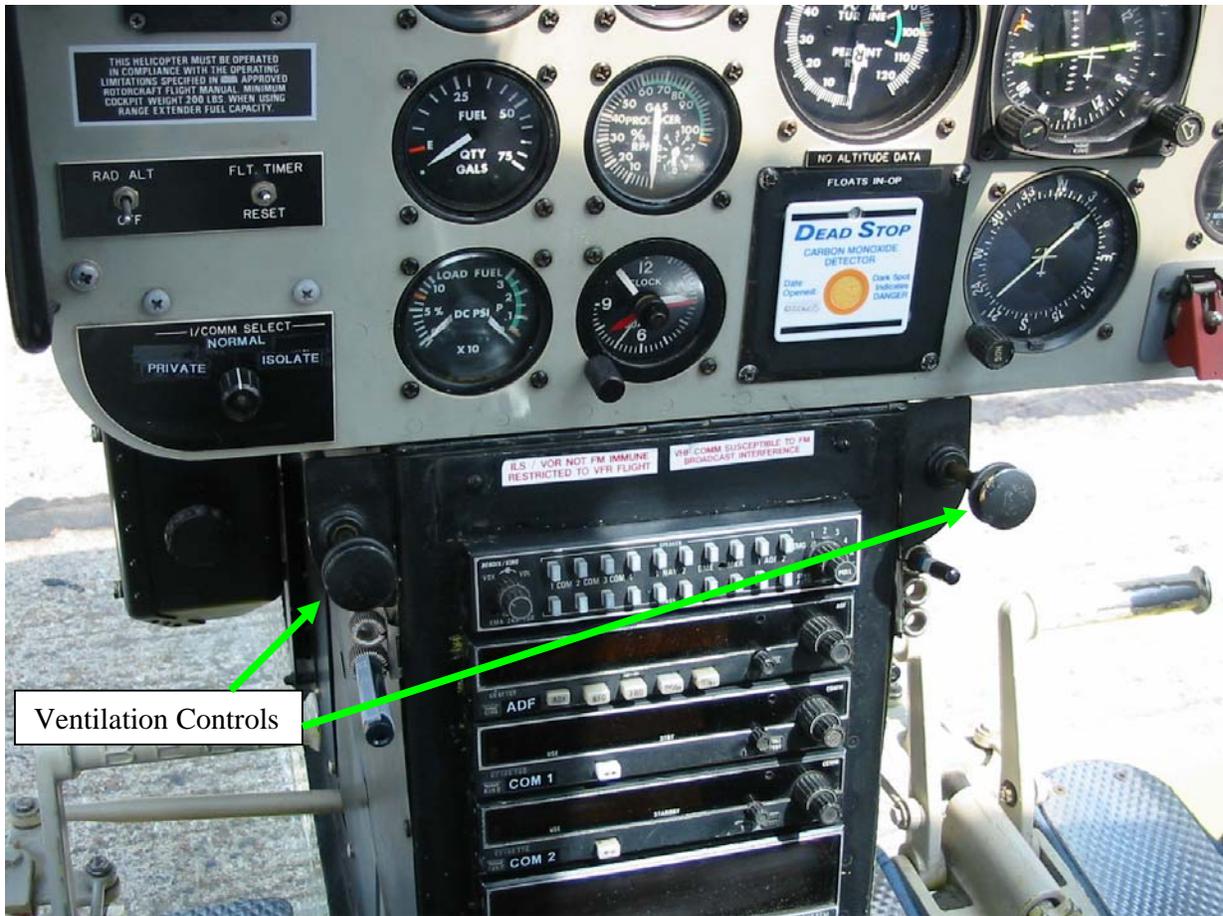
**Figure 4**  
(Instrument console – Hughes 369HS)

The fuel shut off valve is operated by a push-pull control on the left side of the instrument panel. The control, which is pulled out to close the valve, is in a similar but opposite position to the ventilation control on the right side of the panel (see Figure 4). In the Jet Ranger there are two ventilation controls and they are situated in comparable positions to the fuel shut off valve and the ventilation control in the Hughes (see Figure 5). Further, the shapes of the fuel shut off valve and the ventilation control in the Hughes are similar although the fuel shut off control is red in colour whereas the air vent control is black.
