CONTENTS – APPENDICES AND FIGURES

ACCIDENT TO DAN - AIR B Ae 748, G-ASPL, AT NAILSTONE, LEICS. ON 26 JUNE 1981
CORRECTED F.D.R. READOUT

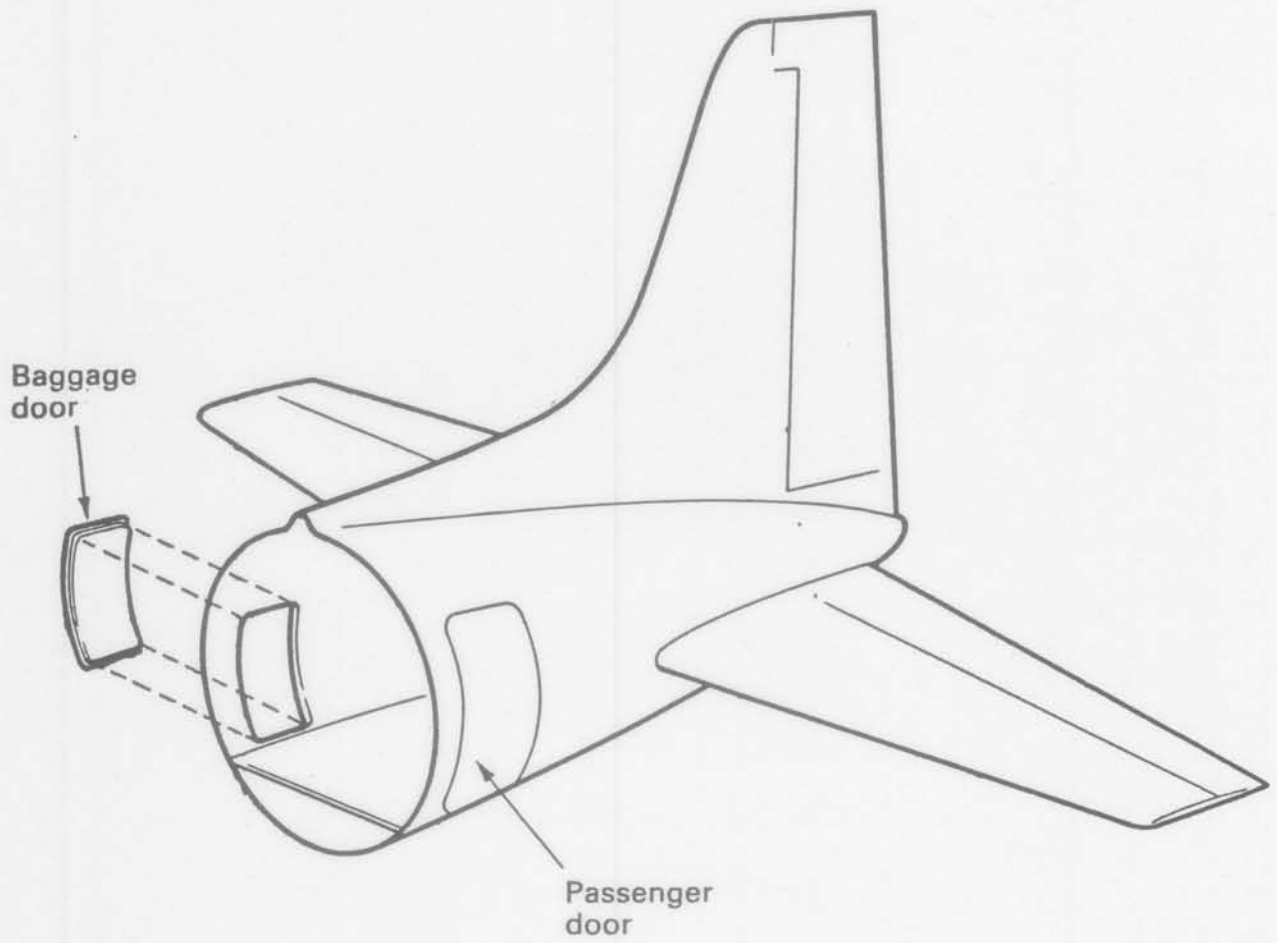
Figure 1 BAe 748

Position of doors at rear of aircraft

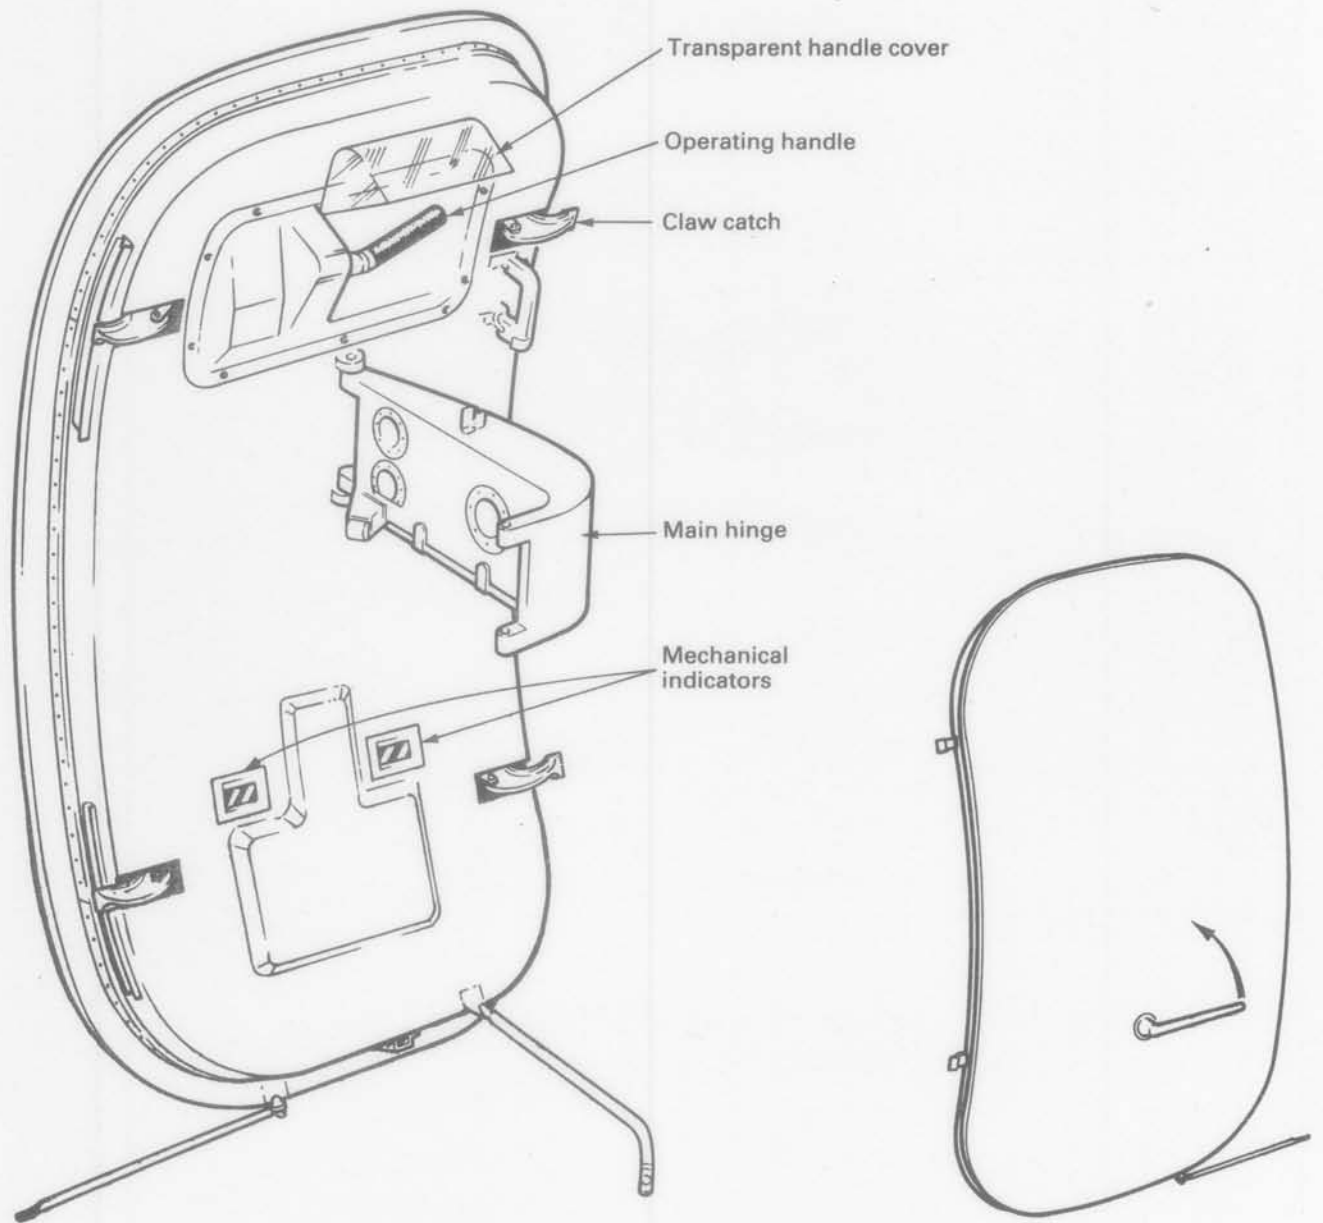
Figure 2 BAe 748-Baggage Door

General door illustration showing hinge and stays, with plastic door trim in position viewed from inside aircraft.

View from outside showing outside handle

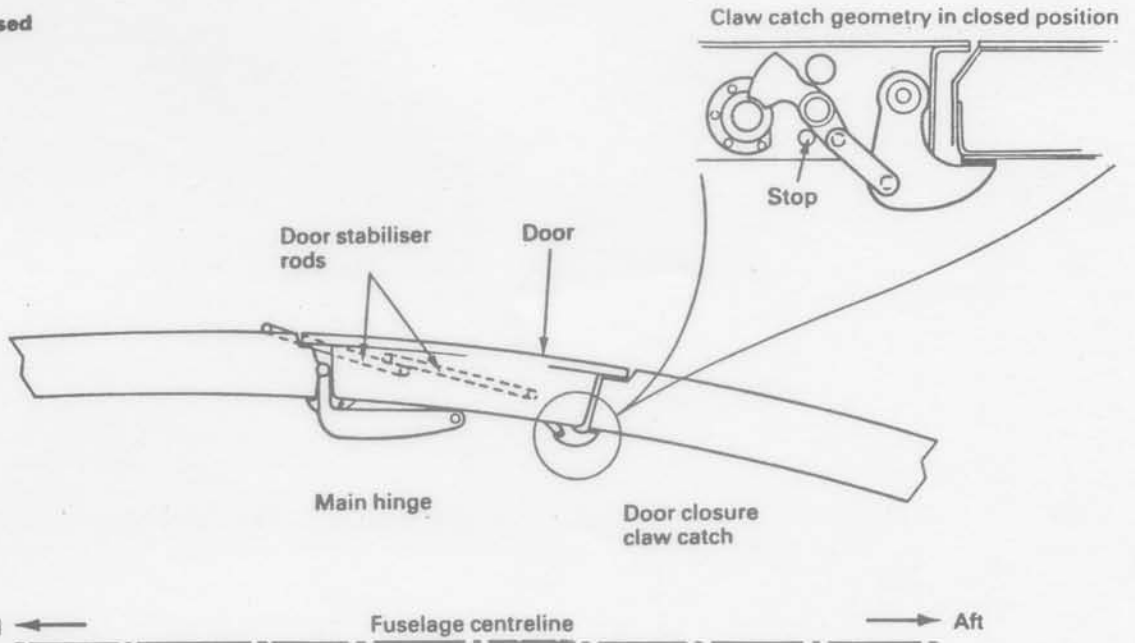
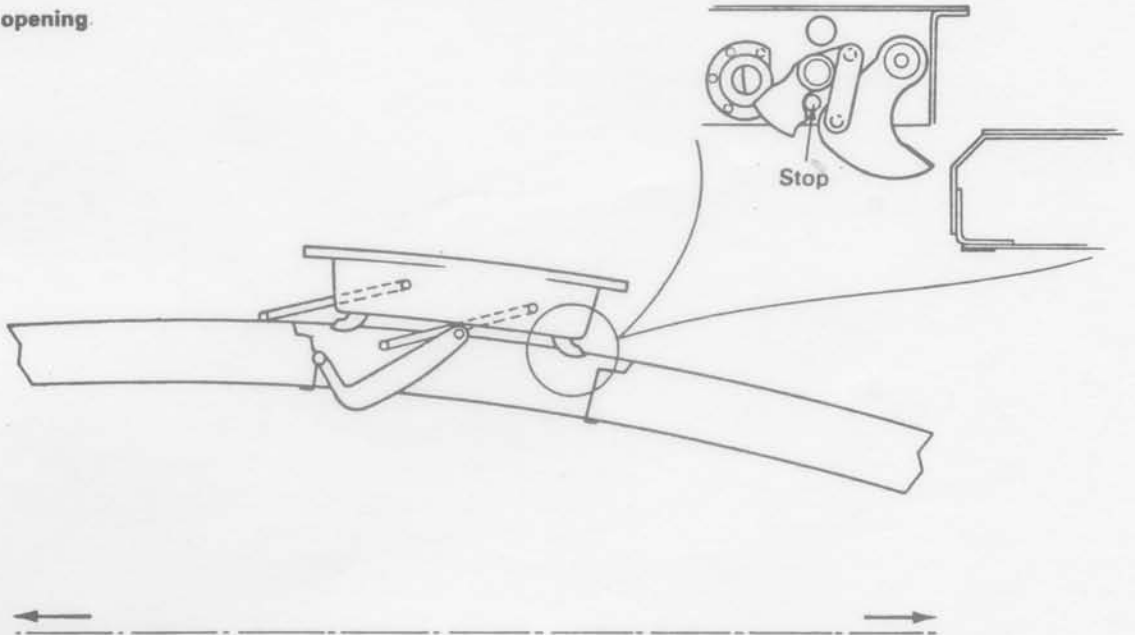
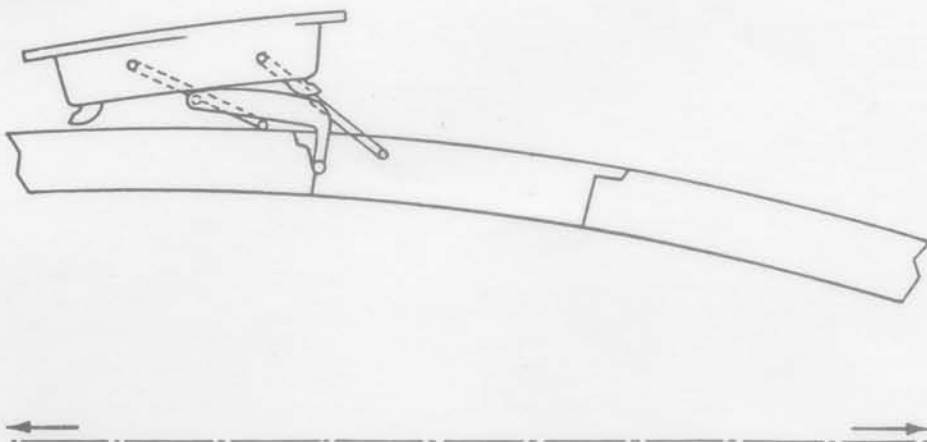
Plan view of door in closed, intermediate and open positions.
Figure 3 BAe 748-Baggage Door

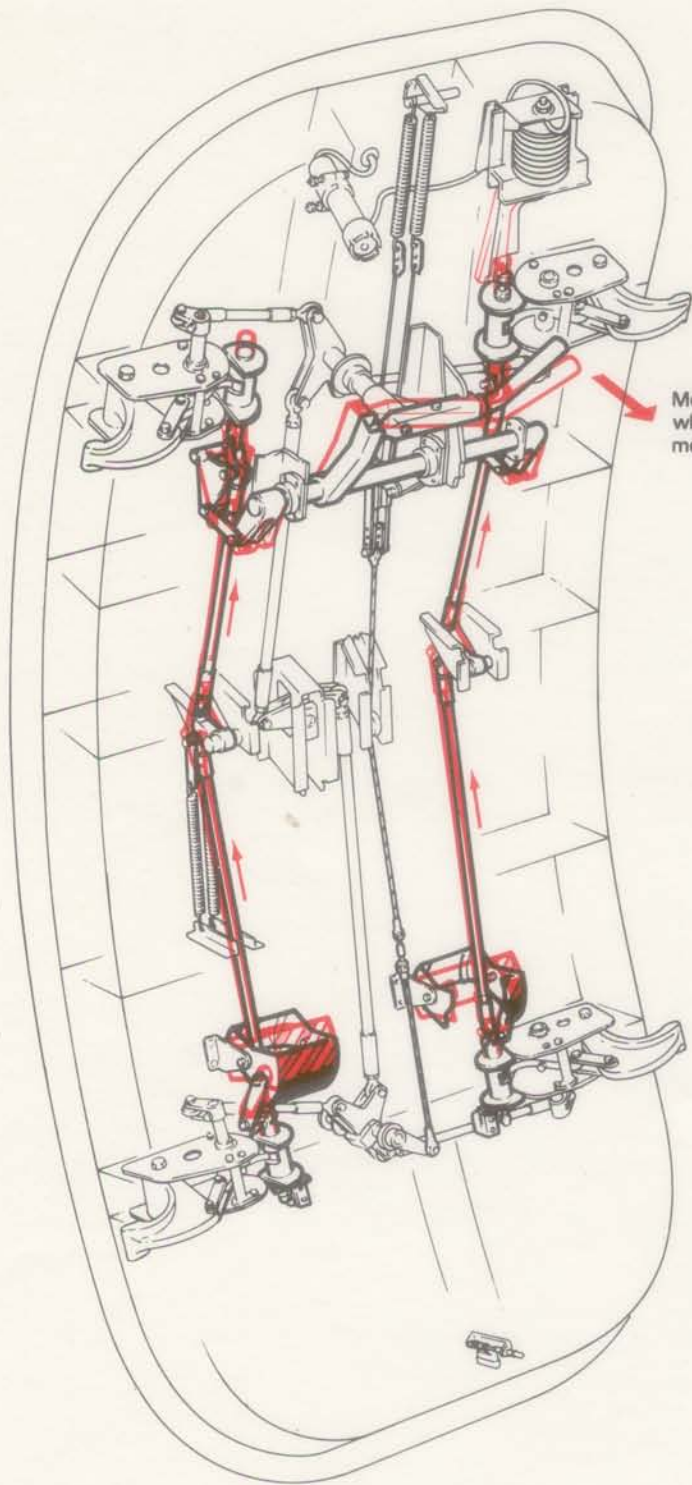
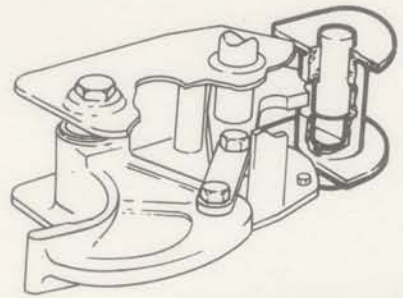
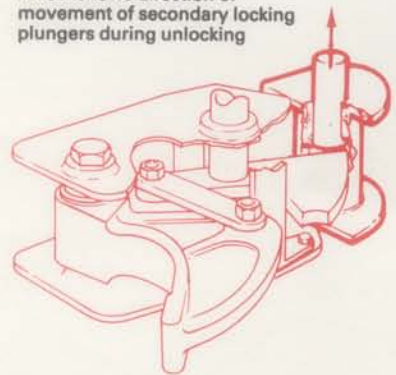
Figure 4 Secondary mechanism open/closed.

Movement of handle when operating secondary mechanism

Locked position

Arrow shows direction of movement of secondary locking plungers during unlocking

Open position

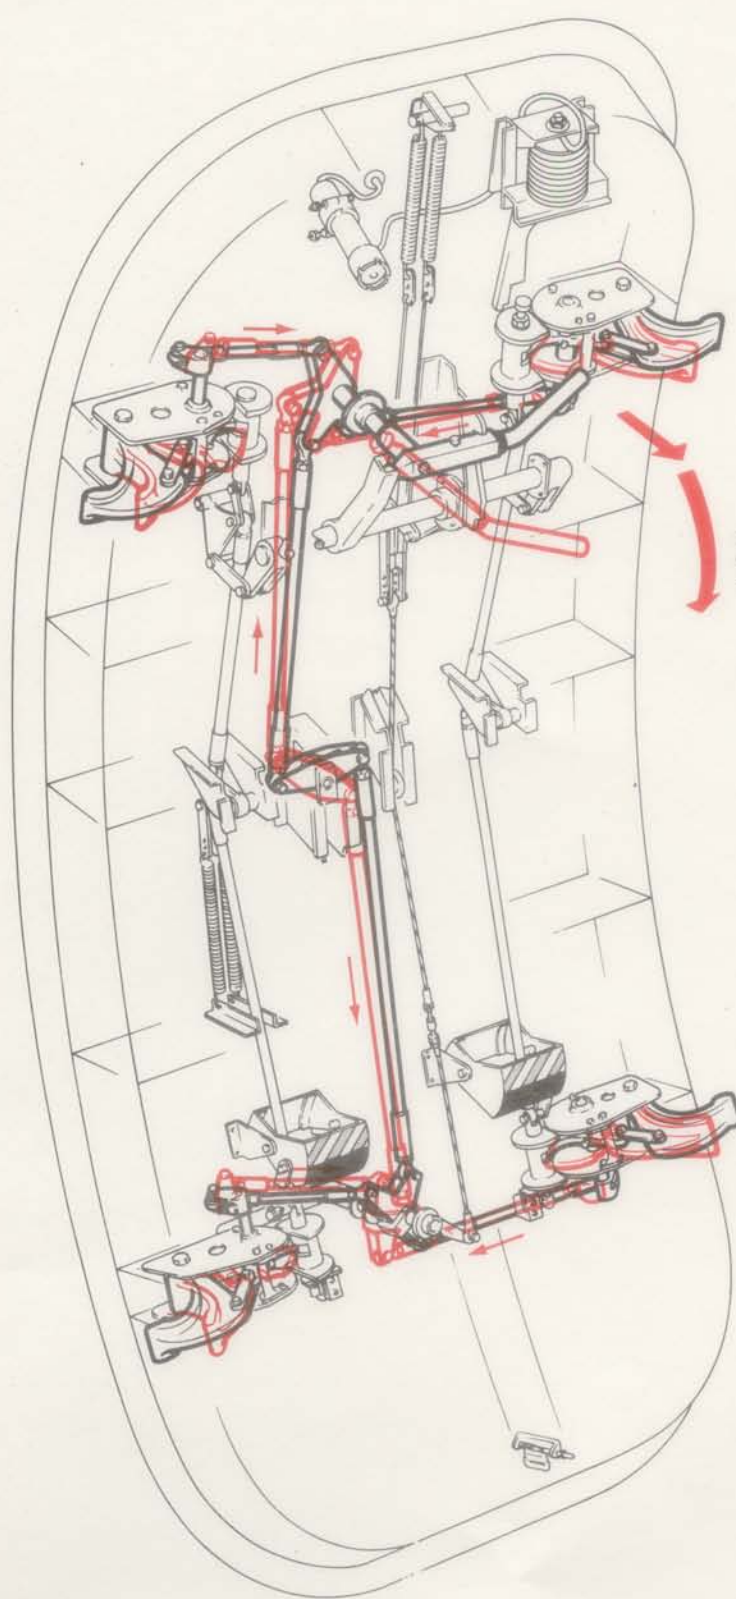
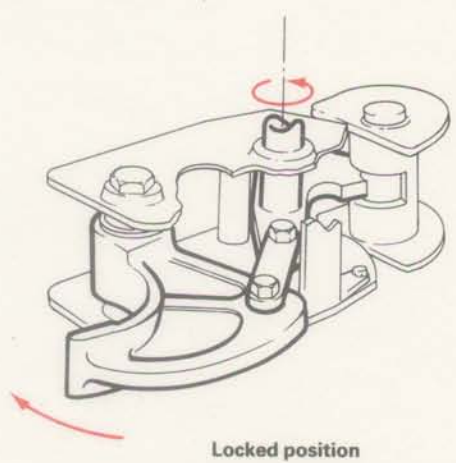
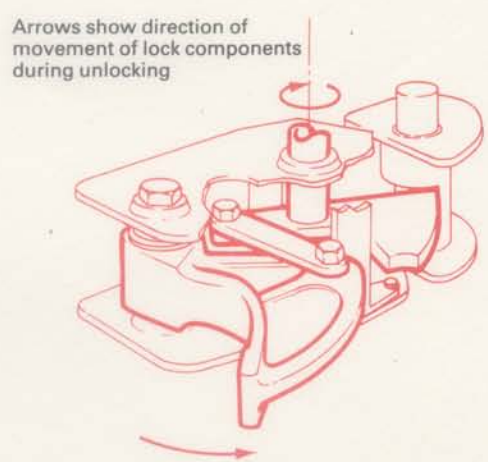
Figure 5 Primary mechanism open/closed.

Movement of handle
when operating primary
mechanism

Arrows show direction of
movement of lock components
during unlocking

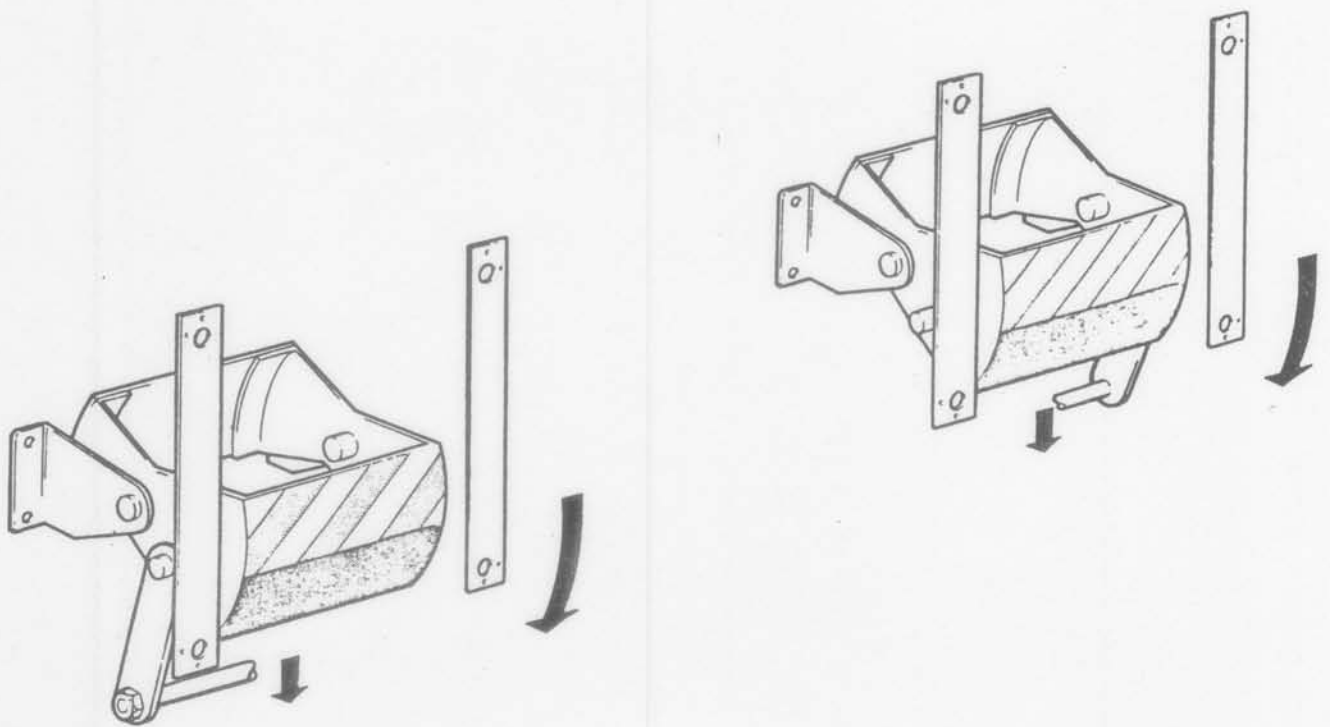
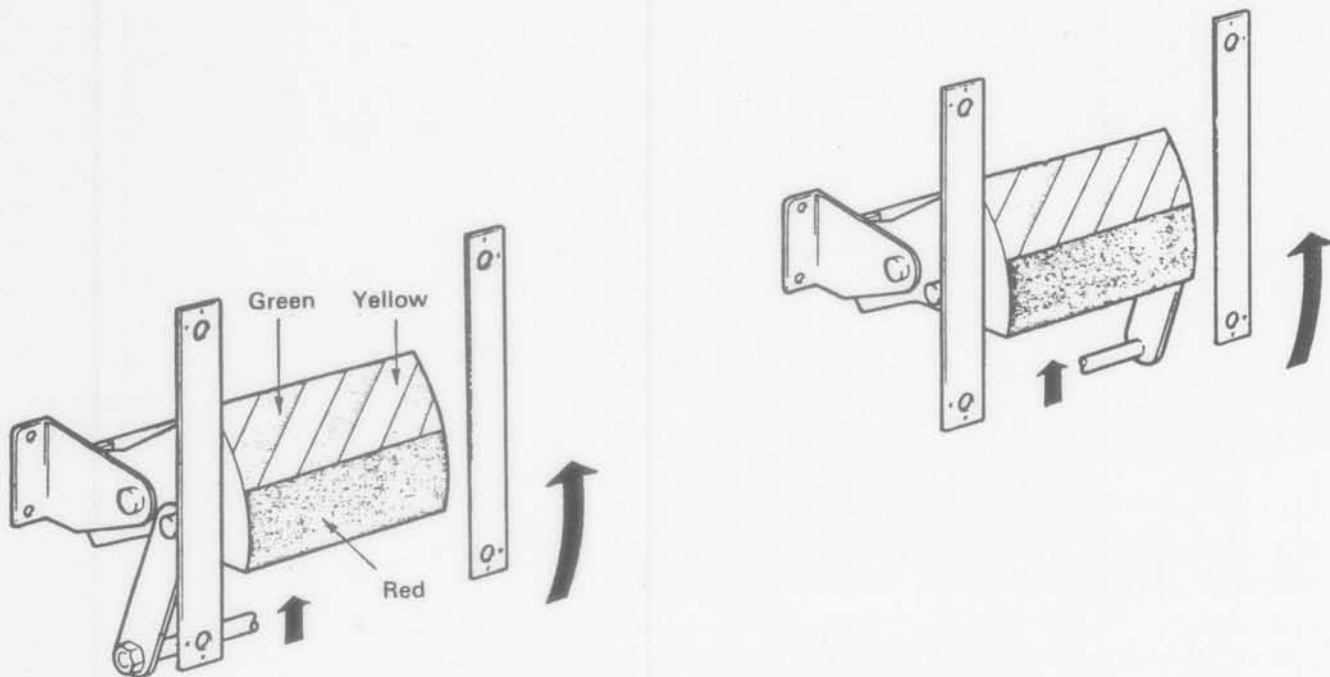
Figure 7 Effect of secondary lock movement on indicator drum position

Position of indicator drums with door safe

Position of indicator drums with door unsafe

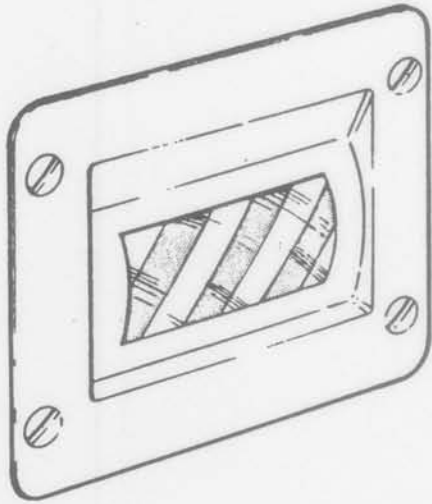
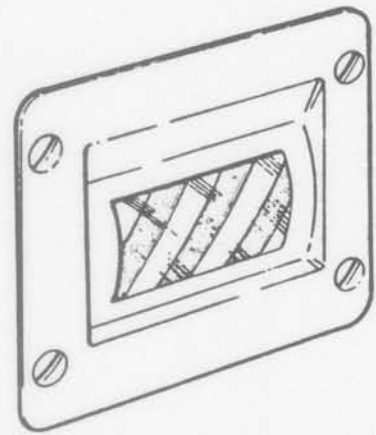
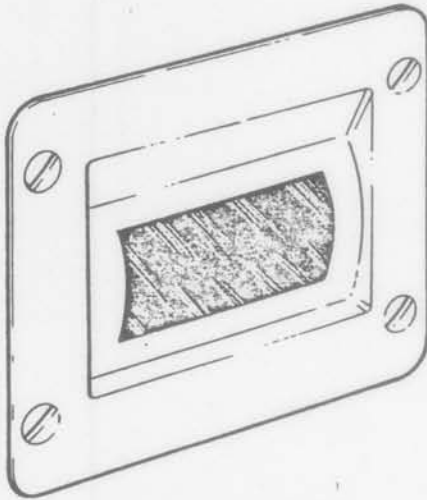
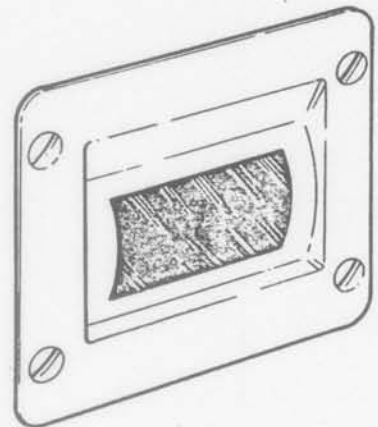
Figure 8 Views of indicators with windows in position

Normal door safe indication

Normal door unsafe indication

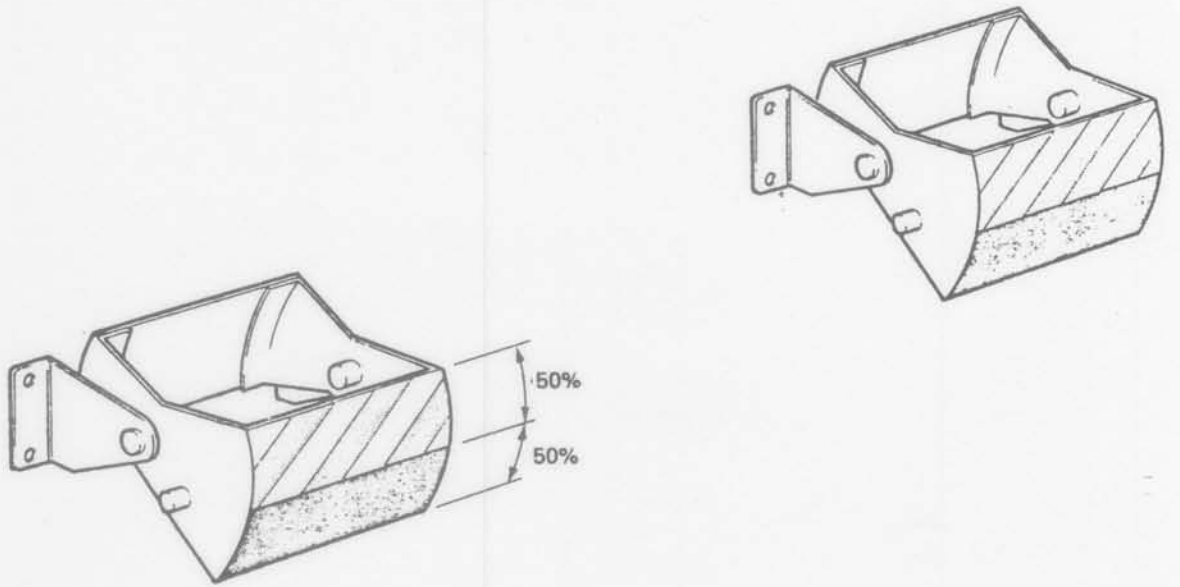
Figure 9 Drums on G-ASPL as apparently manufactured
