ACCIDENT

Aircraft Type and Registration:	Yak-52, G-LENA	
No & Type of Engines:	1 Vedeneyev M-14P piston engine	
Year of Manufacture:	1983	
Date & Time (UTC):	22 July 2006 at 1846 hrs	
Location:	Bournemouth Airport, Dorset	
Type of Flight:	Private	
Persons on Board:	Crew - 1	Passengers - 1
Injuries:	Crew - 1 (Fatal)	Passengers - 1 (Fatal)
Nature of Damage:	Aircraft destroyed, with post crash fire	
Commander's Licence:	Airline Transport Pilot's Licence	
Commander's Age:	49 years	
Commander's Flying Experience:	2,500 hours (of which 34 were on type) Last 90 days - 8 hours Last 28 days - 2 hours	
Information Source:	AAIB Field Investigation

Synopsis

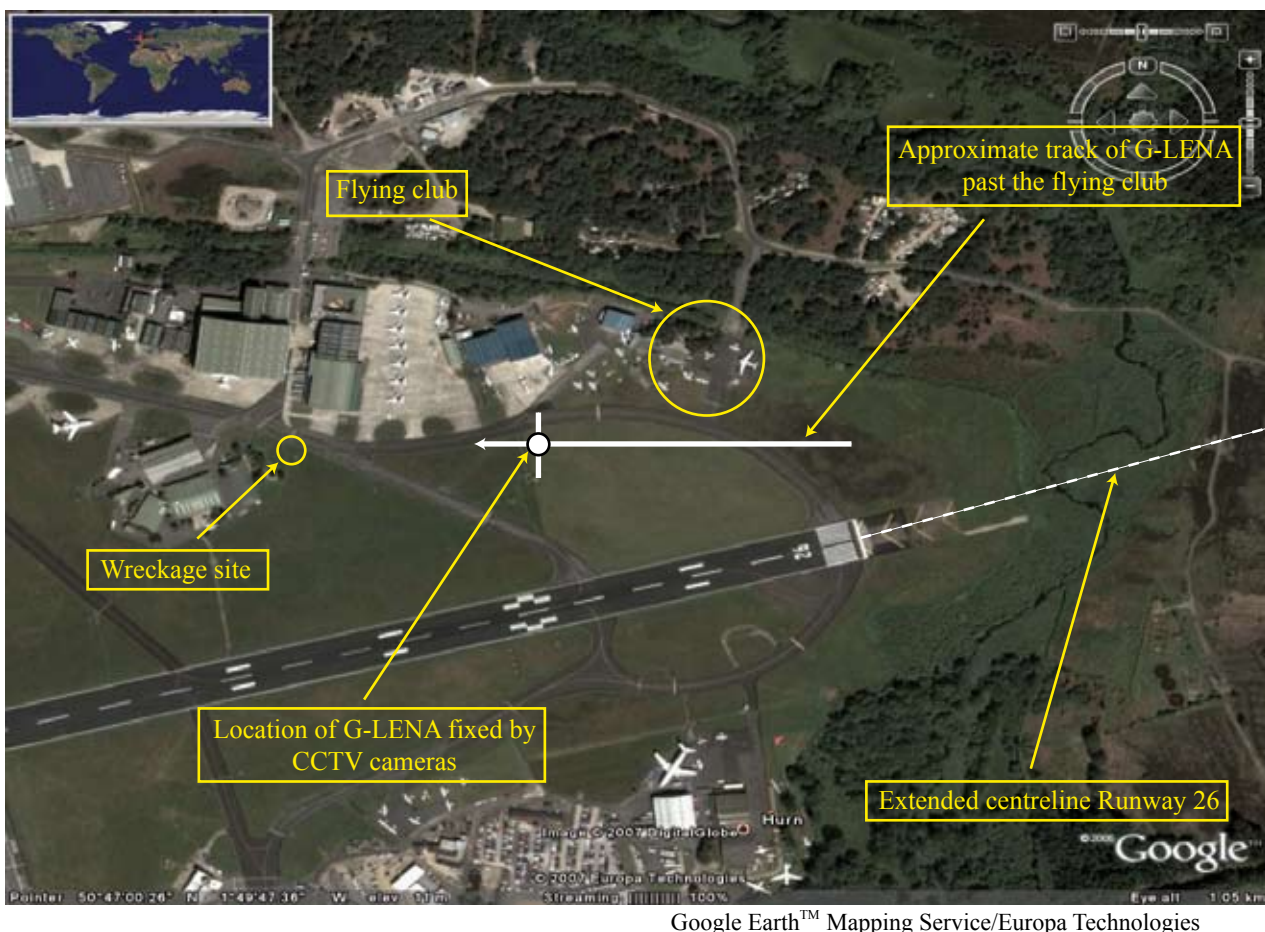
Figure 1

position over the ground was determined at one point, illustrated in Figure 1, when two images from different cameras were captured at the same time; this supported witness information that the aircraft was to the north of the runway centreline as it flew past the flying club.

Diagram illustrating accident site location, Runway 26 threshold area, estimated track of G-LENA and location of the flying club in relation to the accident site

The wreckage of G-LENA was examined on-site both on the night of the accident and the following day. The aircraft had struck the ground on a grassed area between a taxiway and some commercial buildings, Figure 1.
